CHECK OUT REPORT

SAMPLE ADDRESS

SAMPLE DATE

REF: SAMPLE

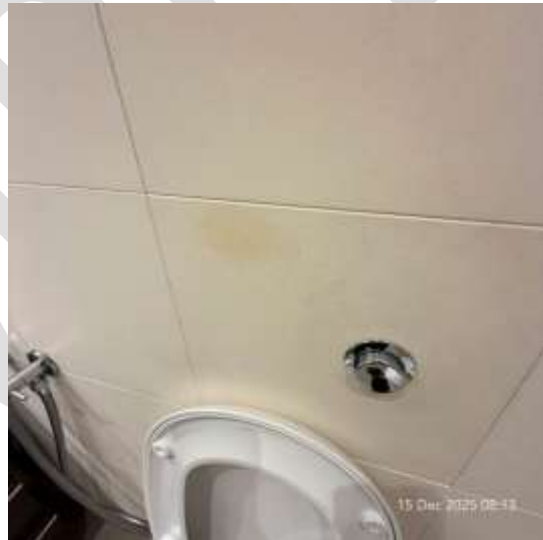
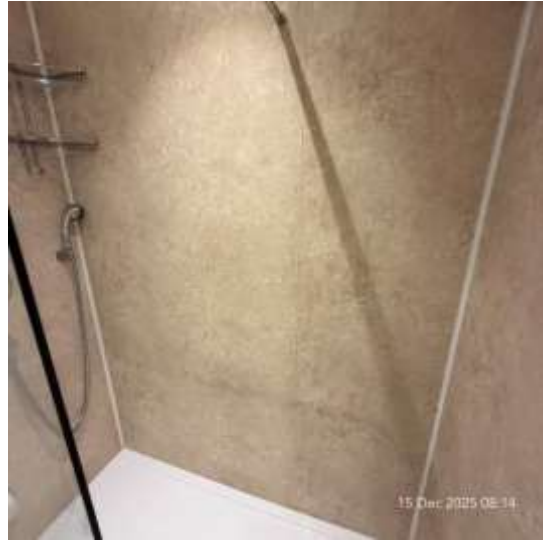
Cream limestone tiles professionally cleaned, additional chip defect to access panel left hand side, area of discolouration to tiles by flush which may improve with further clean, hairline crack defect to access panel by flush

Limestone effect laminate panelling now fitted to walls in shower cubicle, professionally cleaned – informed by tenant there was a leak during tenancy resulting in these being fitted approx 2 years ago, professionally cleaned

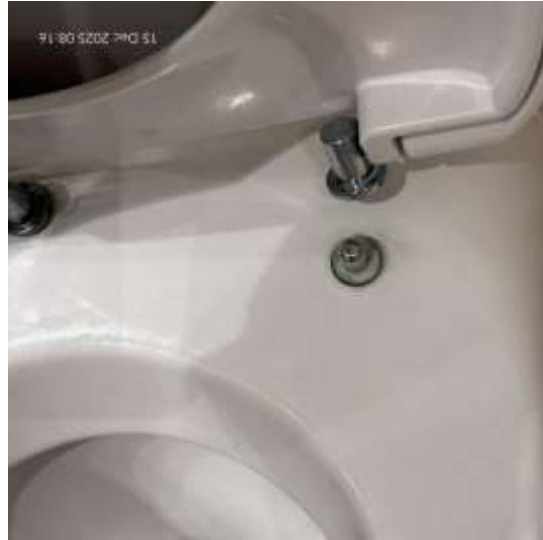
<p>Low level dark wood shelf unit with 2 drawers with chrome handles and chrome legs</p>	<p>Scattered worn marks</p>	<p><i>As per check in</i></p>
<p>White WC with white seat and lid, encased cistern with chrome flush</p>	<p>Seat off brackets, 4 buffers off to seat</p>	<p>professionally cleaned, defects as per check in, right hand seat bracket comes off and requires securing, landlord maintenance</p>

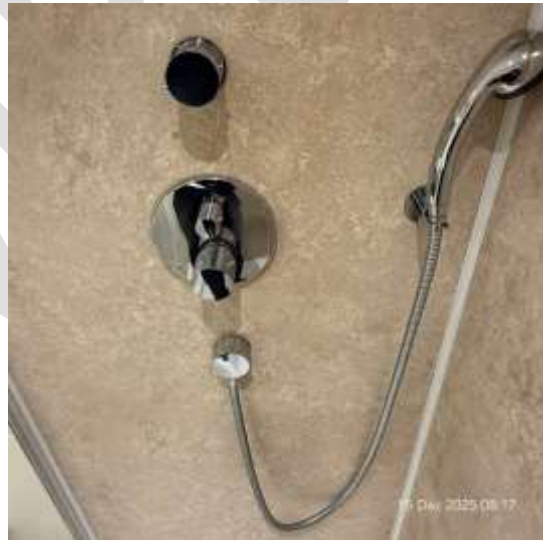
shower cubicle replaced since commencement with white shower tray with fixed tempered glass shower screen

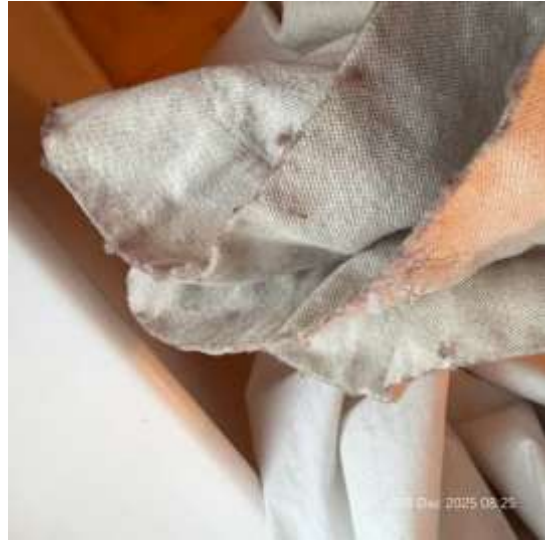
numerous hooks have broken off to left hand curtain and few to right hand curtain, very dusty to hem, not cleaned - **tenant**

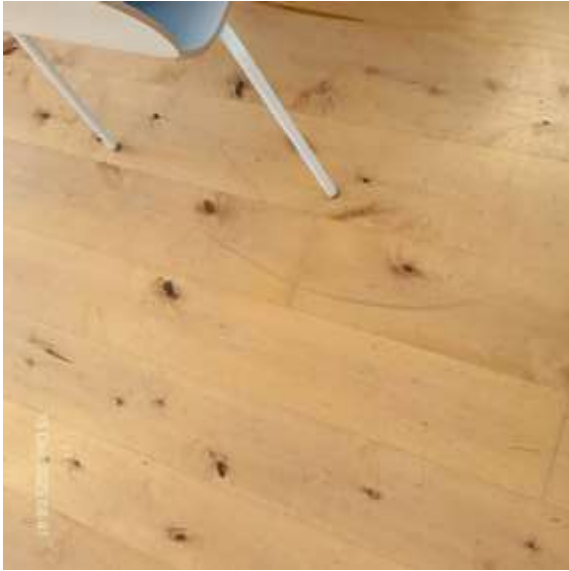
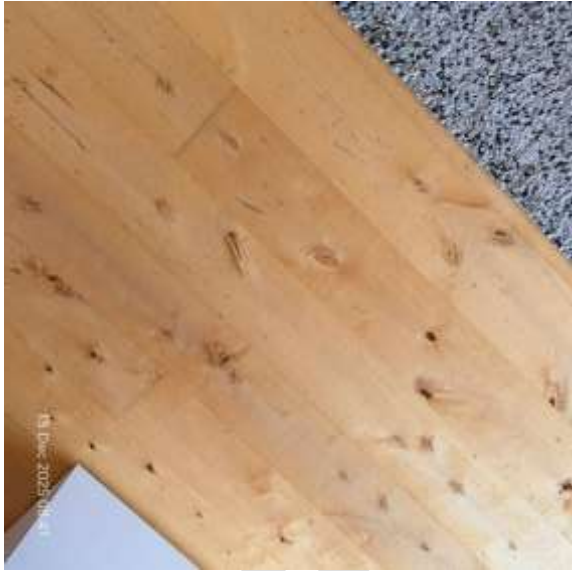
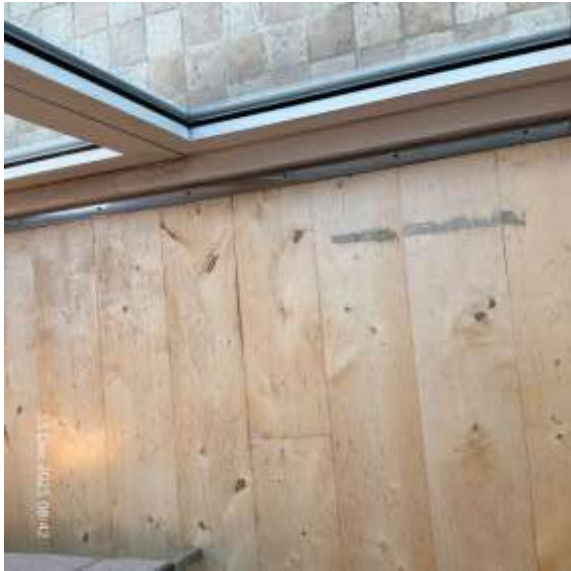
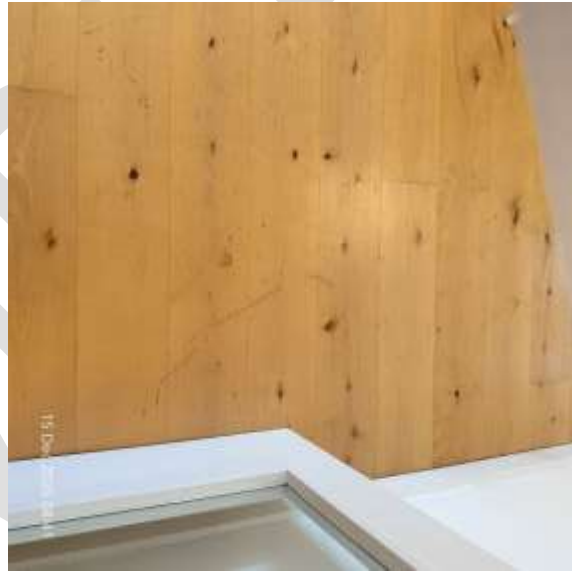
Continuation of wood strip flooring from entrance hall with chrome and rubber doorstop	Professionally cleaned. Scattered scratch and indentation marks around entrance area, not inspected under furniture, scattered indentation marks to walkway areas, slight patchy faded areas and light scratches to centre of room in front of TV, patchy faded appearance along line of windows, long dark line worn mark in front of right hand door onto balcony, long curved line indent by dining table, no rubber to doorstop	Professionally cleaned, not inspected under furniture, further ongoing wear and usage, further ongoing age sun fading in front of window
--	---	--

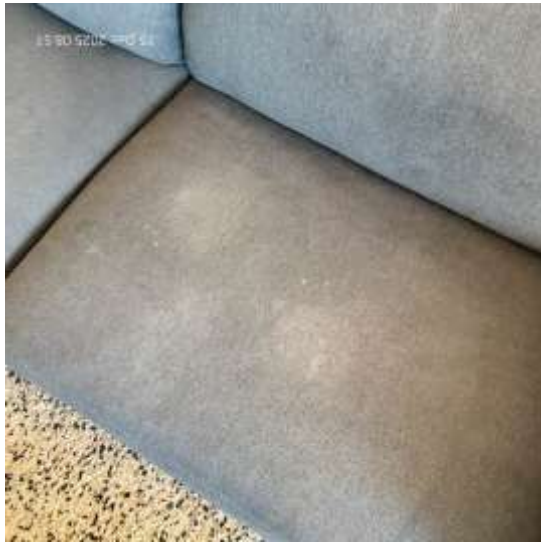
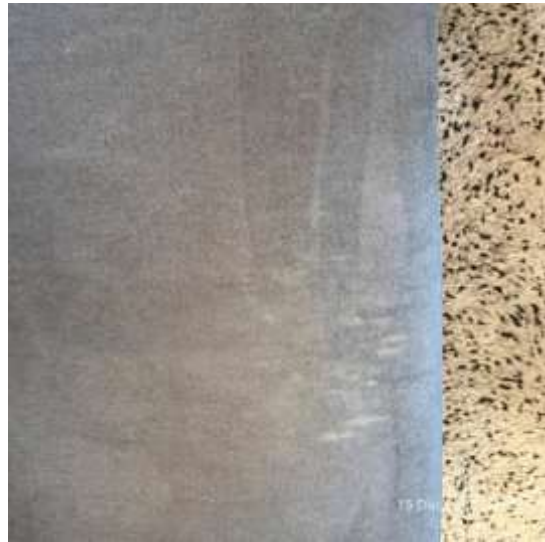
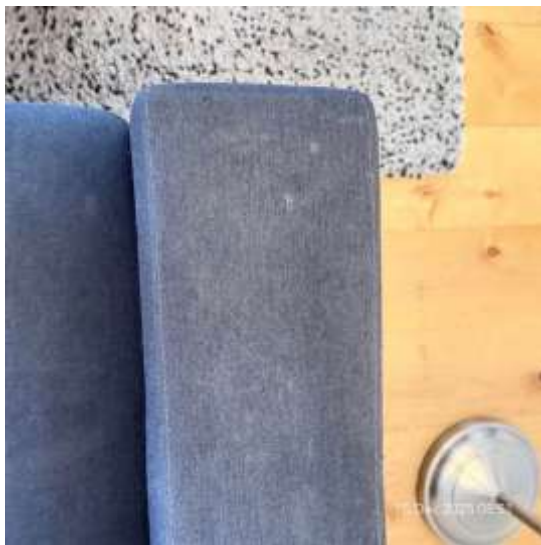
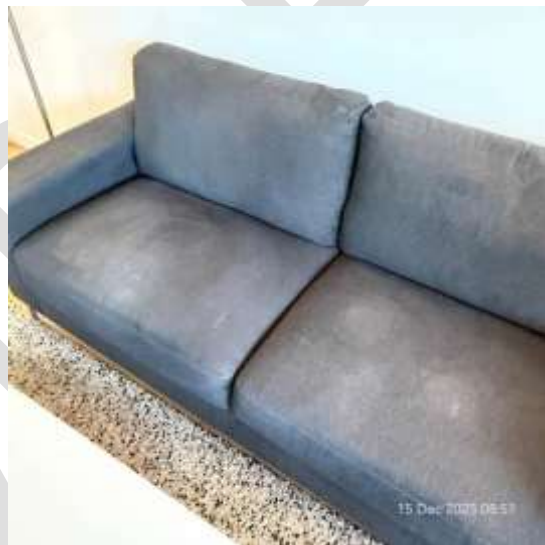
Grey fleece style 2-seater sofa with 2 fixed seat cushions and 2 Velcro backrest cushions on polished chrome legs		not cleaned, heavy patchy faded staining to seat cushions and to left arm, requires cleaning, stains may remain - tenant
---	--	---

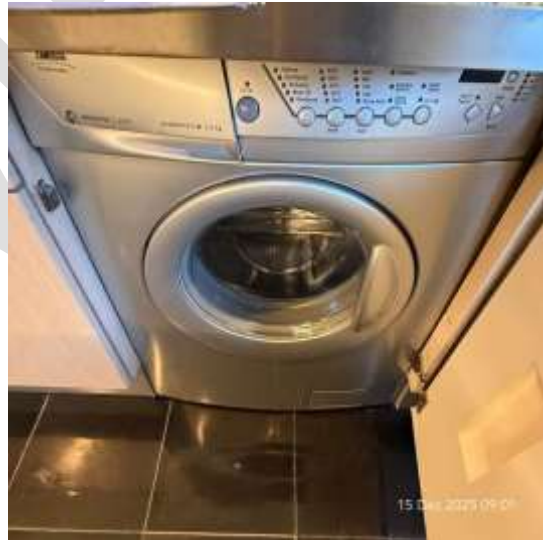
Stainless steel coloured Zanussi washing machine with outer brushed stainless steel décor door with chrome handle

top hinge to décor door loose and requires repair – **landlord maintenance**, tested for power only, professionally cleaned, mildew staining to seal which may improve with further cleaning, **tenant**

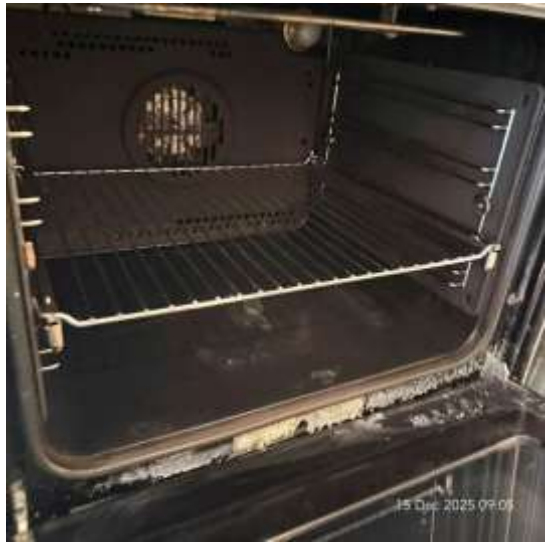
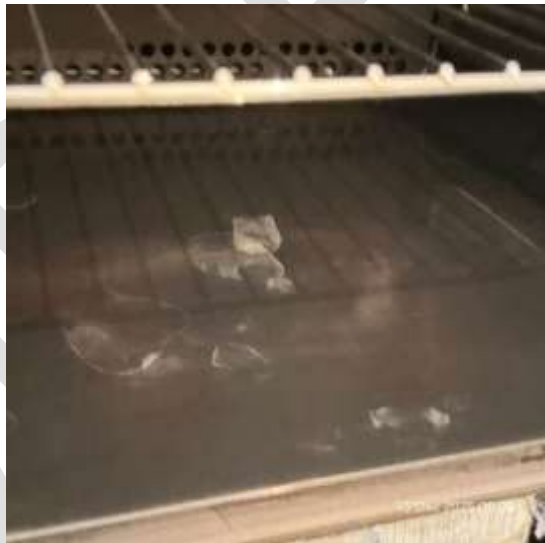
Fitted stainless steel Zanussi oven with black metal handle, grill tray and rack, 1 further rack

tested for power only, grill tray and rack not seen - **tenant**, cleaned but cleanser residue marks around base of casing, cleanser residue marks to base interior, requires further cleaning, light not coming on - **tenant**

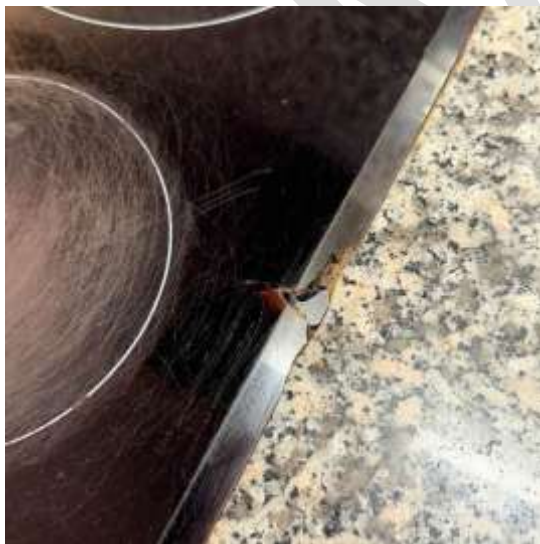
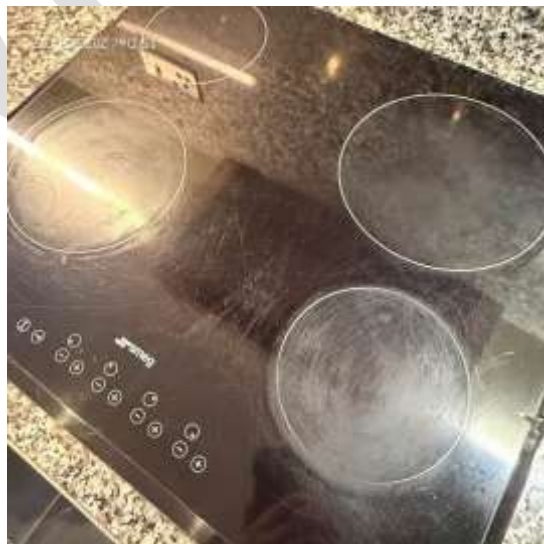
<p>Smeg 4-ring black ceramic hob</p>	<p>Tested for power only, scratches to front rings, 2 chip defects to left edge</p>	<p>Professionally cleaned, chip defects to left edge as per check in, further chip and crack defect to right edge - tenant, heavy marking to rings and scratch marks - tenant, tested for power only</p>
--------------------------------------	---	--

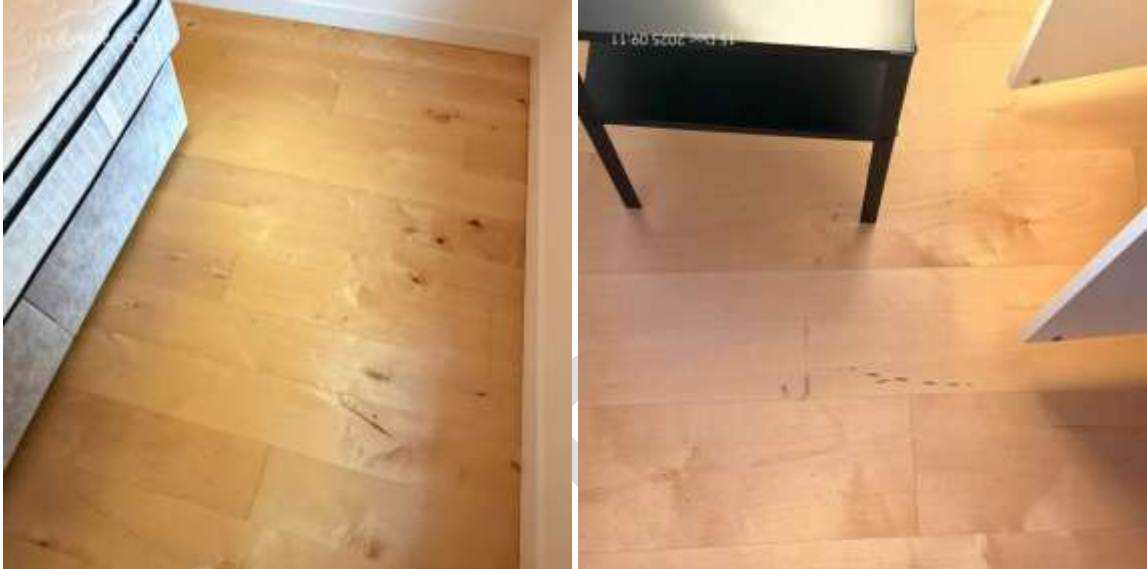
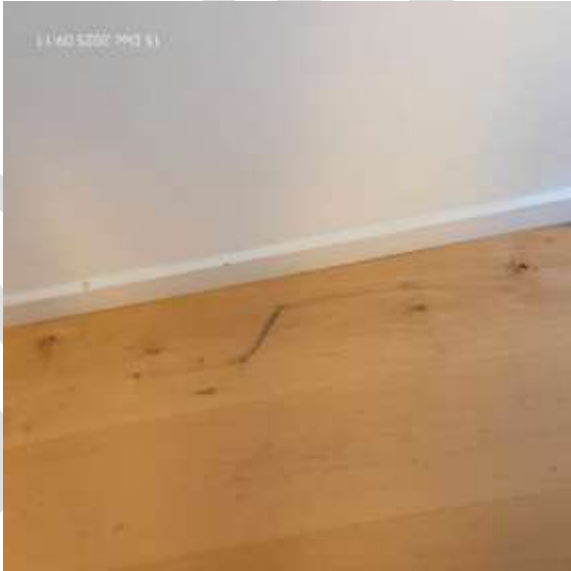
FLOORING		
Continuation of wood strip flooring from entrance hall with chrome door strip, chrome and rubber doorstop	Scattered indentation marks to walkways, scattered scratch marks to right hand side of bed area and in front of wardrobes, dark scratch marked areas forward of entrance with further dark scratch mark at foot of bed	Professionally cleaned, defects generally as per check in with further usage
