CHECK OUT REPORT

SAMPLE ADDRESS

SAMPLE DATE

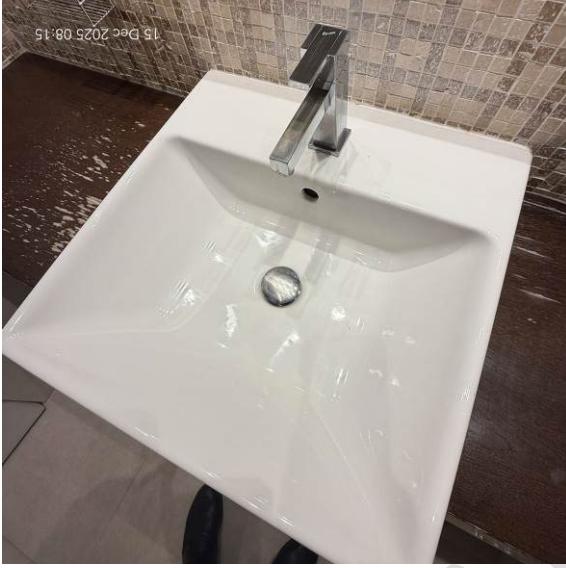
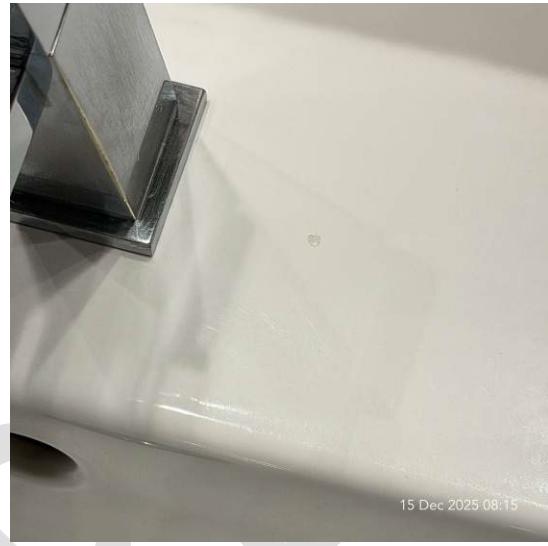
Polished chrome shaver point		
White wash basin with chrome mixer taps and chrome pop-up waste	Professionally cleaned Pop-up plug not working, 5mm chip defect to interior of basin to right hand side, heavy abrasions to tap spout	professionally cleaned, further approx 2mm chip defect right hand side of tap and 1 further chip to right edge - tenant

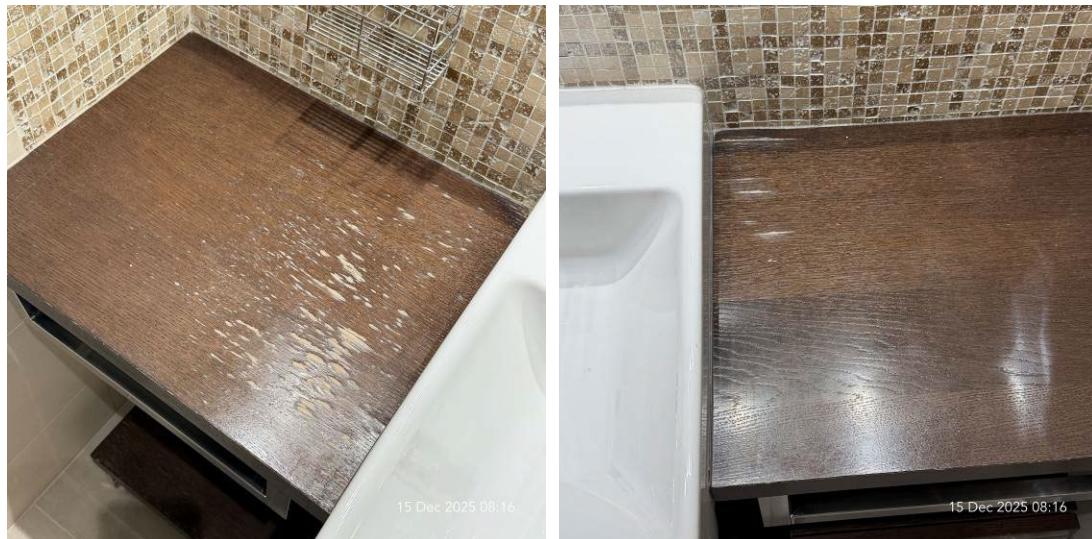
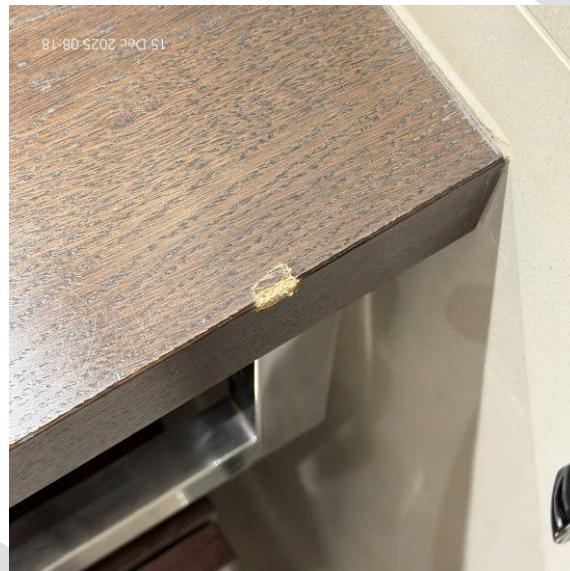
Dark wood worksurface with 2 chrome towel rails under	Very heavily worn to left hand side, further worn and blistered areas to right hand side	professionally cleaned, heavily worn as per check in, further chip defect to right front edge

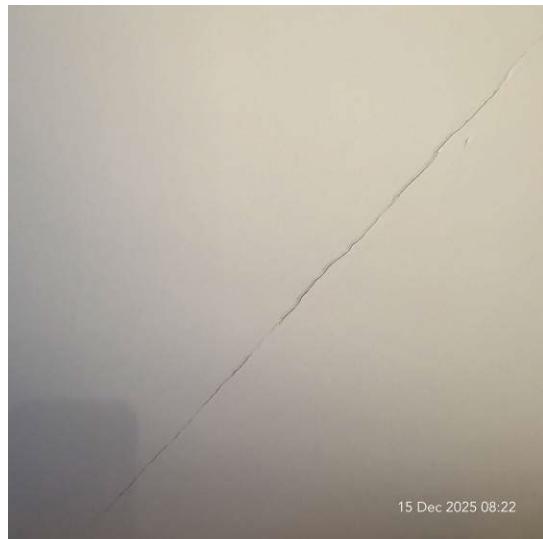
CEILING		
Painted white	Long crack defect across ceiling	As per check in landlord's attention

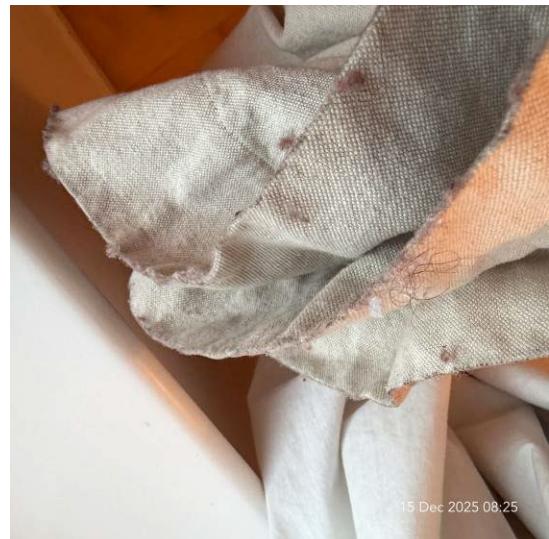
Pair of full length lined cream curtains on double chrome curtain pole with ball finials	Slight creasing, in clean order, minor paint marks to curtain pole	numerous hooks have broken off to left hand curtain and few to right hand curtain, very dusty to hem, not cleaned - tenant
--	--	---

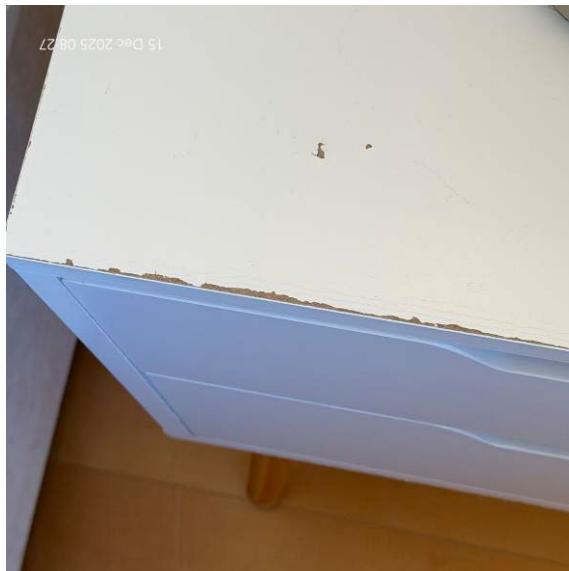
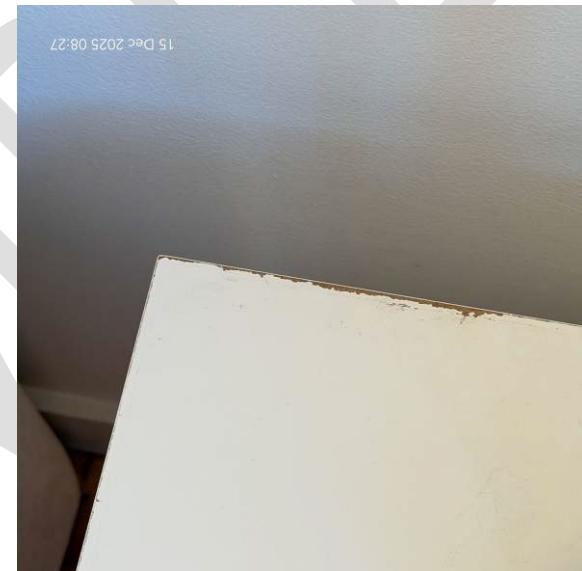
chipping defects to edges on right hand chest - **tenant**

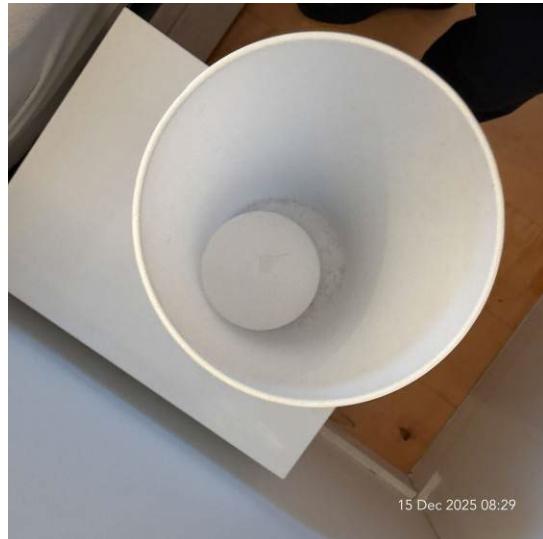
in working order, dusty to interior requires cleaning - **tenant**, shade slightly loose to left hand lamp - **wear and tear**

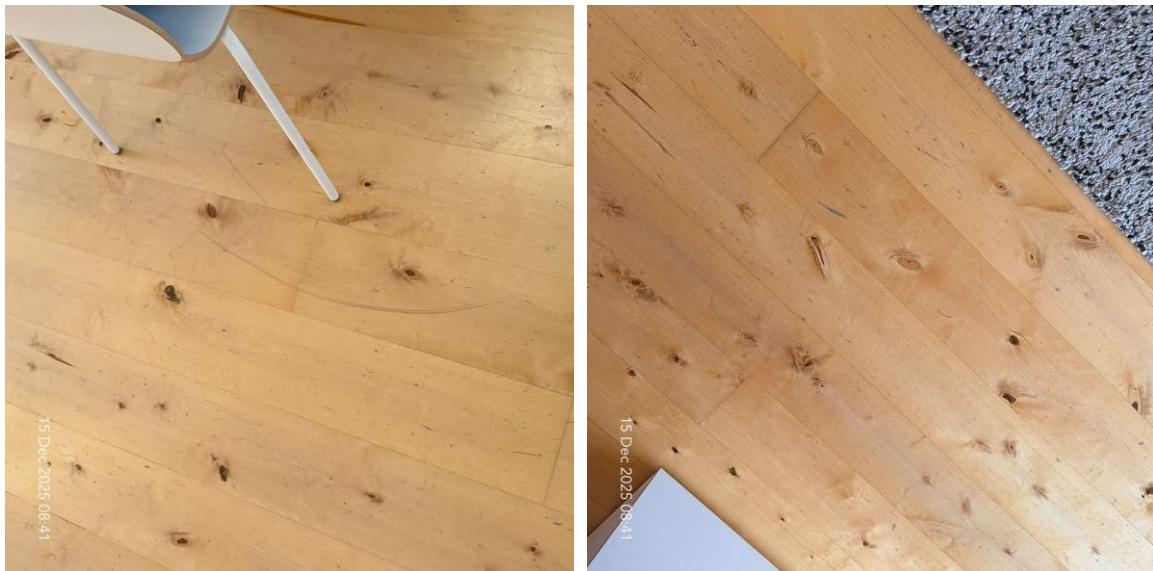
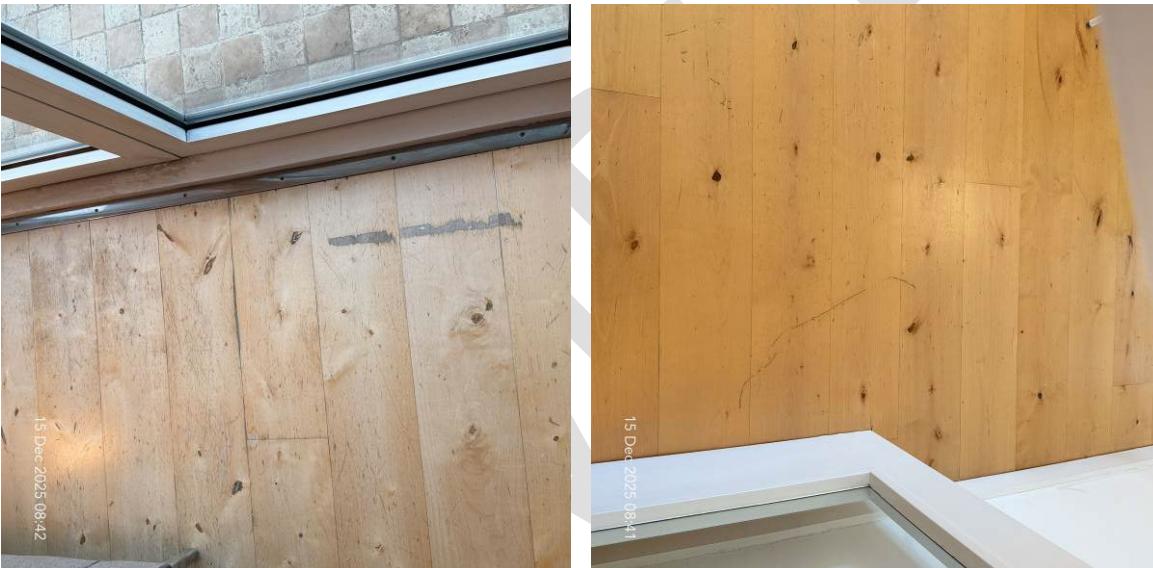
Continuation of wood strip flooring from entrance hall with chrome and rubber doorstop	Professionally cleaned. Scattered scratch and indentation marks around entrance area, not inspected under furniture, scattered indentation marks to walkway areas, slight patchy faded areas and light scratches to centre of room in front of TV, patchy faded appearance along line of windows, long dark line worn mark in front of right hand door onto balcony, long curved line indent by dining table, no rubber to doorstop	Professionally cleaned, not inspected under furniture, further ongoing wear and usage, further ongoing age sun fading in front of window
--	---	--

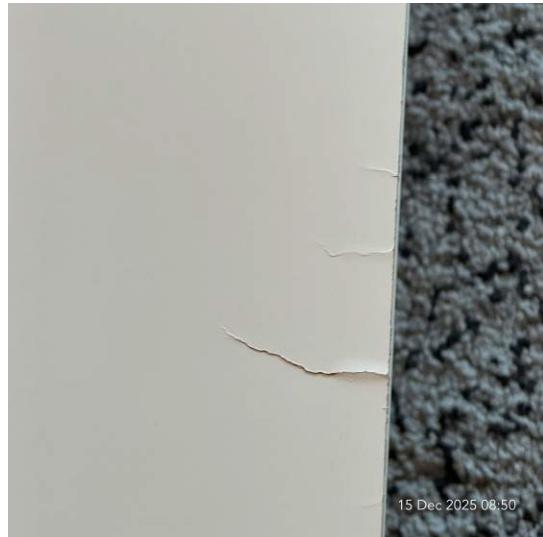
Rectangular white laminate 2-tier coffee table		3 crack defects to edge - tenant
--	--	---

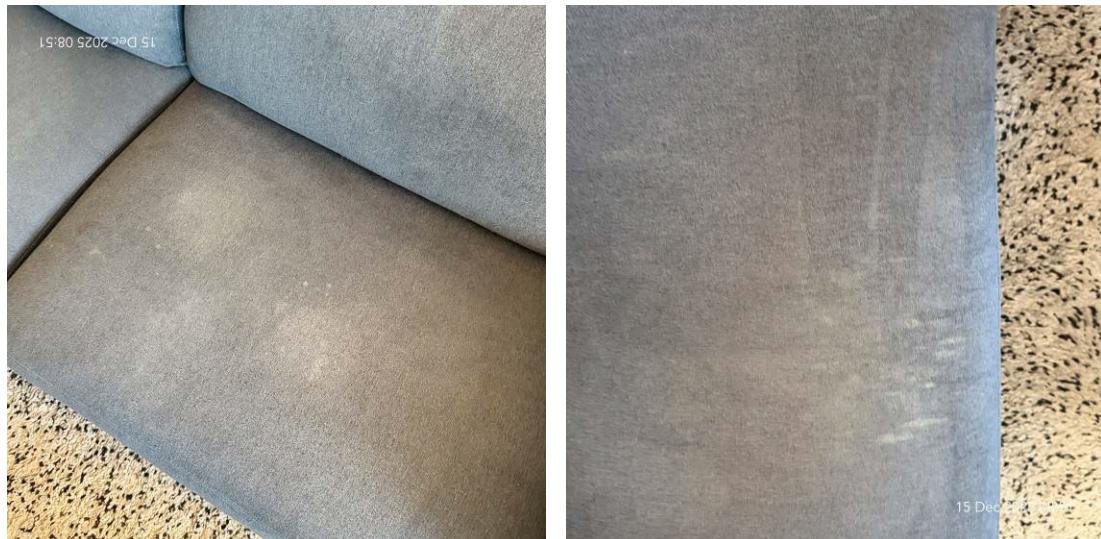
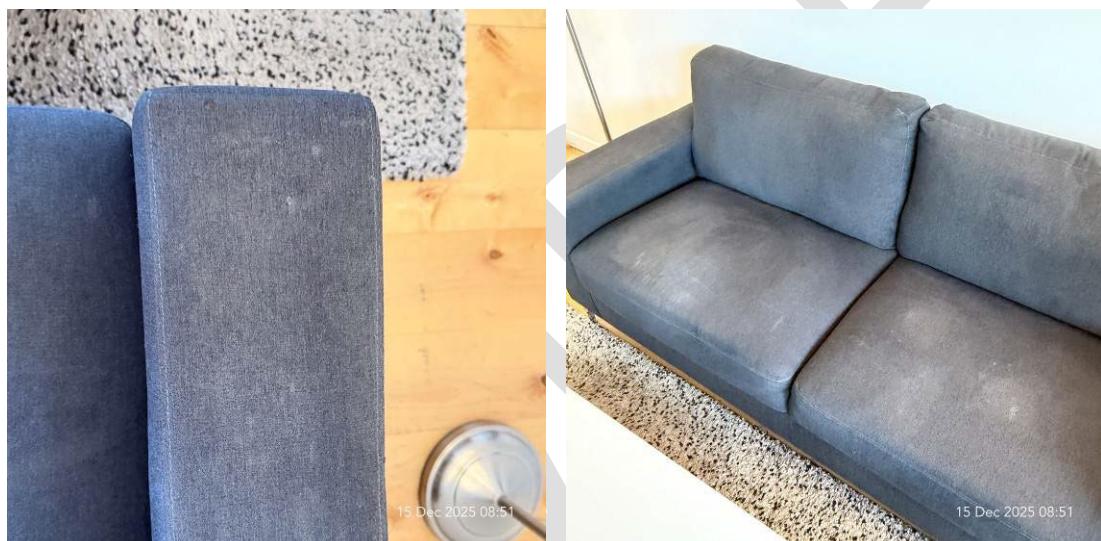
Grey fleece style 2-seater sofa with 2 fixed seat cushions and 2 Velcro backrest cushions on polished chrome legs		not cleaned, heavy patchy faded staining to seat cushions and to left arm, requires cleaning, stains may remain - tenant
---	--	---

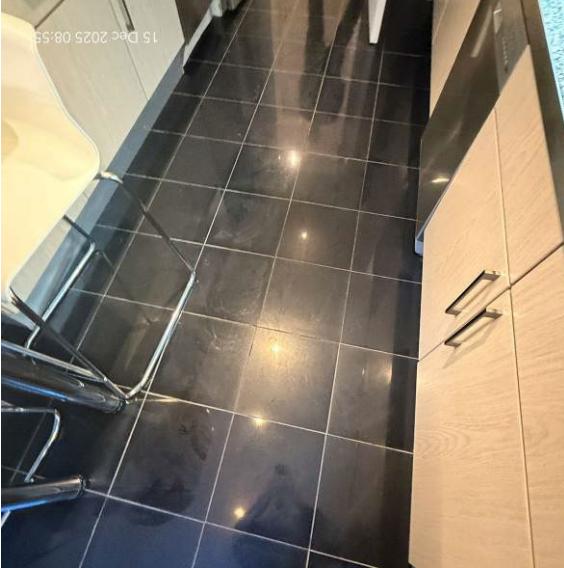
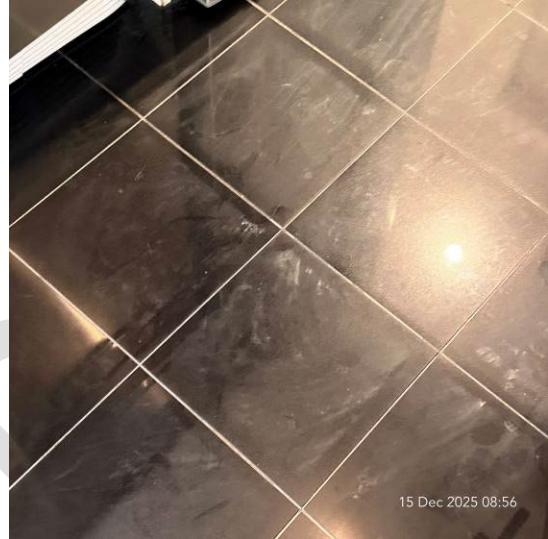
FLOORING		
Polished black marble tiles with chrome door strip	Minor crumbling to grouting at entrance, slightly smeary, scattered light scratches in front of hob area, slight white discolouration to grouting in parts, slightly dusty	very smeary and require cleaning - tenant

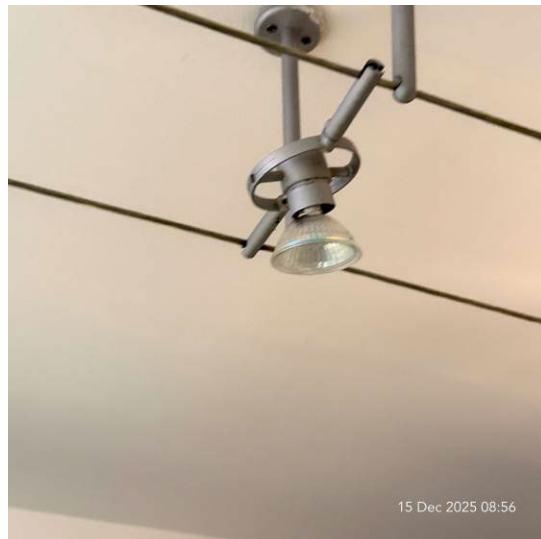
15 Dec 2025 08:56
CEILING		
Painted white	Slight crack defect by window	As per check in
LIGHTING		
Cable fitting running across room with 3 small halogen spotlights and 2 further cylindrical halogen spotlights with opaque glass shades	In working order and glass broken to same fitting	1 bulb not working - tenant

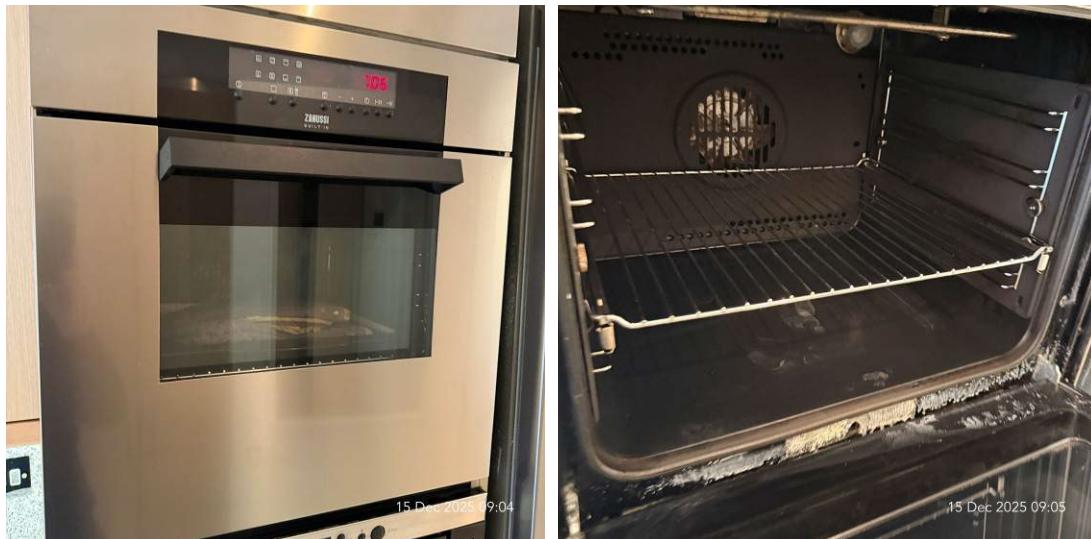
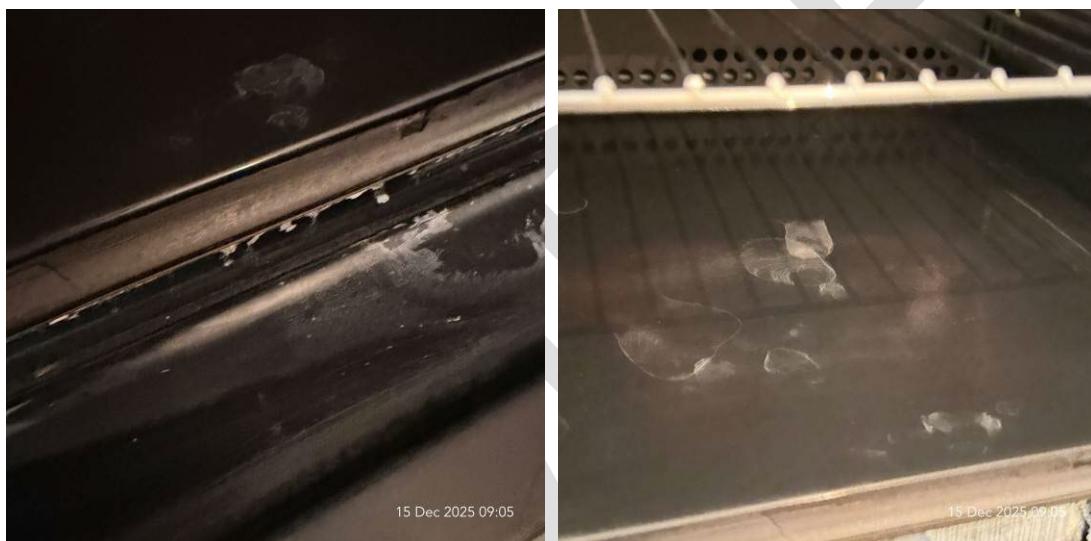
tested for power only, grill tray and rack not seen - **tenant**, cleaned but cleanser residue marks around base of casing, cleanser residue marks to base interior, requires further cleaning, light not coming on - **tenant**
