CHECK OUT REPORT

SAMPLE ADDRESS

SAMPLE DATE

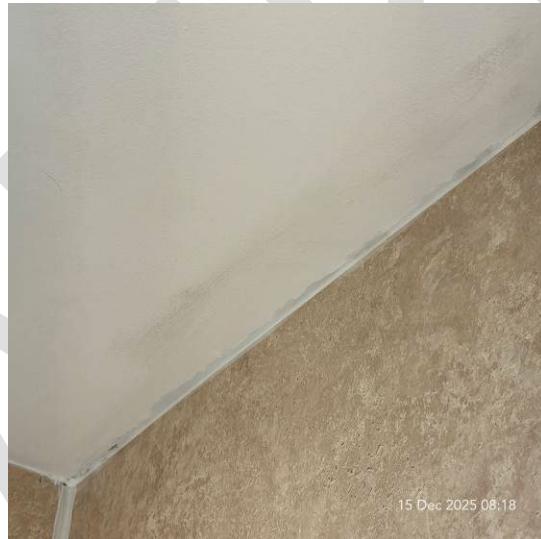
CEILING

Painted white	Small chip defect by 1 light fitting	Discolouration around edge of ceiling over shower cubicle which appears to be from where panelling has been fitted
---------------	--------------------------------------	--

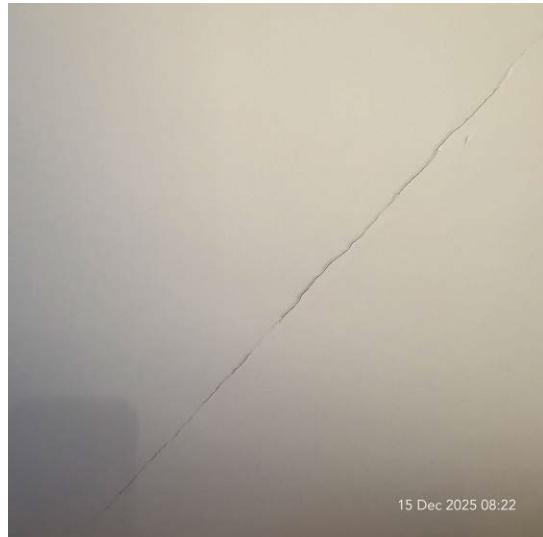
CEILING		
Painted white	Long crack defect across ceiling	As per check in landlord's attention

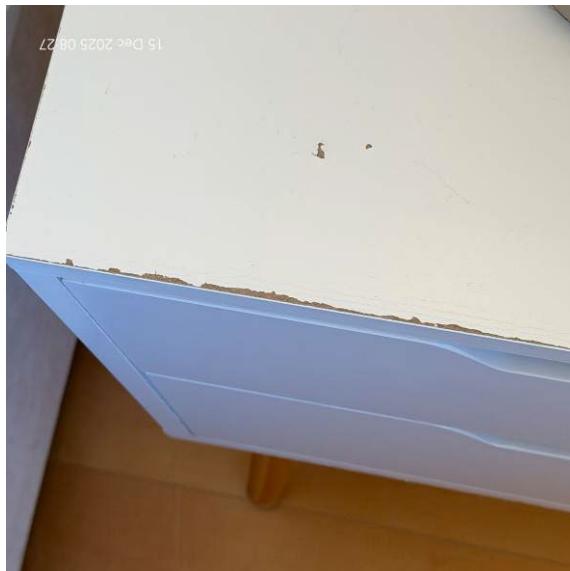
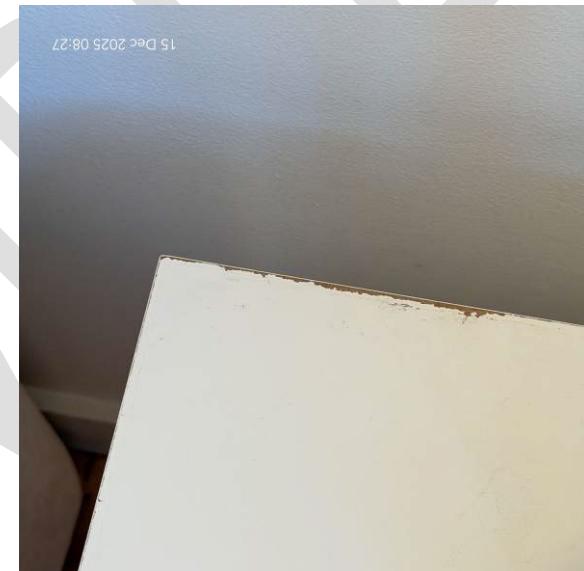
2 white laminate 2-drawer bedside chests with light wood legs

chipping defects to edges on right hand chest - **tenant**

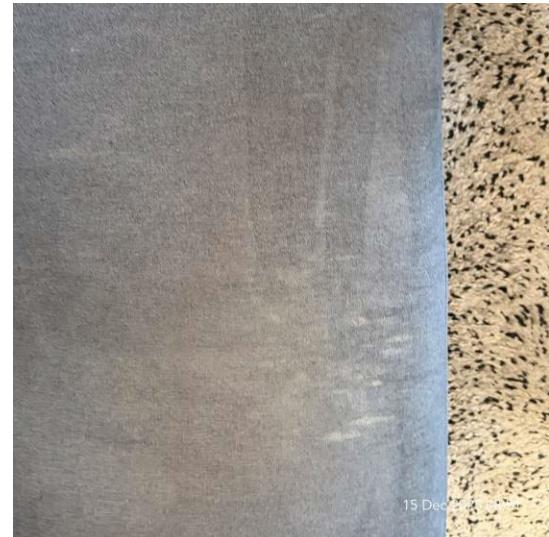
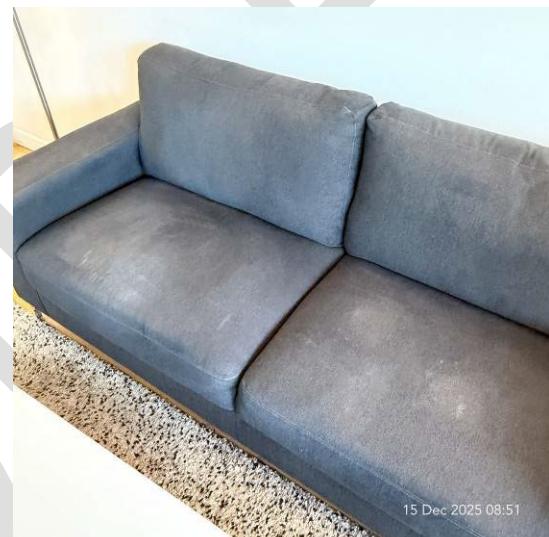
Grey fleece style 2-seater sofa with 2 fixed seat cushions and 2 Velcro backrest cushions on polished chrome legs		not cleaned, heavy patchy faded staining to seat cushions and to left arm, requires cleaning, stains may remain - tenant
---	--	---

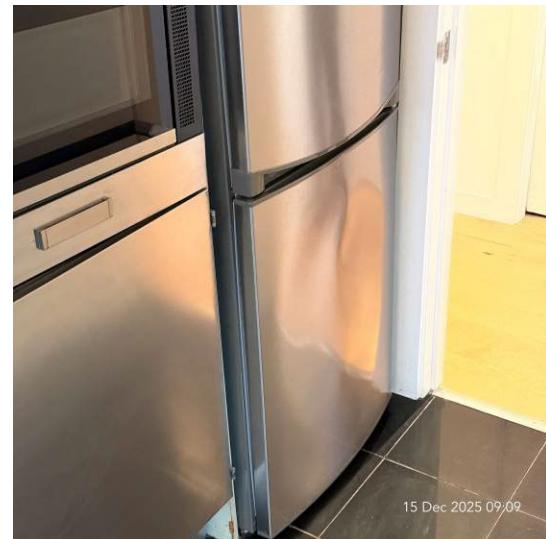
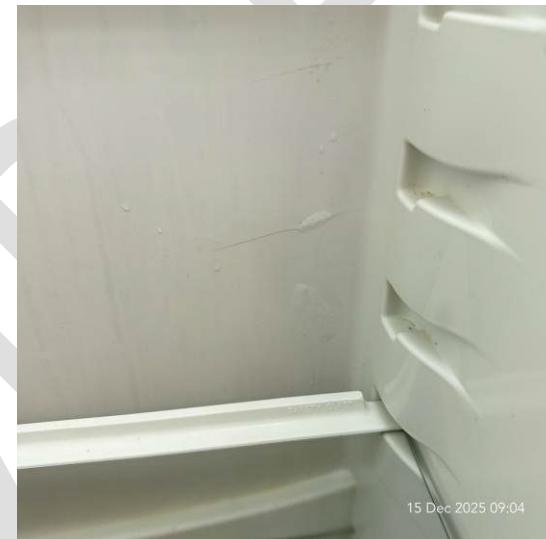
tested for power only, professionally cleaned, large dent to exterior of freezer door - **tenant**, 1 further spare door compartment found on top of kitchen units, hairline crack to back panel
