INTERIM INSPECTION REPORT

SAMPLE ADDRESS

SAMPLE DATE

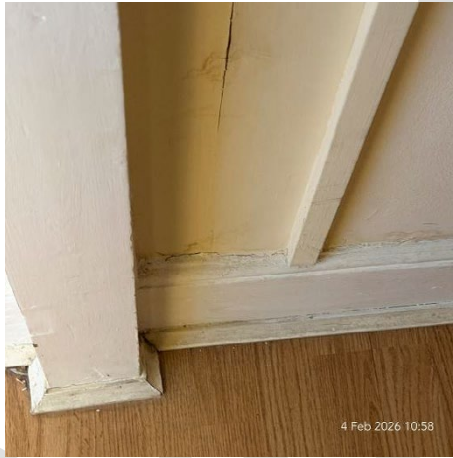
Staining noted adjacent to the shower room door, consistent with previous water ingress. Area appeared dry at the time of inspection, with damp meter readings within a normal range (indicative only). Leak staining to ceiling as per check in

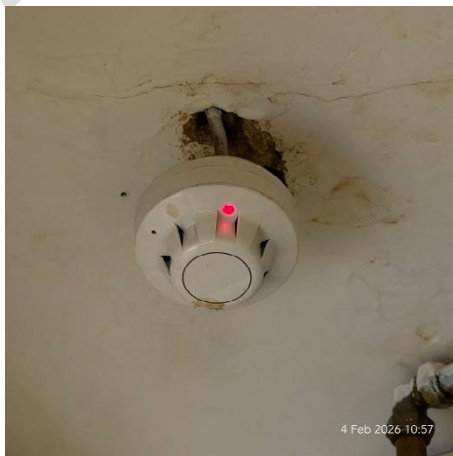
Heat detector hanging loose from ceiling and requires repair

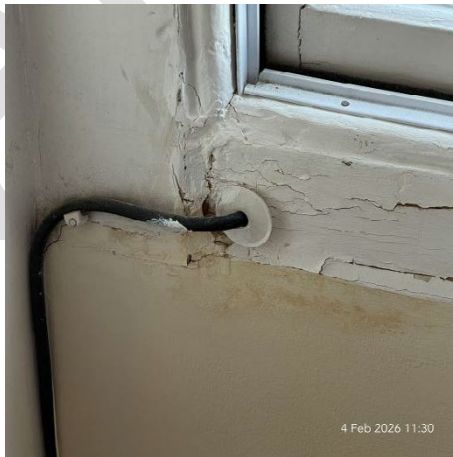
leak staining under window, area appeared dry at the time of inspection, with damp meter readings within a normal range (indicative only)

Paint flaking to base of frame possibly due to leak damage as noted under decor

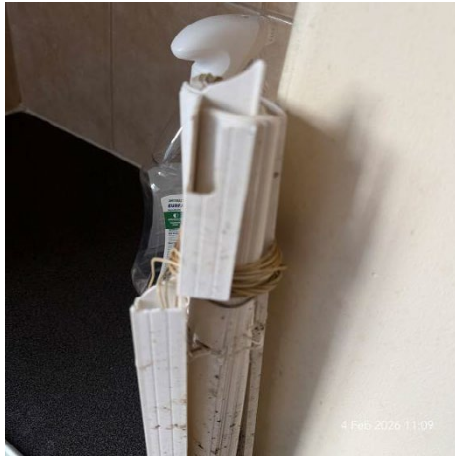
Decor	further low level scuffs and splash marks to walls, now very grubby to wall left hand side of entrance
Flooring	Observed to be in reasonable condition, consistent with normal occupation and the condition recorded at check-in.
Windows	Crack to 1 pane – appears due to stress.
Units & worktops	1: Kitchen unit door below sink noted as being taped at commencement now no longer taped but hinge loose. 2: Worktops as per check in
Sink & taps	Loose taps repaired since check in
Appliances	Appliances observed externally only. No testing carried out. Cleanliness below the standard recorded at check-in.
Cleanliness	below the standard recorded at check-in
Content defects	Venetian blind off and broken

Blind as above

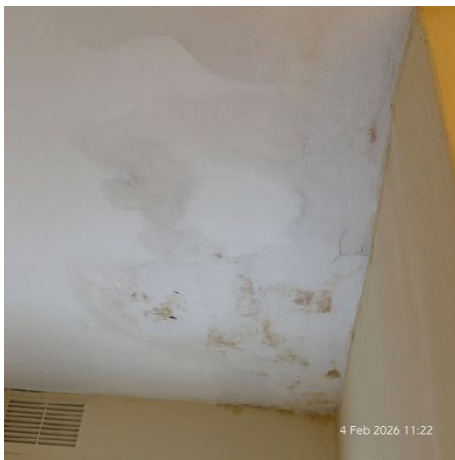
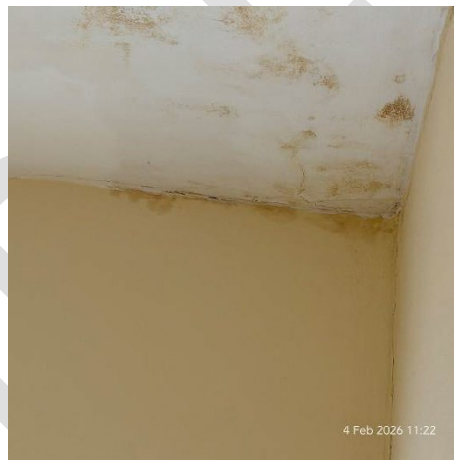
Large leak damaged area over WC which continues to wall to same area

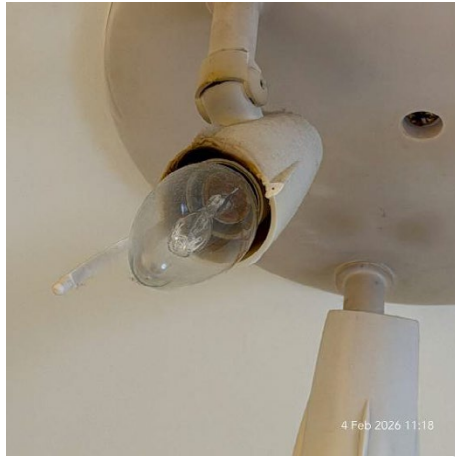
piece of bracket broken off to 1 of the lights with heat marking to same light

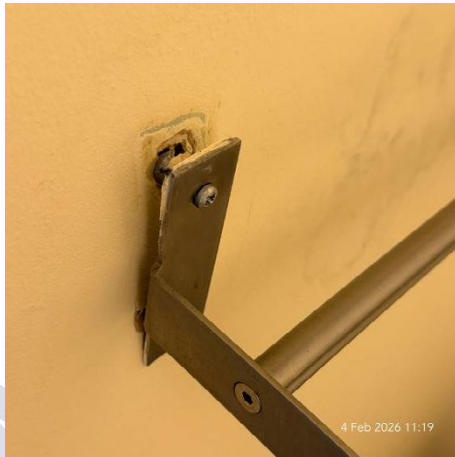
towel rail coming away from wall
