**INTERIM INSPECTION REPORT**

**SAMPLE ADDRESS**

<b>Inspection date:</b>	4 <sup>th</sup> February 2026
<b>Tenancy Check in date:</b>	3 <sup>rd</sup> August 2025
<b>Property type:</b>	1 bedroom, furnished apartment
<b>Tenant Present:</b>	No
<b>Access Gained To:</b>	All main rooms
<b>Access Restrictions (if any):</b>	none

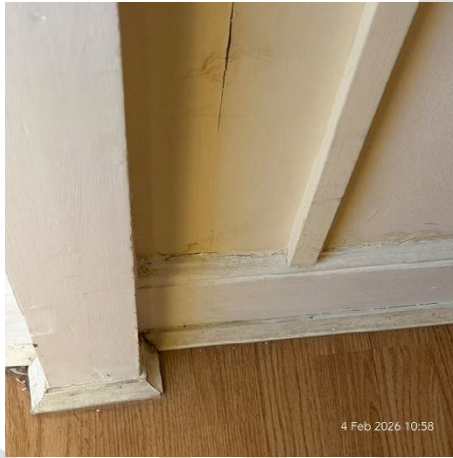
Staining noted adjacent to the shower room door, consistent with previous water ingress. Area appeared dry at the time of inspection, with damp meter readings within a normal range (indicative only). Leak staining to ceiling as per check in

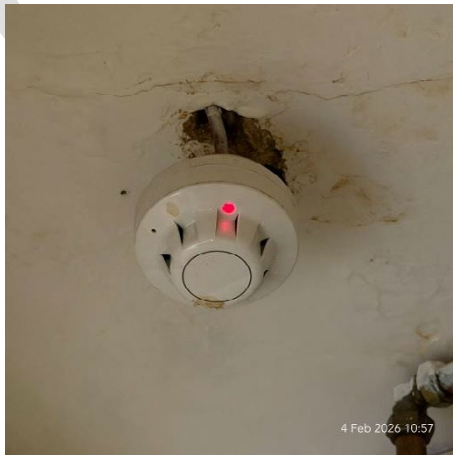
Heat detector hanging loose from ceiling and requires repair

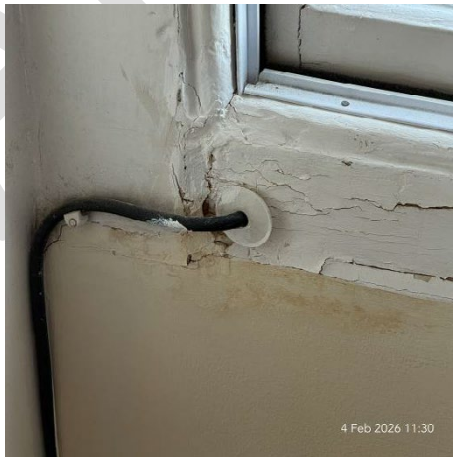
leak staining under window, area appeared dry at the time of inspection, with damp meter readings within a normal range (indicative only)

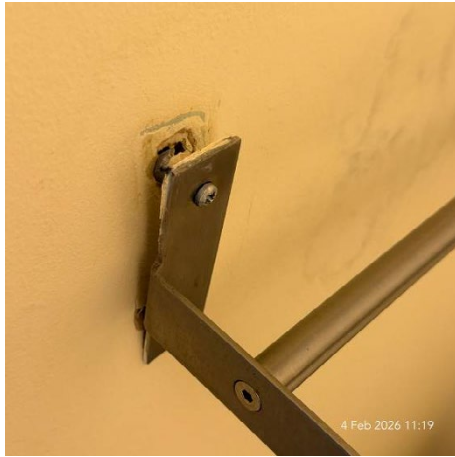
<b>Decor</b>	Large leak damaged area over WC which continues to wall to same area

<b>Maintenance issues</b>	towel rail coming away from wall

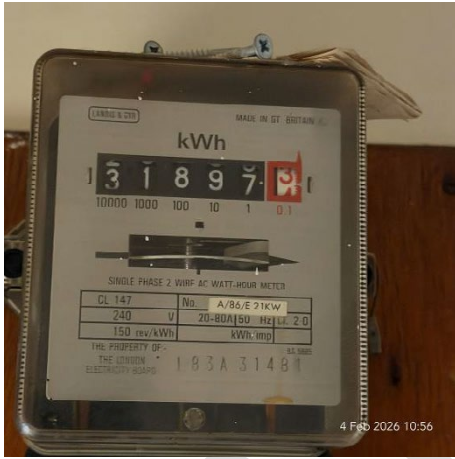
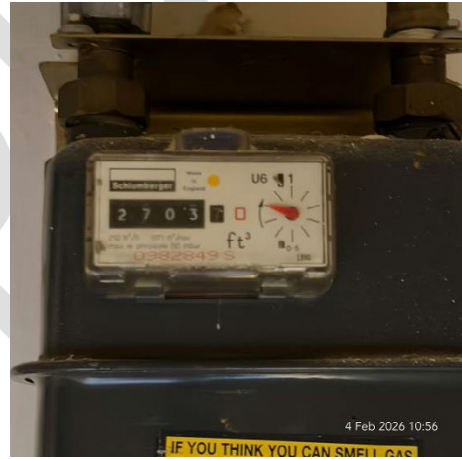
ELECTRIC METER:		GAS METER:	
READING	31897	READING	2703
SERIAL NUMBER	183A31481	SERIAL NUMBER	0982849S
LOCATION	Entrance Hall	LOCATION	Entrance Hall
