INTERIM CONDITION REPORT

SAMPLE ADDRESS

SAMPLE DATE

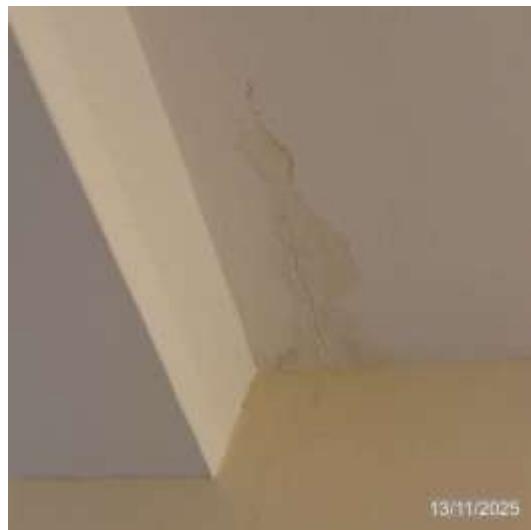
ENTRANCE HALL

Walls appear in reasonable condition overall at the time of inspection. Crack and historic leak staining to the ceiling in the central hallway area, appearing dry at the time of inspection. Tenant advised that the leak has been repaired [landlord information](#)

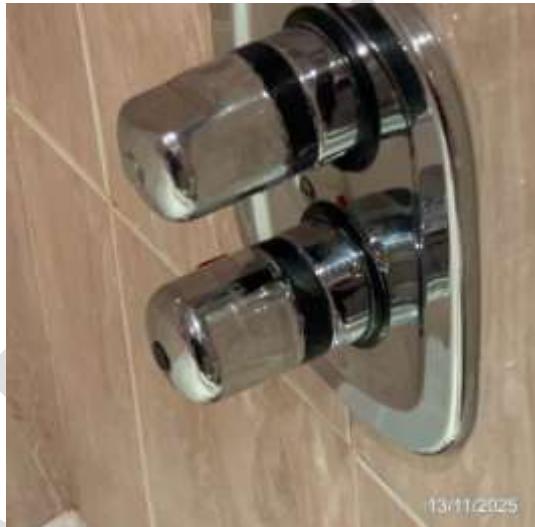
BATHROOM

Decor	Appear in reasonable condition marks consistent with ongoing occupation.
Flooring	Observed to be in reasonable condition at the time of inspection.
Windows	Appear serviceable at the time of inspection. No obvious concerns noted.
Cleanliness	Considered acceptable at the time of inspection.
Maintenance issues	Intermittent dripping observed from the shower mixer tap at the time of inspection – landlord maintenance

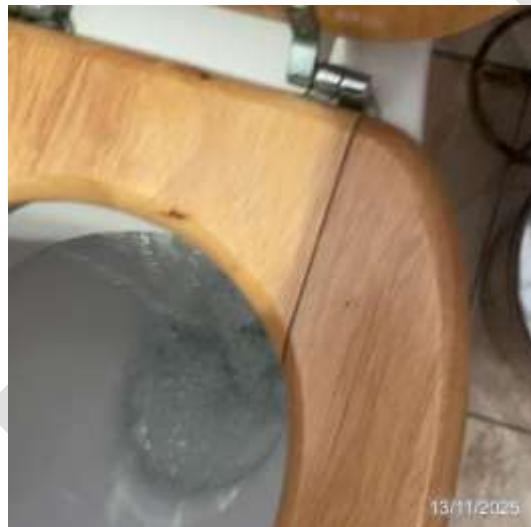
Decor	Appear in reasonable condition marks consistent with ongoing occupation.
Flooring	Observed to be in reasonable condition at the time of inspection.
Windows	Appear serviceable at the time of inspection. No obvious concerns noted.
Cleanliness	Considered acceptable at the time of inspection.
Maintenance issues	WC seat cracked to rear right side

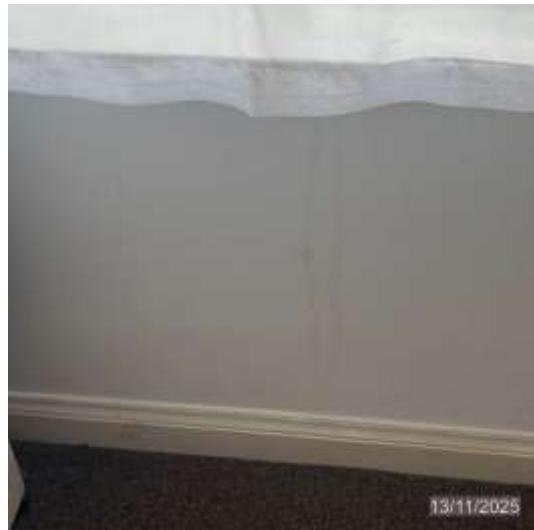
Generally as per check in with further water staining under window which appear dry, **Landlord information and tenant to monitor**

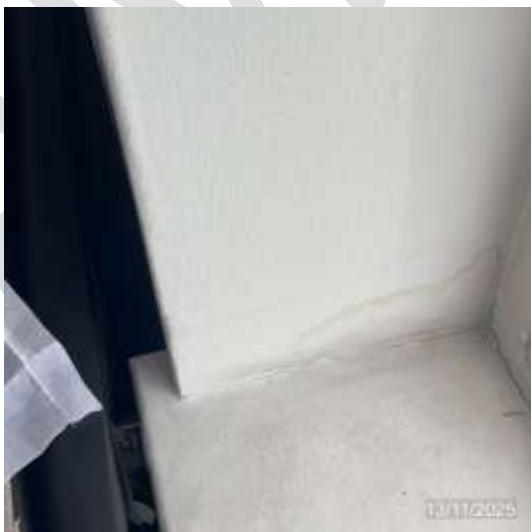
Appear serviceable at the time of inspection, water stains to reveal, informed by tenant that the windows do condensate and requires further investigation, **Landlord**

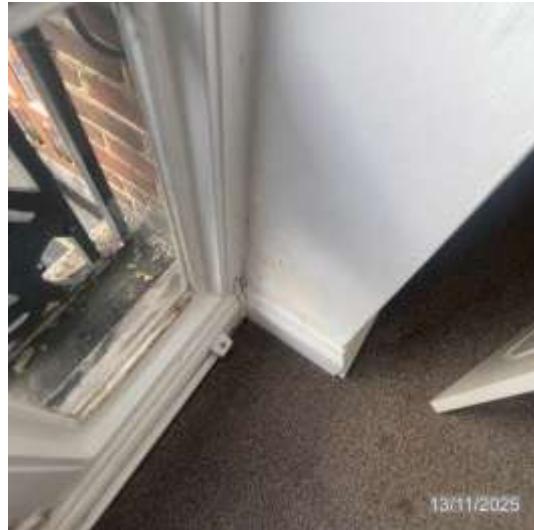
Appear in reasonable condition, with minor marks consistent with normal occupation. Leak damage around window reveal area remains as per check in [Landlord information](#)

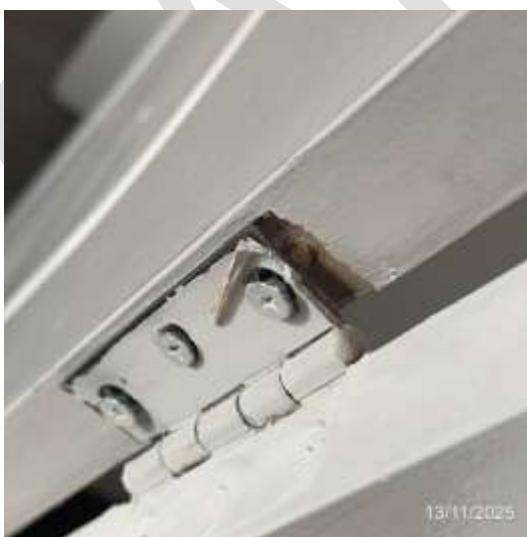
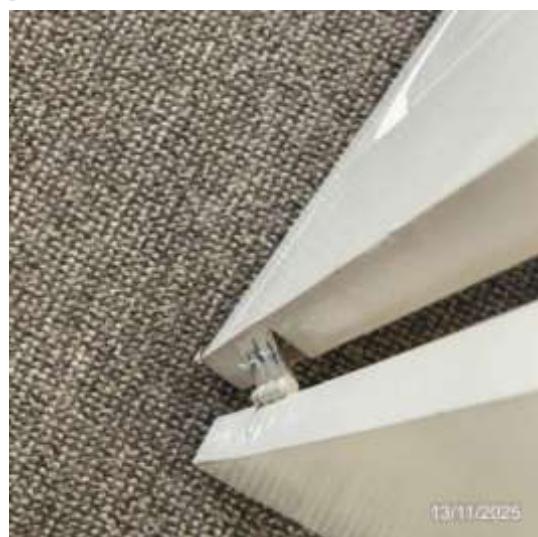
hinges loose to right and left hand doors, [landlord maintenance](#)

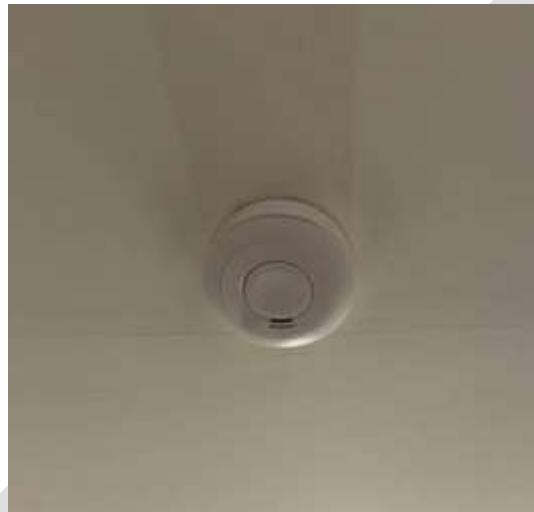
Type	Smoke Alarm	Location	Entrance Hall
------	-------------	----------	---------------

Audibly tested at the time of inspection and responded appropriately

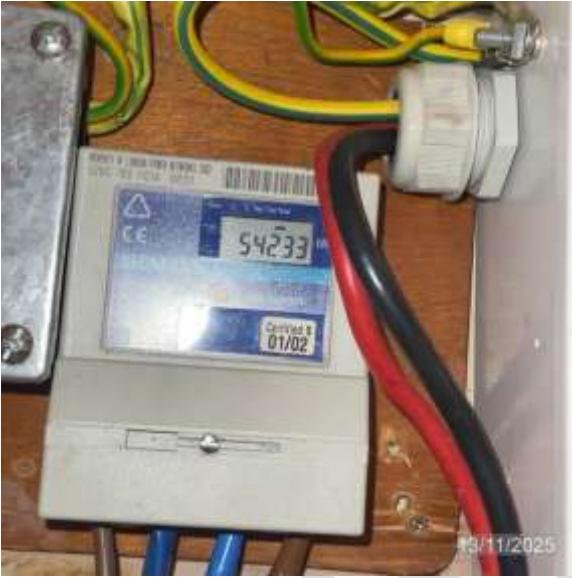
ELECTRIC METER:		GAS METER:	
READING	54233	READING	n/a
SERIAL NUMBER	F02A09251	SERIAL NUMBER	
LOCATION	Kitchen, cupboard over entrance	LOCATION
