CHECK OUT REPORT

SAMPLE ADDRESS

SAMPLE DATE

REF: SAMPLE

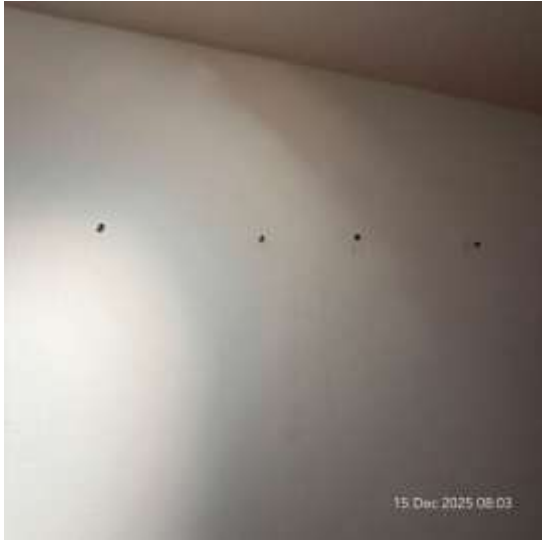
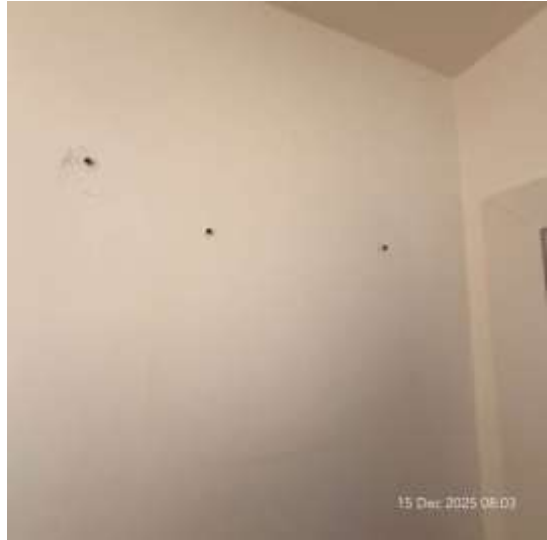
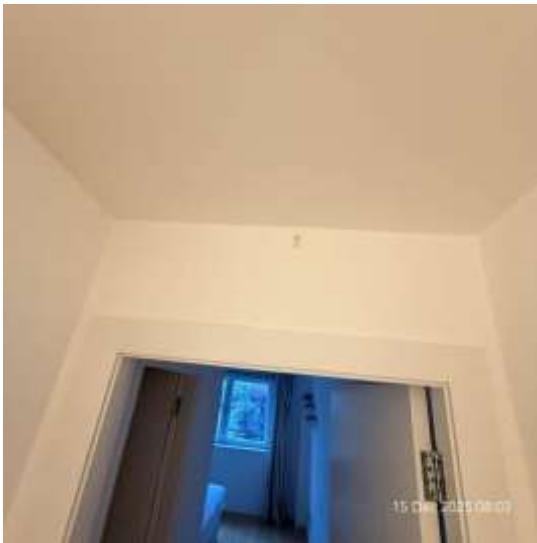
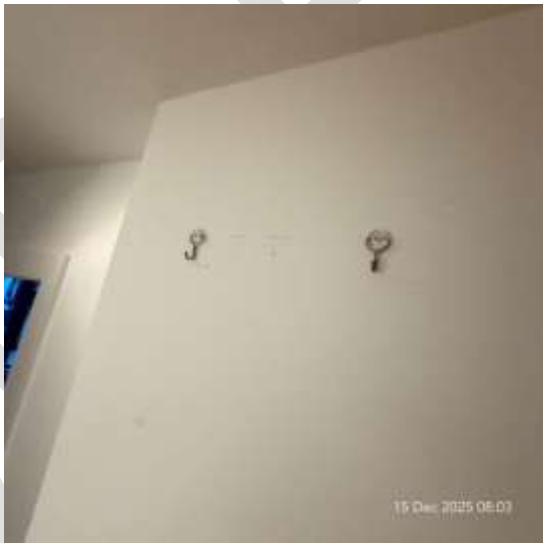
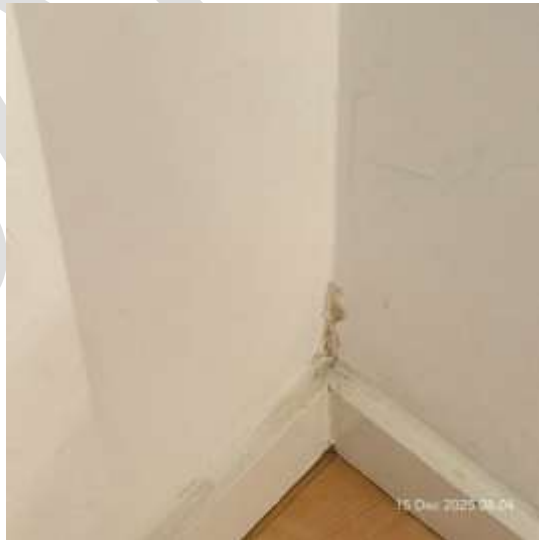
ENTRANCE HALL		
DESCRIPTION	CHECK IN CONDITION	CHECK OUT CONDITION AS CHECK IN UNLESS STATED
DOOR		
Exterior: grey oak style door with 44 in chrome numerals, chrome knocker, chrome letterbox, chrome handle, 2 chrome locks, chrome blanking plate	Slight scratch mark by knocker, shaded with slight paint marks around edges of door, knocker loose	knocker loose as per check in – landlord's maintenance
Interior: painted white with chrome letterbox with cover, chrome spyhole with cover, chrome lever handle, chrome lock, chrome twist lock, chrome arm door closer		handle now loose and screw require tightening – landlord's maintenance
WALLS		
Painted white	Slight scuff marking to angle to left side of shower room, few mid to low level scuff marks to right side of shower room, mid level scuff marked area to left hand side of bedroom 1	6 additional high level screw fixings left side of bedroom 1, picture hook over bedroom 1 and 2 further hook fixings left side of kitchen – tenant , small leak stained area low level left side of entrance appears from attended bathroom leak mid tenancy – landlord's attention , few mid to low level scuff marks either side of bathroom and light further wear and tear usage

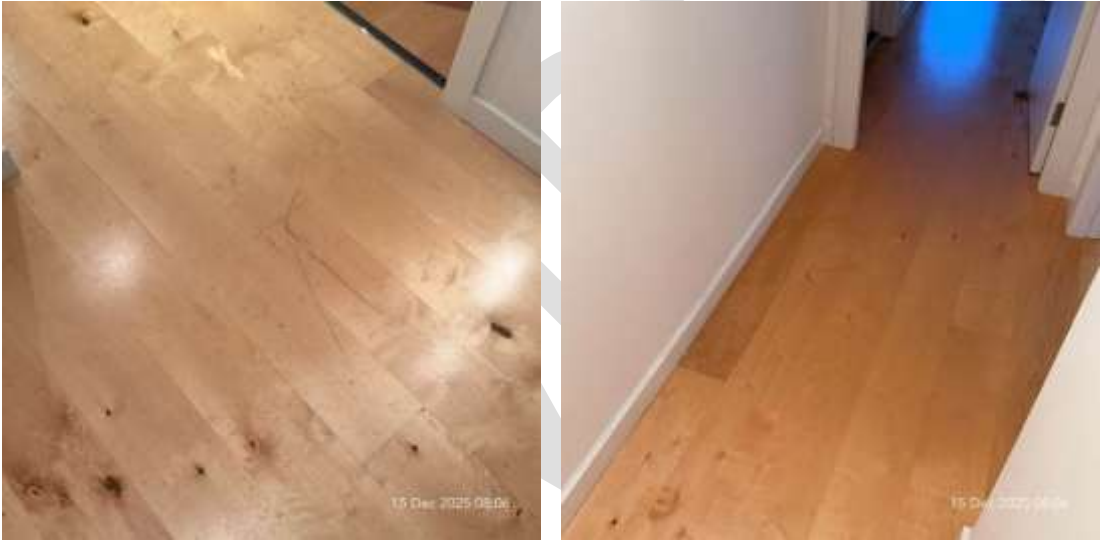
WOODWORK		
Painted white	few minor light angle rubs to architrave onto kitchen, small chip defect to edge of skirting to left side of kitchen	wear and tear light scuffing to architraves, minor light angle rubs
FLOORING		
Light wood strip flooring with chrome and rubber doorstop	Professionally cleaned, scattered indentation marks to walkways, long scratch mark forward of entrance, areas of line indentation marks to left hand side of shower room, few dark scratch marks to centre in front of reception room	Professionally cleaned, defect as per check in

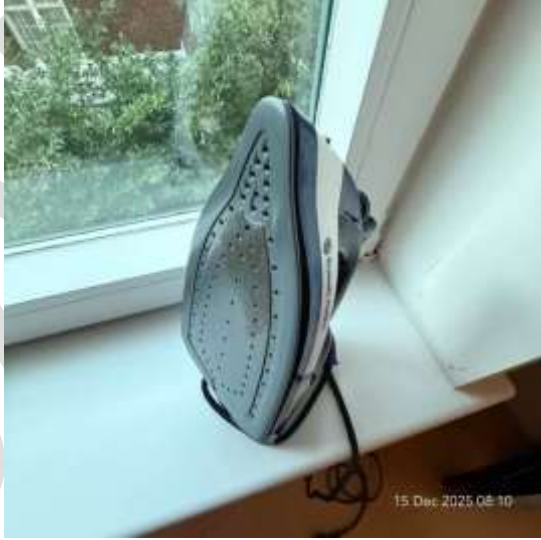
CURTAINS/BLINDS		
n/a		
CONTENTS		
Comelit video entryphone mounted onto white perspex panel with 4 plastic screw caps		<i>As per check in</i>
Rectangular mirror in shades of grey patterned frame		<i>As per check in</i>
Fitted cupboard units with dark wood doors with soft closers and small chrome stud fixing to edge of 3 doors	Soft closers slightly intermittent	<i>As per check in</i>
<ul style="list-style-type: none"> Left double with white laminate interior and 3 shelves with striped light wood trim, further concealed shelf with light wood trim, 5 white laminate drawers with light wood trim and chrome handles 	patchy shading to upper sections to interior	<i>As per check in</i>
<ul style="list-style-type: none"> Russell Hobbs iron 	Not tested	found in bedroom 2, marking to plate which may improve with further cleaning - tenant

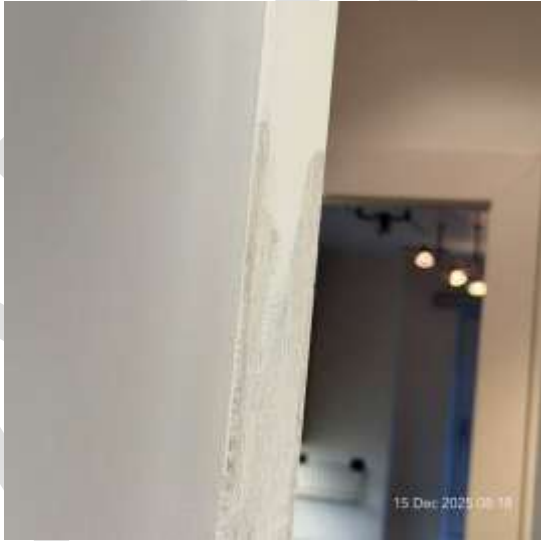
SHOWER ROOM		
DESCRIPTION	CHECK IN CONDITION	CHECK OUT CONDITION AS CHECK IN UNLESS STATED
DOOR		
Painted white with chrome lever handles and chrome twist lock, double chrome hook to interior	Low level edge chip to exterior, line shaded mark to base edge, handle slightly loose to exterior	Few minor light wear and tear edge chips, door edge shaved and touched up – possible due to leak during tenancy

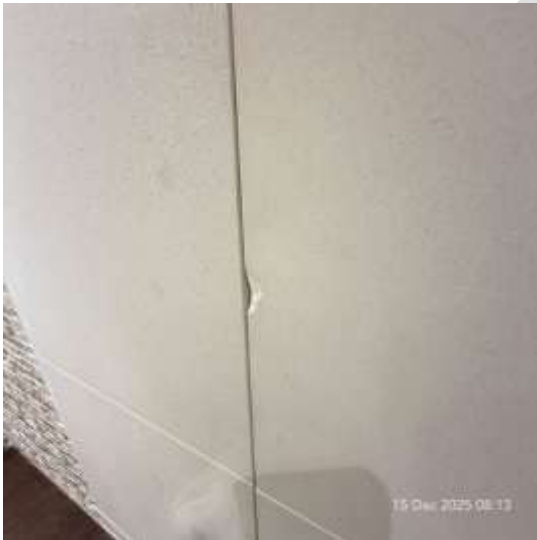
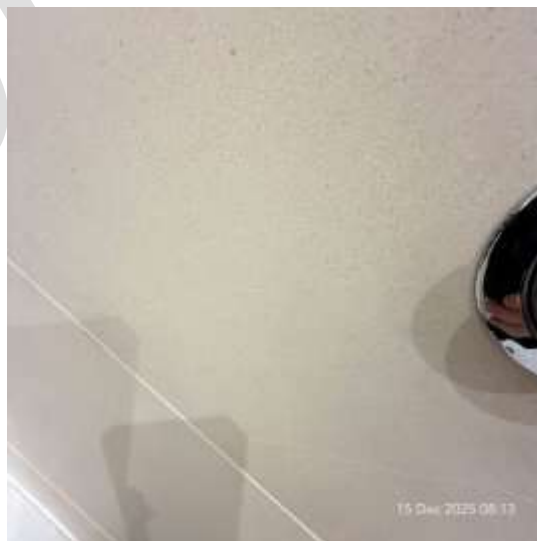
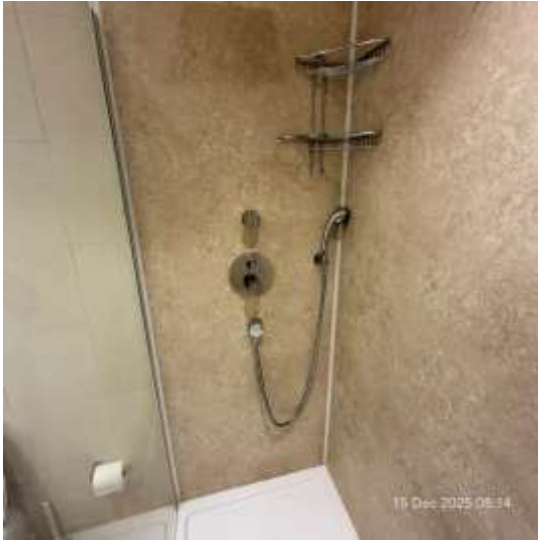
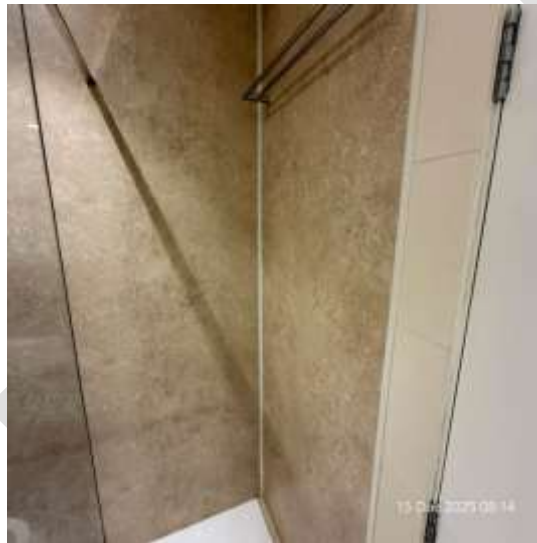
professionally cleaned, few light scuff marks within shower cubicle
Minor discolouration and slight paint marks around top edges of tiles, 4 small chip defects to edge by access panel

Cream limestone tiles professionally cleaned, additional chip defect to access panel left hand side, area of discolouration to tiles by flush which may improve with further clean, hairline crack defect to access panel by flush

Limestone effect laminate panelling now fitted to walls in shower cubicle, professionally cleaned – informed by tenant there was a leak during tenancy resulting in these being fitted approx 2 years ago, professionally cleaned

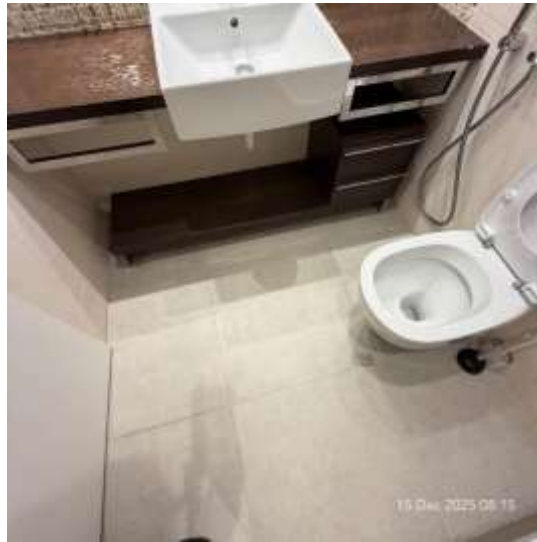
Access panel over WC		<i>As per check in</i>
Shades of beige/brown tumbled marble style mosaic tiles		<i>As per check in</i>
WOODWORK		
Doorframe painted white		<i>As per check in</i>
FLOORING		
Shades of beige/brown marble tiles with door strip, chrome and rubber doorstep	Professionally cleaned Natural cracking along veins in parts, 1 tile cracked to left hand side of WC	Replaced since commencement with pale grey porcelain tiles, informed by tenant there was a leak during tenancy resulting in flooring being replaced approx 2 years ago, professionally cleaned

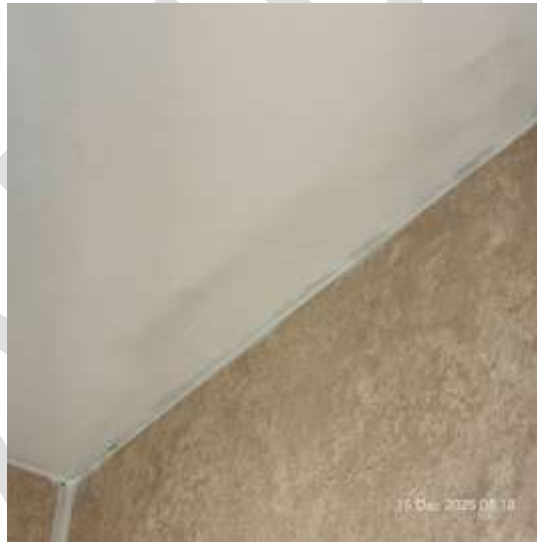
Small chip defect by 1 light fitting

Discolouration around edge of ceiling over shower cubicle which appears to be from where panelling has been fitted

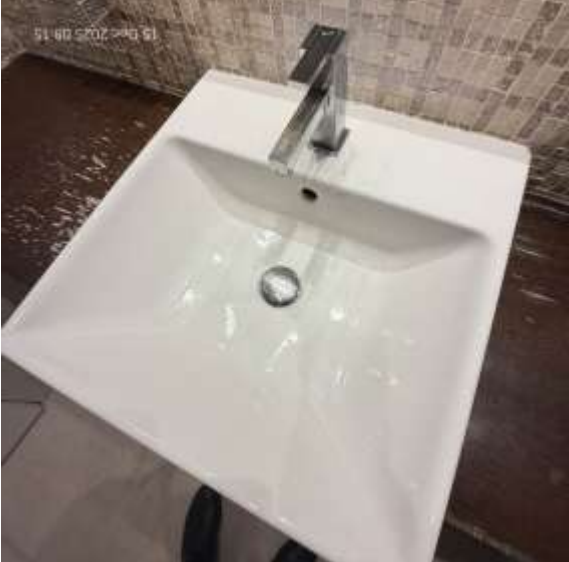
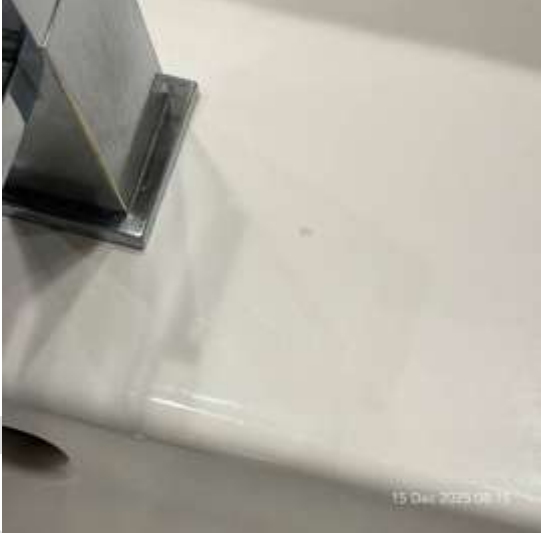
<p>Polished chrome shaver point</p>		
<p>White wash basin with chrome mixer taps and chrome pop-up waste</p>	<p>Professionally cleaned Pop-up plug not working, 5mm chip defect to interior of basin to right hand side, heavy abrasions to tap spout</p>	<p>professionally cleaned, further approx 2mm chip defect right hand side of tap and 1 further chip to right edge - tenant</p>
<div style="display: flex; justify-content: space-around;">

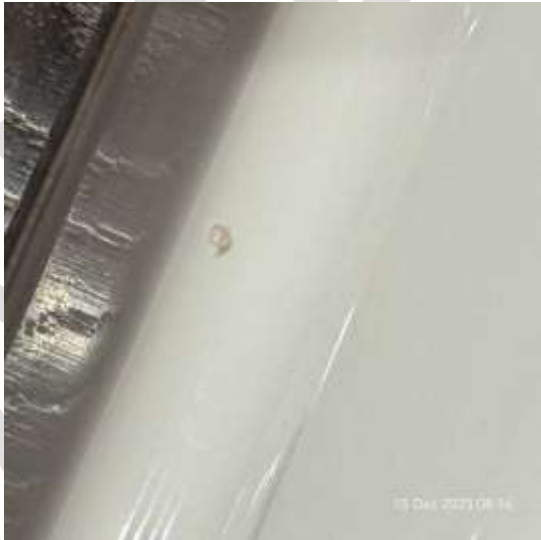
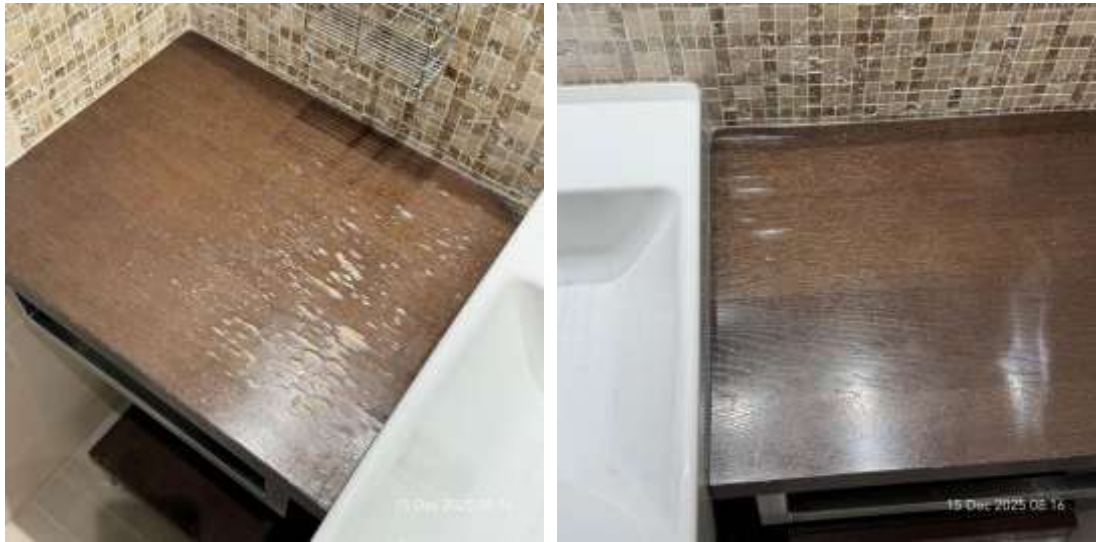
<p>Dark wood worksurface with 2 chrome towel rails under</p>	<p>Very heavily worn to left hand side, further worn and blistered areas to right hand side</p>	<p>professionally cleaned, heavily worn as per check in, further chip defect to right front edge</p>

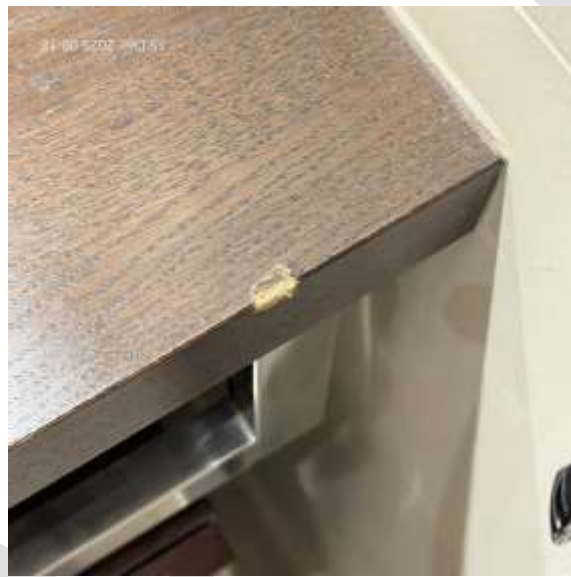
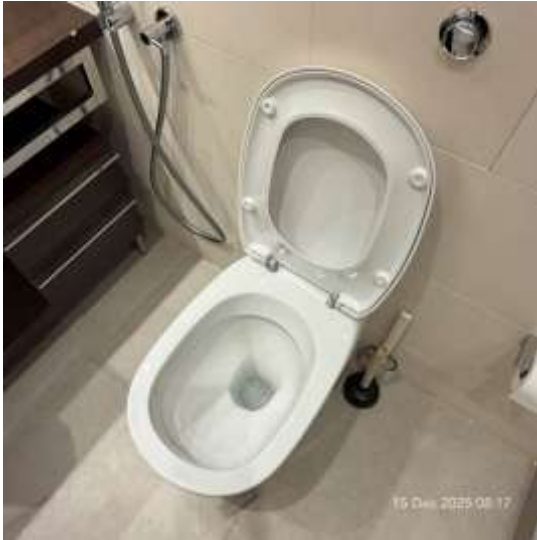
<p>Low level dark wood shelf unit with 2 drawers with chrome handles and chrome legs</p>	<p>Scattered worn marks</p>	<p><i>As per check in</i></p>
<p>White WC with white seat and lid, encased cistern with chrome flush</p>	<p>Seat off brackets, 4 buffers off to seat</p>	<p>professionally cleaned, defects as per check in, right hand seat bracket comes off and requires securing, landlord maintenance</p>

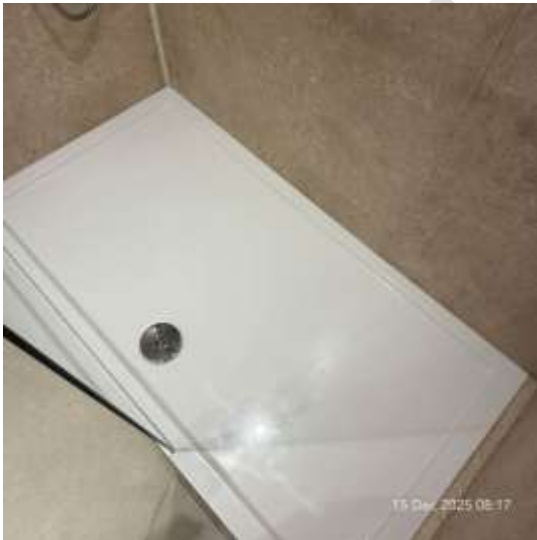
shower cubicle replaced since commencement with white shower tray with fixed tempered glass shower screen

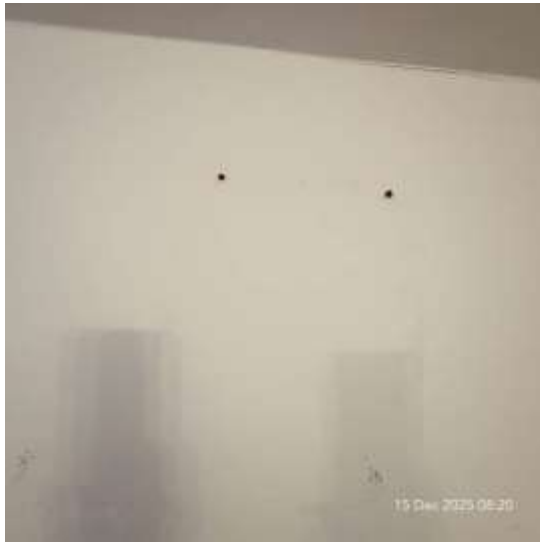
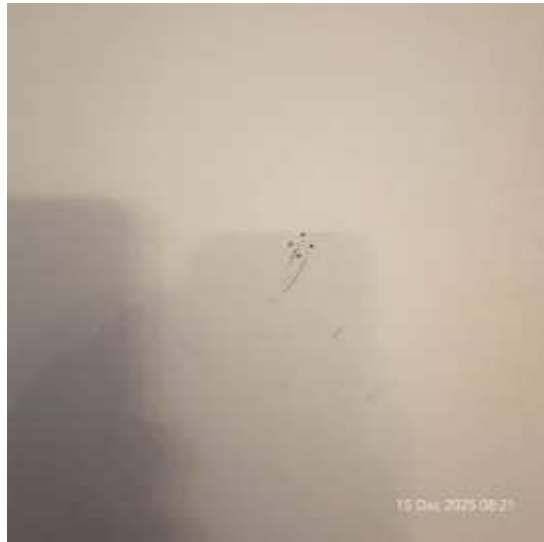
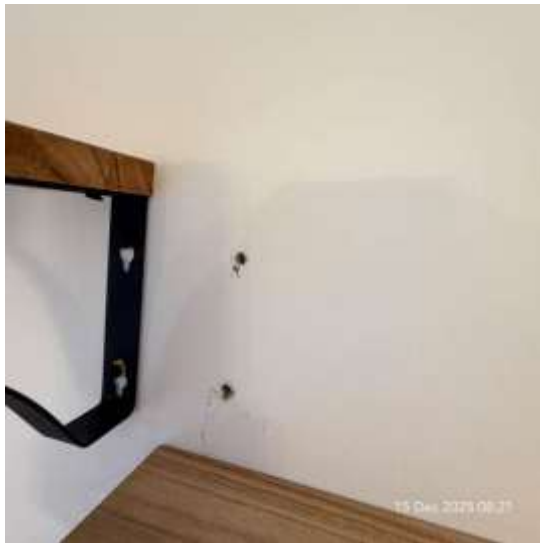
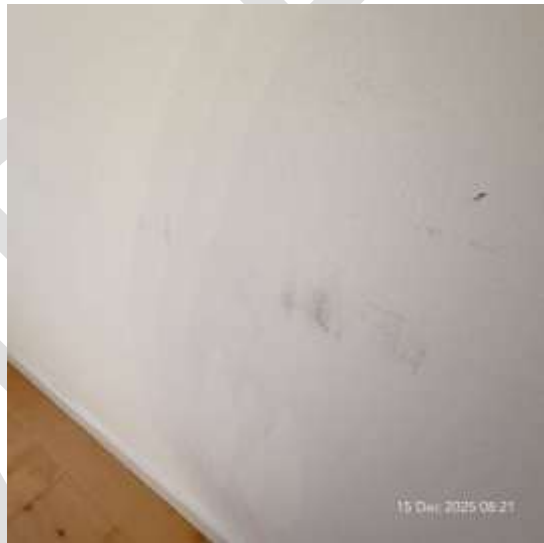
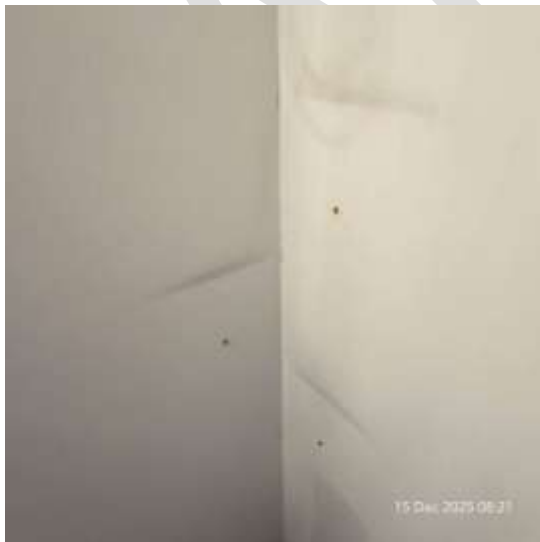
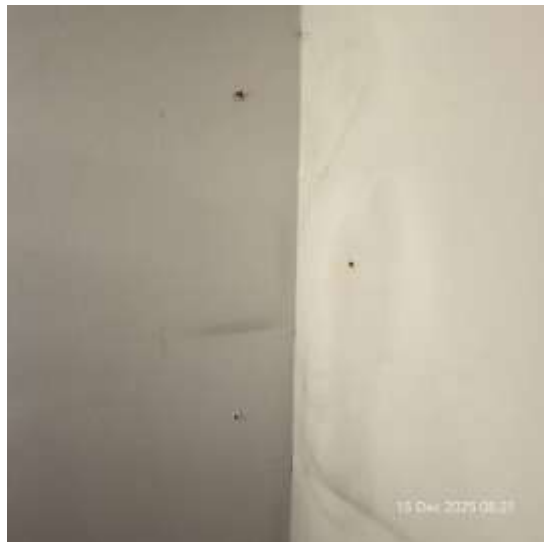
BEDROOM 1 - MASTER		
DESCRIPTION	CHECK IN CONDITION	CHECK OUT CONDITION AS CHECK IN UNLESS STATED
DOOR		
Painted white with chrome lever handles and chain door closer	Minor patchy shading to centre on exterior	<i>As per check in</i>
WALLS		
Painted white	Slight cracking around fuse point to right side of en suite, few small scuff marks under window, minor shrinkage cracking over wardrobes	2 screw fixings with picture shading to high level opposite the entrance, picture hook removal mark to same wall and 2 screw holes – tenant , area of mid to low level scuffing to centre on same wall, 6 rawl plug fixings and shading to corner left side of window – tenant, wear and tear shading with slight cracking around light switch for ensuite, light wear and tear scuff marking under window, low level possible water stain to angle right hand side of ensuite – landlord's information

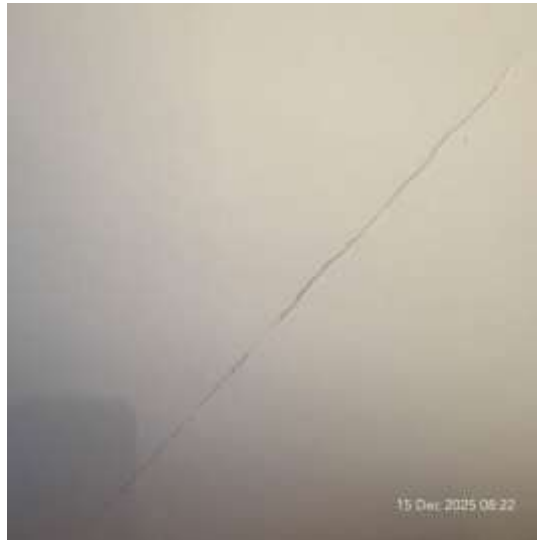
CEILING		
Painted white	Long crack defect across ceiling	As per check in landlord's attention

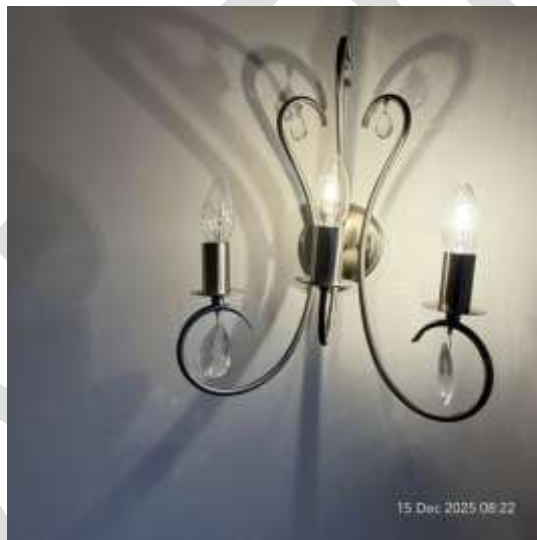
LIGHTING

1 bulb not working to right hand fitting - **tenant**

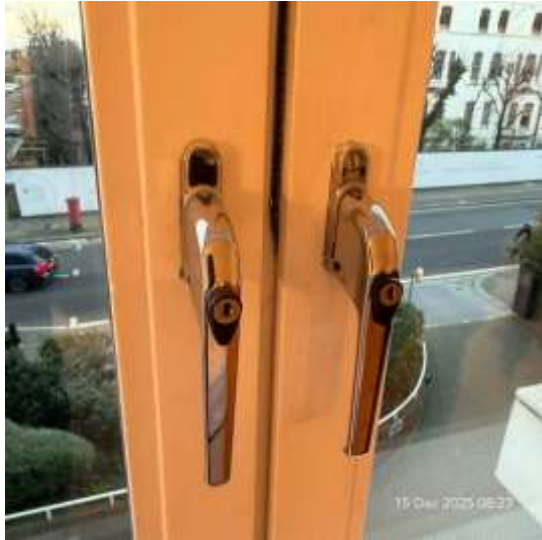
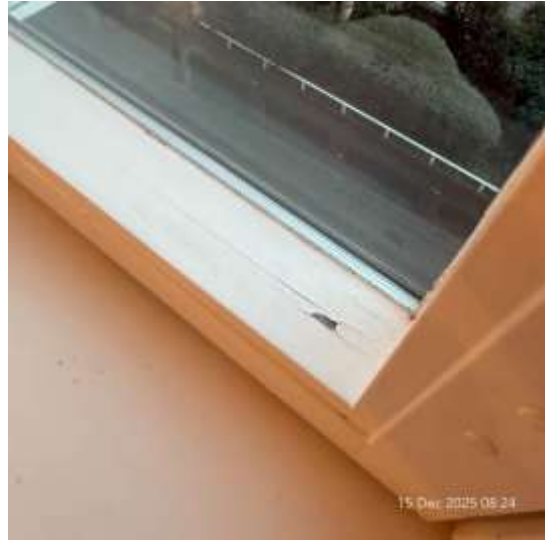
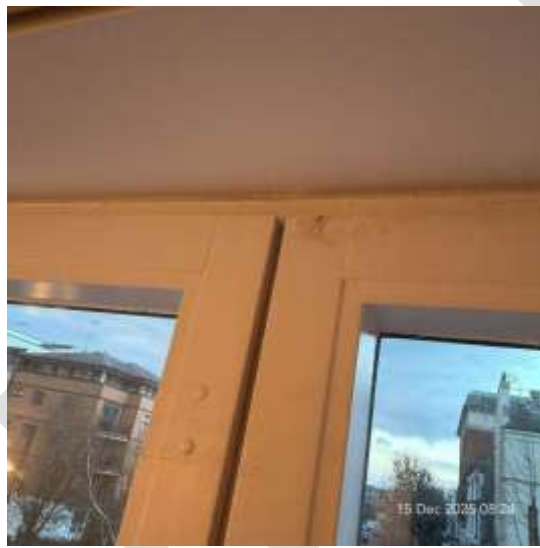
WINDOWS

Cleaned to interior and exterior, 2 keys not seen – **tenant**, further scuff marking to sill area and flaking areas to paintwork to base of frame in parts, scuffing around top of reveal, small filled area to top of right hand window, minor shading to frame

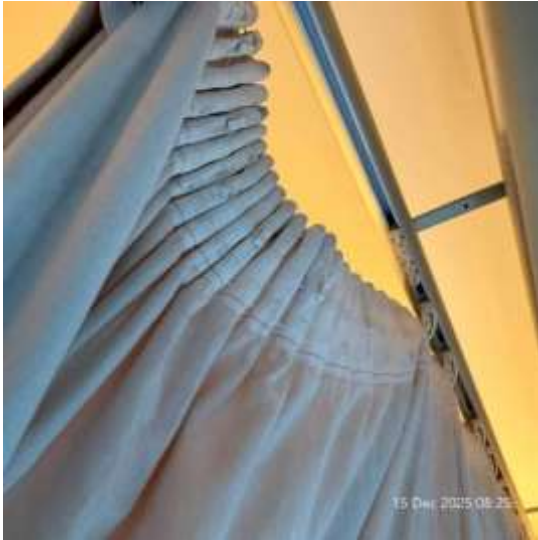
CURTAINS/BLINDS

numerous hooks have broken off to left hand curtain and few to right hand curtain, very dusty to hem, not cleaned - **tenant**

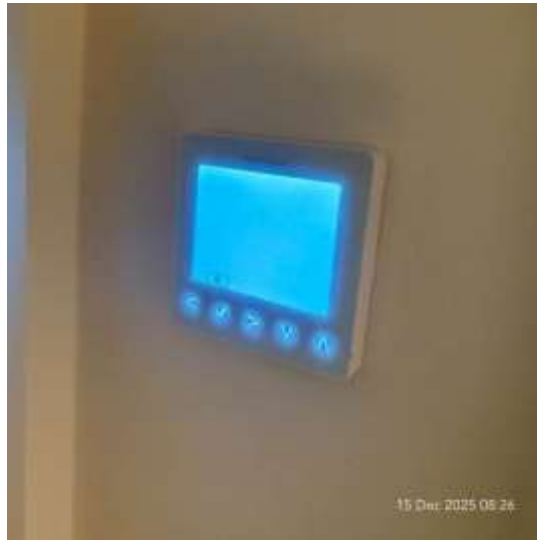
replaced during tenancy with Heatmiser thermostat

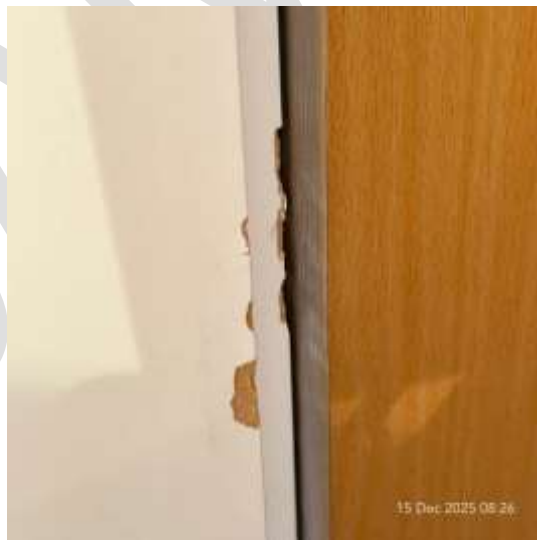
<p>2 double fitted wardrobes with white laminate doors with chrome handles</p>	<p>Professionally cleaned</p>	<p><i>As per check in</i></p>
<ul style="list-style-type: none"> Left double with light wood laminate interior, darker wood laminate upper shelf with automatic striplight under with plastic shade, chrome hanging rail, 2 narrow fitted laminate shelves and 3 laminate drawers with chrome handles 	<p>Small black mark and small scratch on right hand door, light in working order, left door handle slightly loose, partly filled chip defect to base of left hand door</p>	<p>lights in working order, cleaned</p>
<ul style="list-style-type: none"> Right double with light wood laminate interior, automatic striplight with plastic shade, 2 chrome hanging rails 	<p>Few small black scuffs on left hand door, light in working order, few small black scuff marks to front base interior</p>	<p>key seen to safe, light in working order, cleaned, chipping defects to interior edge of left hand door</p>

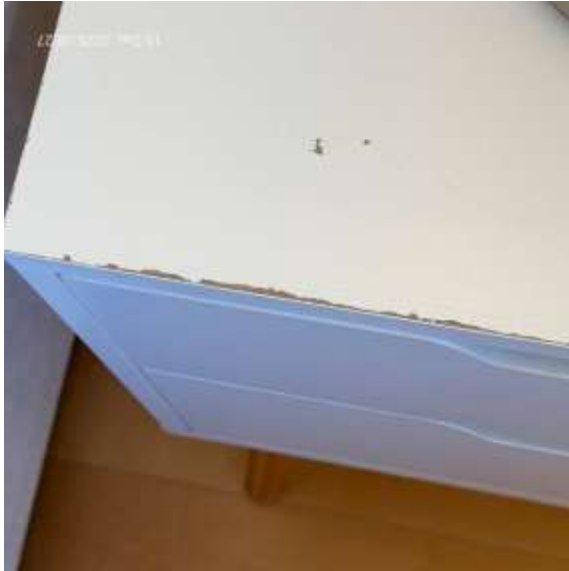
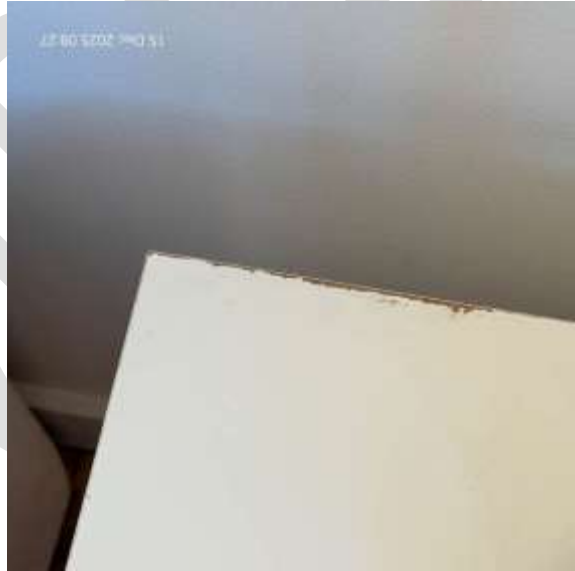
chipping defects to edges on right hand chest - **tenant**

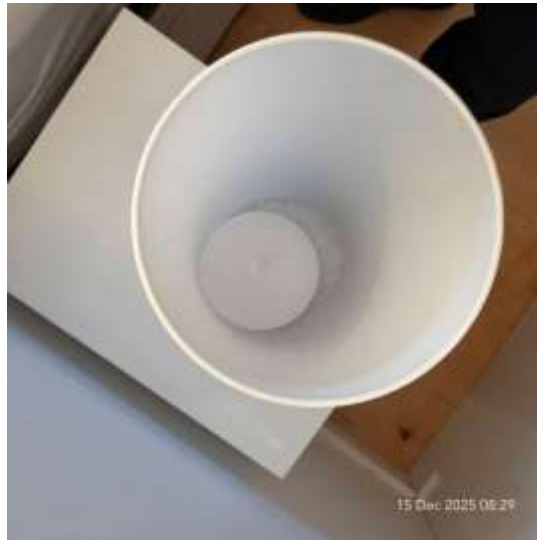
in working order, dusty to interior requires cleaning - **tenant**, shade slightly loose to left hand lamp - **wear and tear**

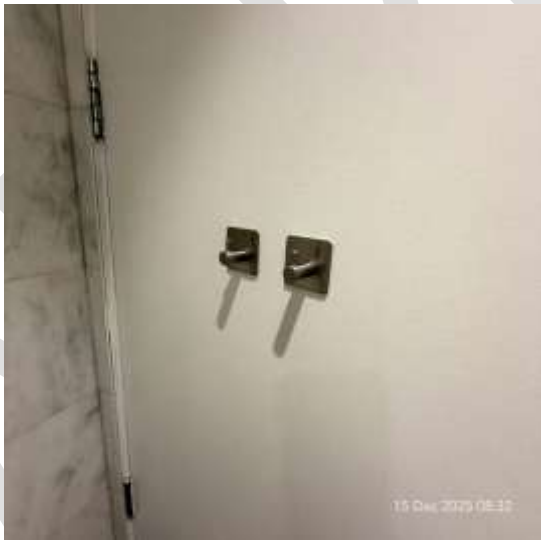
ENSUITE BATHROOM		
DESCRIPTION	CHECK IN CONDITION	CHECK OUT CONDITION AS CHECK IN UNLESS STATED
DOOR		
Painted white with chrome lever handles and chrome twist lock	Small chip defect to left edge on exterior, minor blistering along base edge to exterior	2 additional chrome hooks to interior of door - tenant

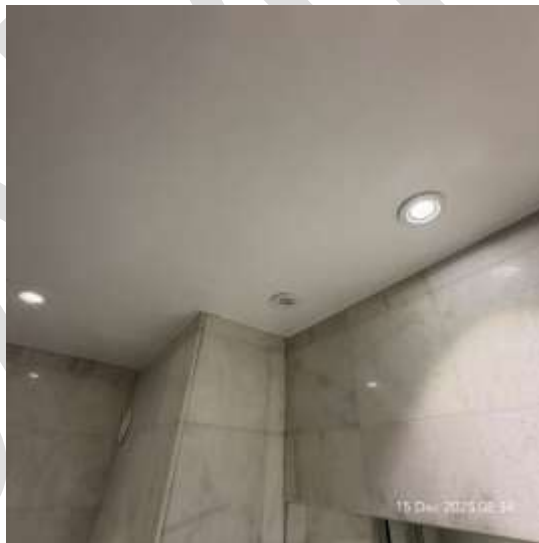
LIGHTING

7 inset LED spotlights	All in working order	1 bulb not working - tenant
------------------------	----------------------	------------------------------------

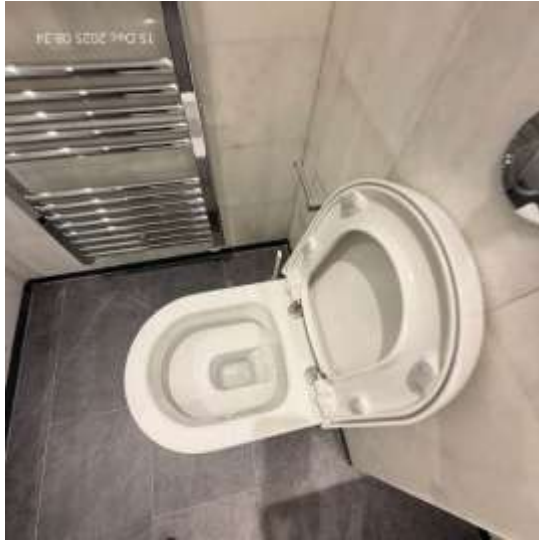
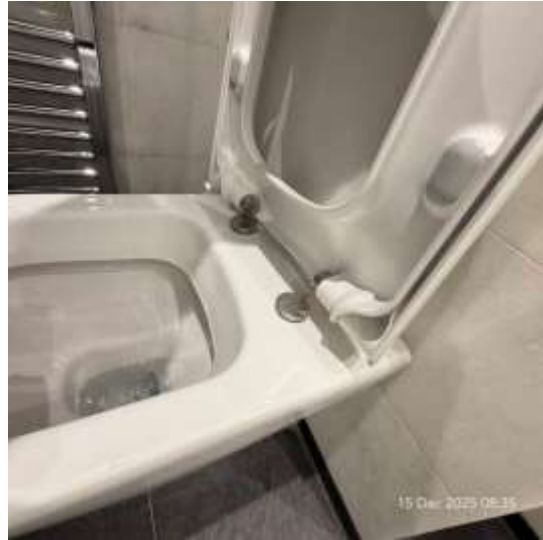
White gloss laminate vanity unit with deep single drawer with opaque glass drawer front and polished chrome frame		professionally cleaned
White WC with white seat and lid, encased cistern with chrome flush	Minor discolouration around base edges of pedestal, professionally cleaned	professionally cleaned, seat bracket comes off landlords maintenance

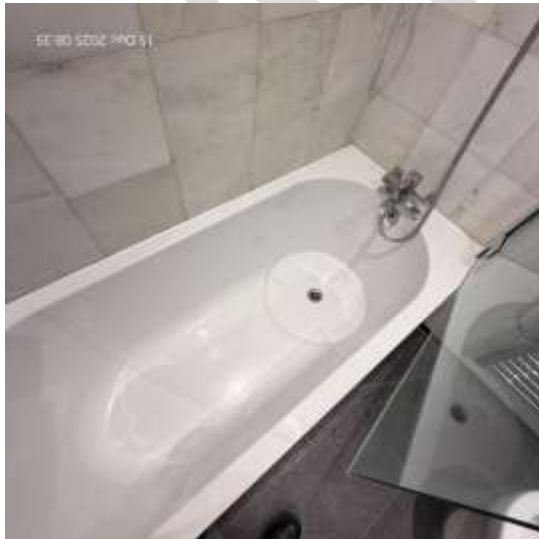
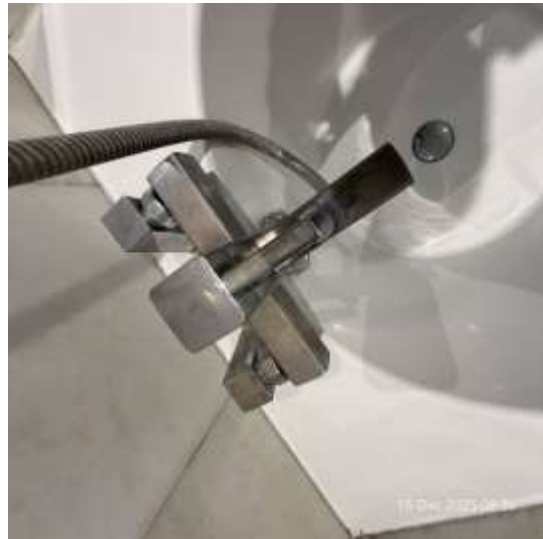
Chrome toilet roll holder		<i>As per check in</i>
Chrome ladder heated towel rail	Cap missing to top right hand bracket	<i>As per check in</i>
Vent to wall	Slight discolouration around edge	<i>As per check in</i>
White bath with chrome mixer taps with shower attachment, chrome shower hose and head on chrome shower holder to wall, pop-up waste	Heavy tarnishing/abrasions to tap, slight wear to coating on shower head, professionally cleaned	Professionally cleaned. pop up plug sticking landlord maintenance , slight yellowing discolouration to interior of bath which may improve with further cleaning - tenant , mastic slightly splitting around edge of bath and requires renewing – landlord maintenance

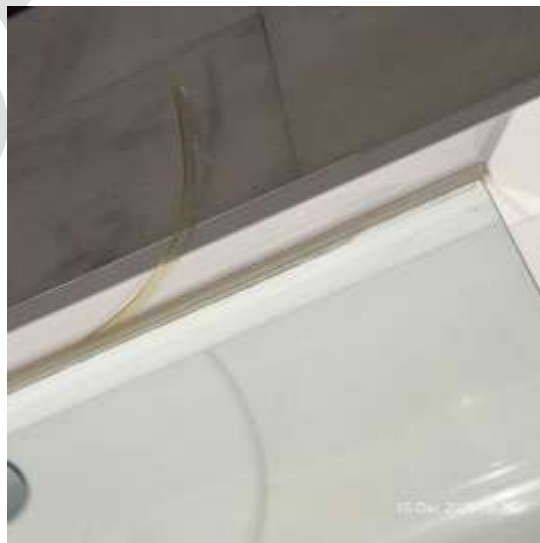
professionally cleaned, rubber seal split and coming away – requires replacing - tenant

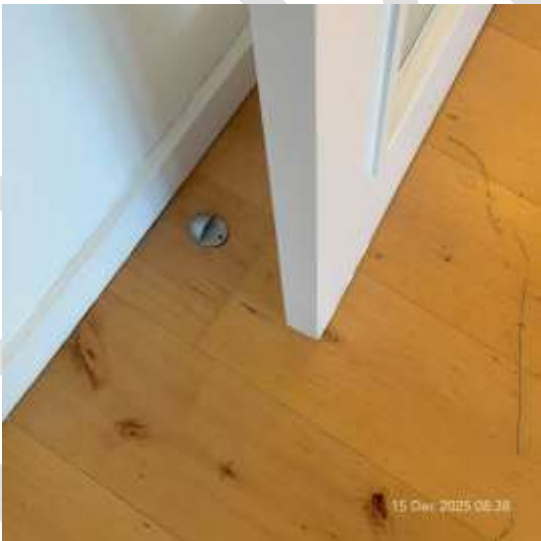
RECEPTION ROOM		
DESCRIPTION	CHECK IN CONDITION	CHECK OUT CONDITION AS CHECK IN UNLESS STATED
DOOR		
Painted white with 2 glazed panels, chrome lever handles and chain door closer	Door closer disconnected and painted over, handles loose	Handles loose, door slightly binds with floor when fully opened – landlord's maintenance

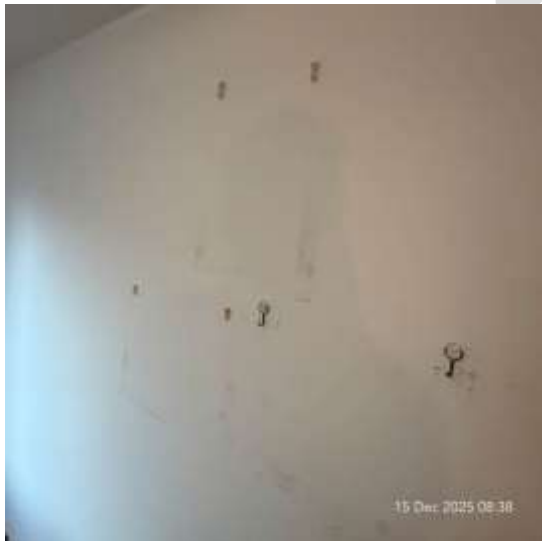
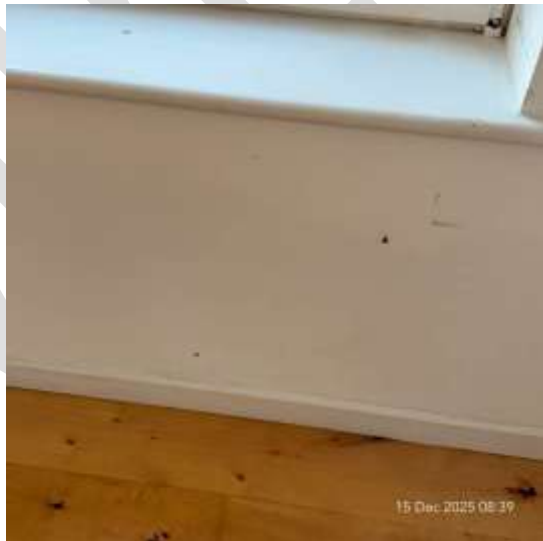
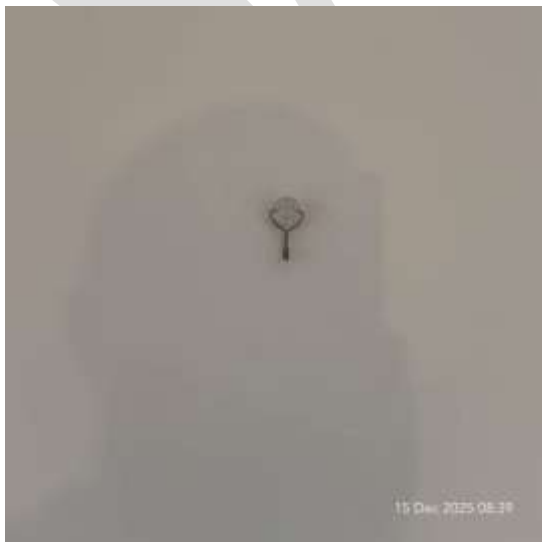
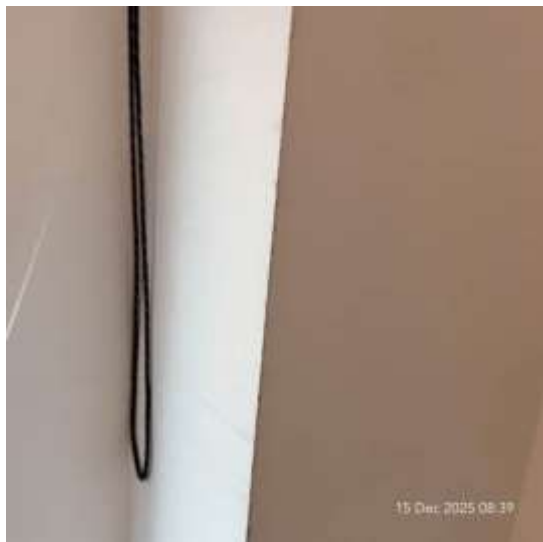
<p>Painted white</p>	<p>Area of low level scuff marking to centre of right hand wall with small red spot mark to same area, remainder of walls in good order</p>	<p>Right hand wall – 4 picture hooks and 2 slightly larger hook fixings, 5 picture hook removal marks and picture shading, further hook fixing left hand side of right hand window, scuff marking under same window, mid to low level angle scuffing right hand side of windows, 4 rawl plug fixings with line shaded areas left hand side of the windows and 1 further screw fixing over the sofa, - tenant wear and tear shading around light switch area, wear and tear cracking over skirting to right hand wall</p>
----------------------	---	--

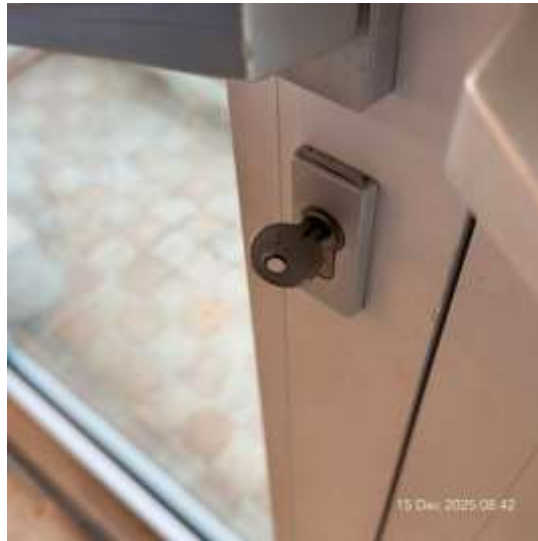
<p>Pair of white framed double glazed doors onto balcony with chrome handles, lock and key</p>	<p>Cleaned to interior and exterior, patchy shading to frame</p>	<p>keys seen in lock, cleaned to interior only, exterior requires cleaning - tenant</p>
--	--	---

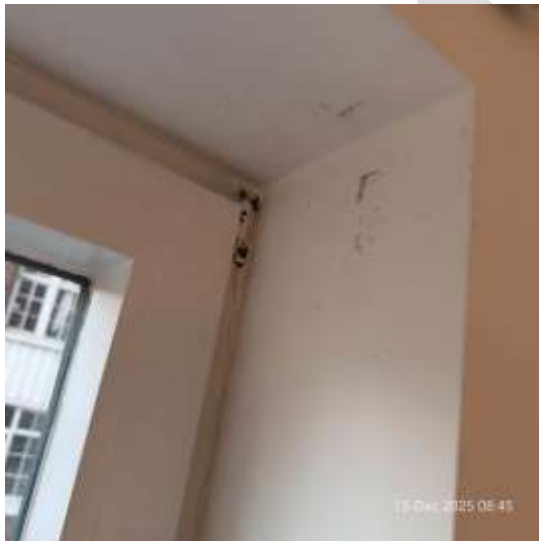
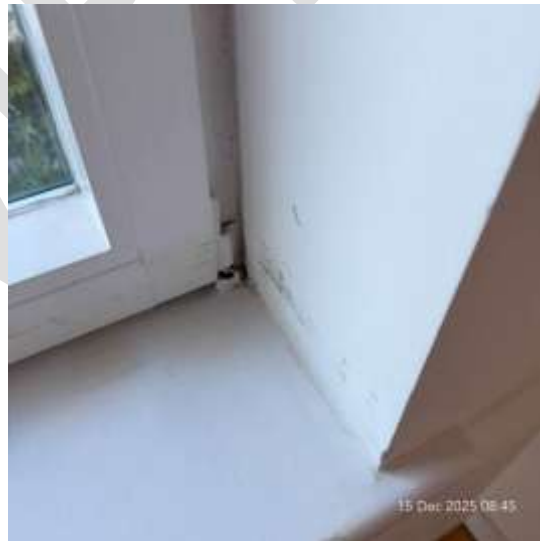
<p>2 white framed double glazed casement and 4 fixed side windows with chrome handle, lock and further lock to each casement window</p>	<p>Cleaned to interior and exterior, patchy shading to frames</p>	<p>cleaned to interior only, exterior requires cleaning - tenant</p>
---	---	--

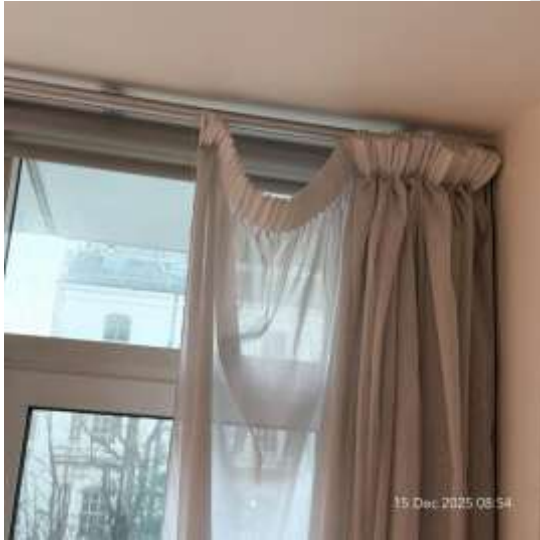
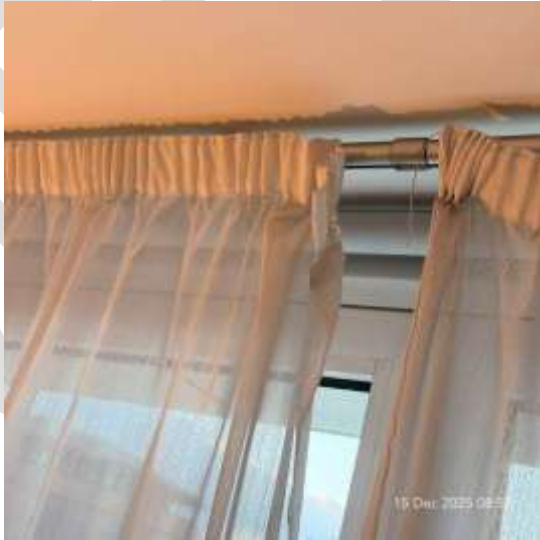
<p>Pair of slightly longer than full length white voile curtains on chrome curtain pole with 2 pulleys</p>	<p>2 faint black line marks at low level on left hand curtain, clean order</p>	<p>Tested, not cleaned, require cleaning, number of hooks off - tenant</p>
--	--	---

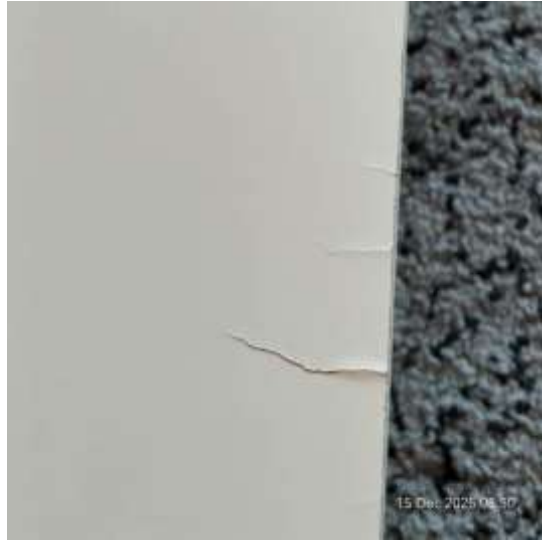
Rectangular white laminate 2-tier coffee table		3 crack defects to edge - tenant
--	--	---

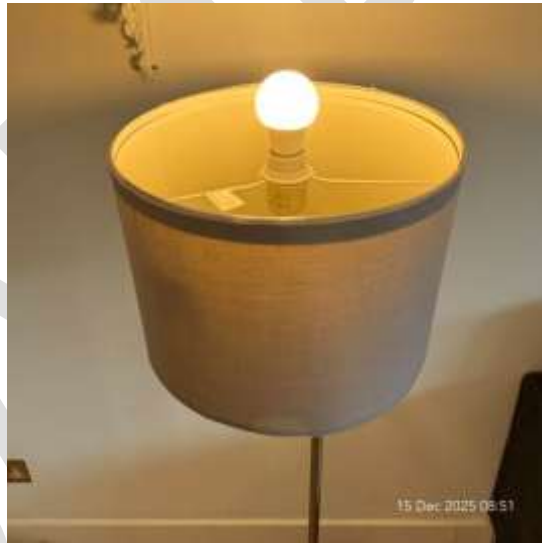
Shades of grey and black fleck patterned rectangular rug, approx. 7ft x 6ft		Vacuumed
Light wood tripod standard lamp with cream shade	in working order	In working order
Brushed chrome adjustable standard lamp with grey shade	in working order	in working order, shade fitted upside down

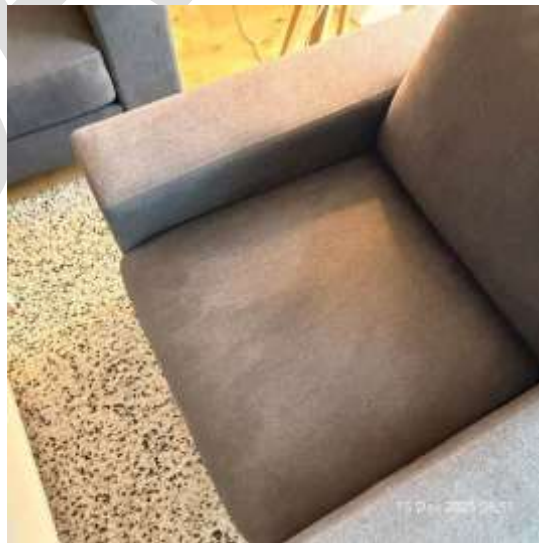
Matching armchair on chrome legs

slightly patchy faded appearance to seats - **tenant**

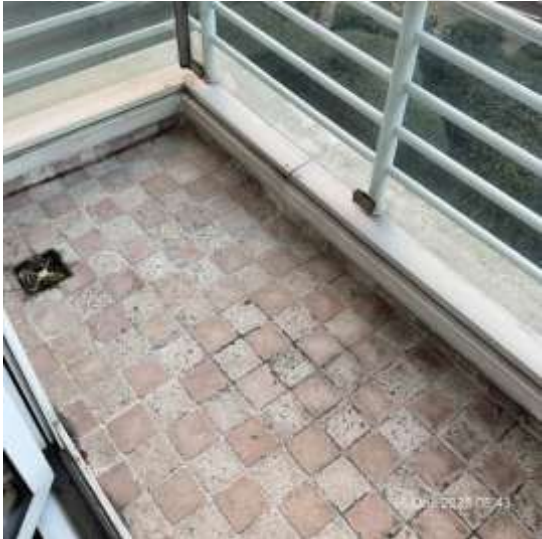
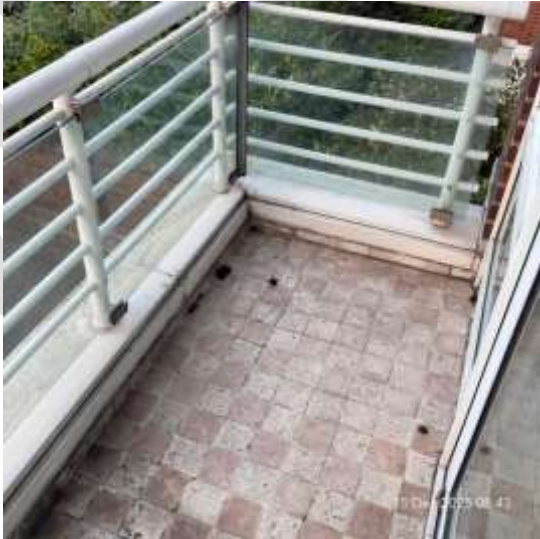
BALCONY		
DESCRIPTION	CHECK IN CONDITION	CHECK OUT CONDITION AS CHECK IN UNLESS STATED
Shades of beige tiled flooring	Weathered	<i>As per check in</i>
Glass safety panels with white painted handrails	Glazed panels not fully cleaned, slight weathering to handrail	<i>As per check in</i>

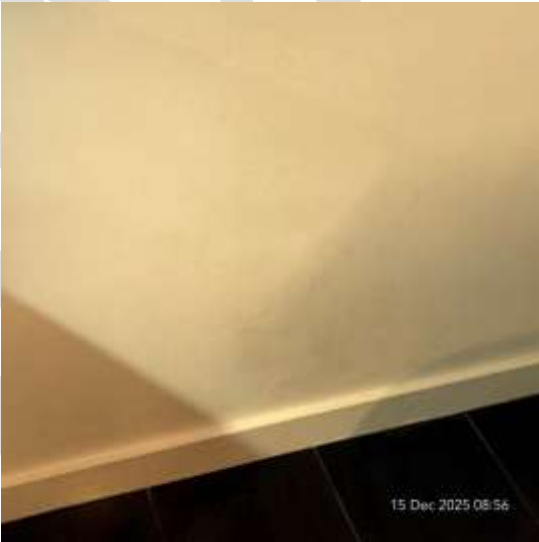
KITCHEN		
DESCRIPTION	CHECK IN CONDITION	CHECK OUT CONDITION AS CHECK IN UNLESS STATED
DOOR		
Painted white with glazed panel, chrome lever handles and chain door closer	Door closer disconnected, nail fixing to interior	<i>As per check in</i>
WALLS		
Painted white	1 removable plastic hook, 2 filled and unpainted nail holes to right side of window, few minor drip marks under window	wear and tear patchy shading under window area
