CHECK OUT REPORT

SAMPLE ADDRESS

SAMPLE DATE

REF: SAMPLE

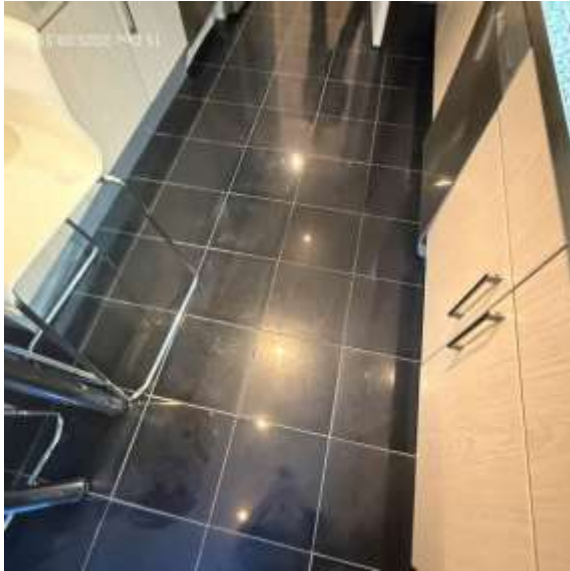
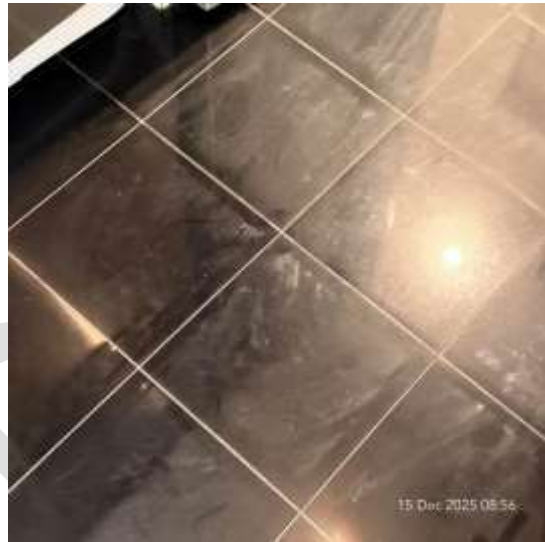
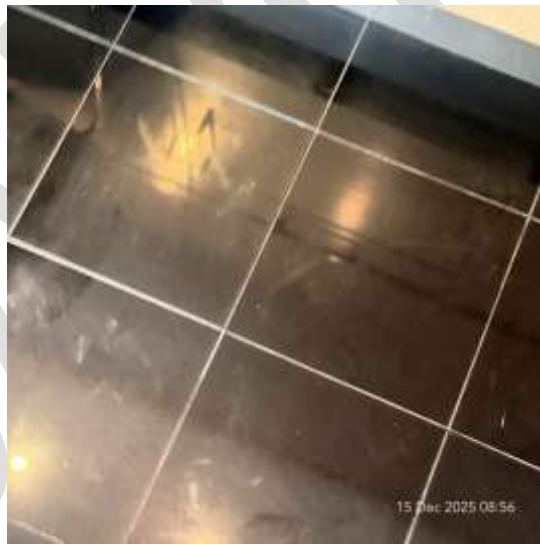
FLOORING

<p>Polished black marble tiles with chrome door strip</p>	<p>Minor crumbling to grouting at entrance, slightly smeary, scattered light scratches in front of hob area, slight white discolouration to grouting in parts, slightly dusty</p>	<p>very smeary and require cleaning - tenant</p>
---	---	---

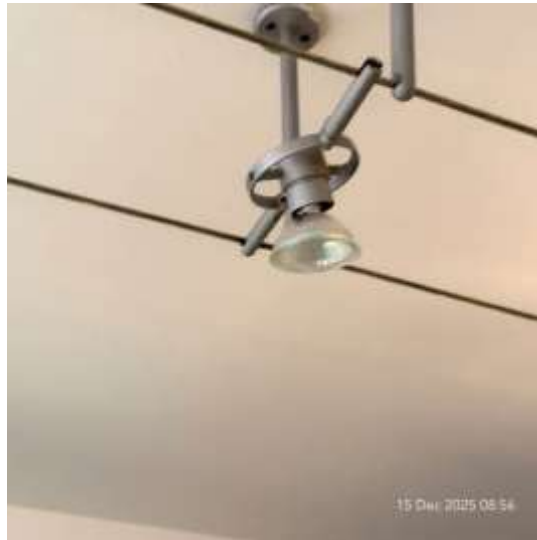
LIGHTING

<p>Cable fitting running across room with 3 small halogen spotlights and 2 further cylindrical halogen spotlights with opaque glass shades</p>	<p>In working order and glass broken to same fitting</p>	<p>1 bulb not working - tenant</p>
--	--	---

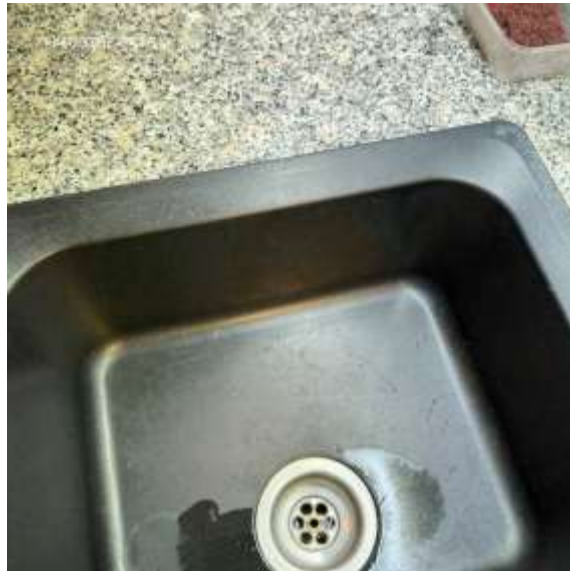
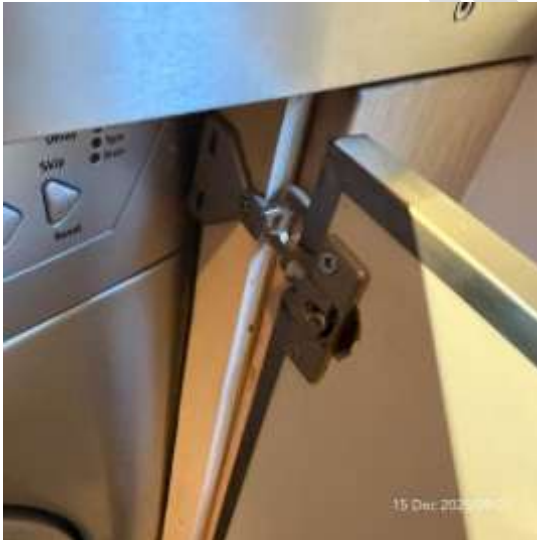
Stainless steel coloured Zanussi washing machine with outer brushed stainless steel décor door with chrome handle

Tested for power only, professionally cleaned, drip marks to base of casing

top hinge to décor door loose and requires repair – **landlord maintenance**, tested for power only, professionally cleaned, mildew staining to seal which may improve with further cleaning, **tenant**

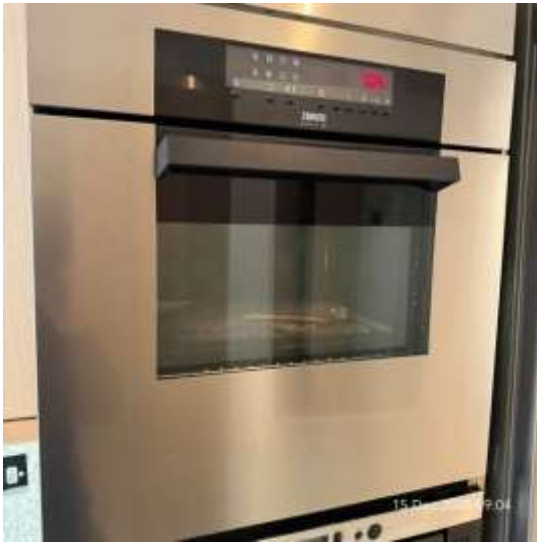
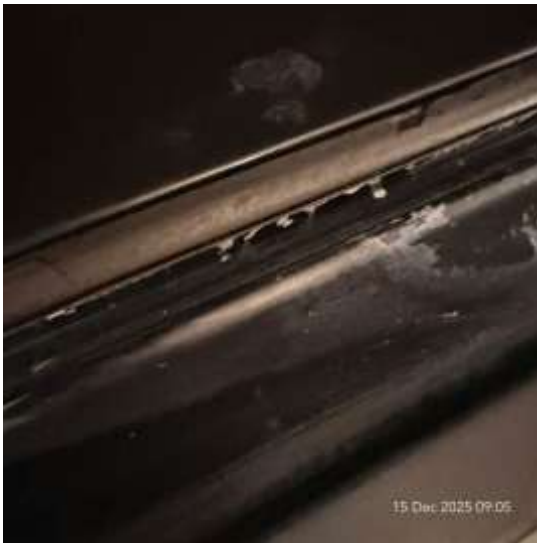
Fitted stainless steel Zanussi oven with black metal handle, grill tray and rack, 1 further rack

Tested for power only, light in working order, light scratches to interior of door, burnt on residues to interior side panels

tested for power only, grill tray and rack not seen - **tenant**, cleaned but cleanser residue marks around base of casing, cleanser residue marks to base interior, requires further cleaning, light not coming on - **tenant**

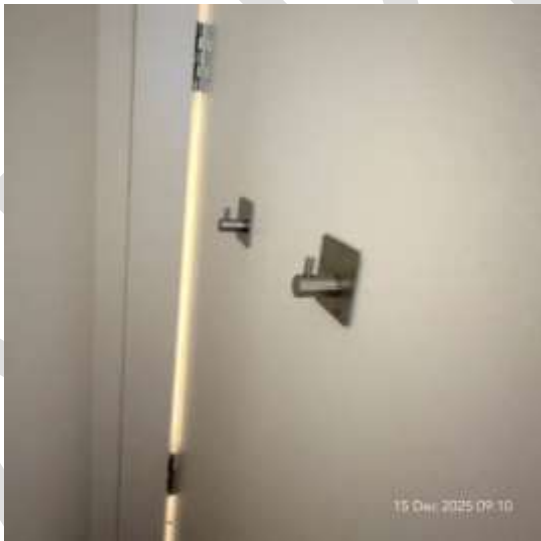
BEDROOM 2		
DESCRIPTION	CHECK IN CONDITION	CHECK OUT CONDITION AS CHECK IN UNLESS STATED
DOOR		
Painted white with chrome lever handles and chain door closer	Handles slightly loose Minor chip defect to edge	2 additional chrome hooks to interior - tenant , further minor wear and tear chips to door

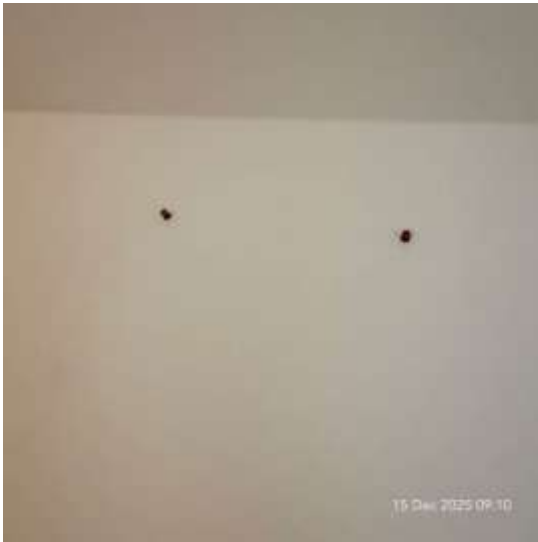
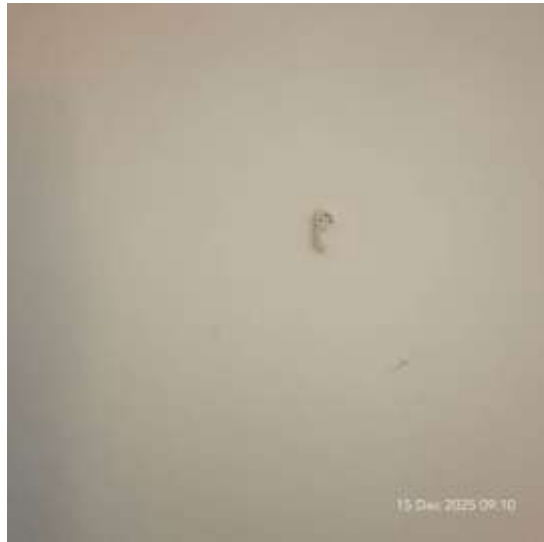
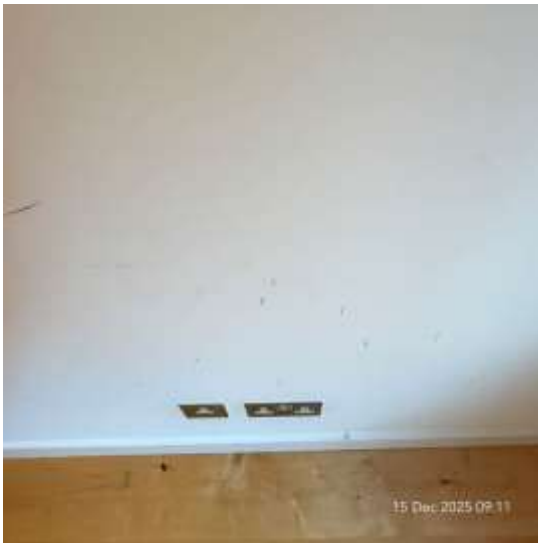
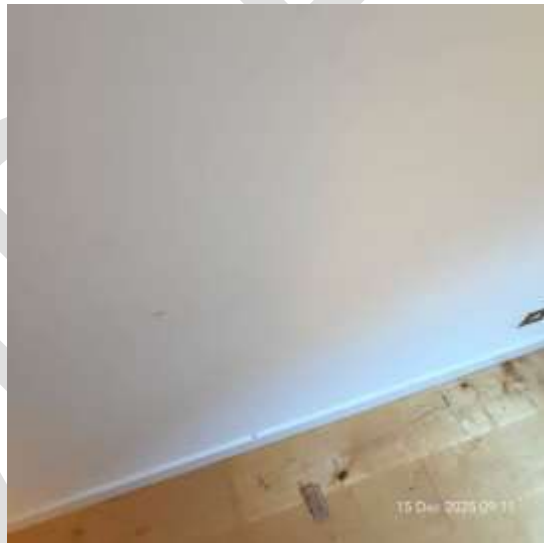
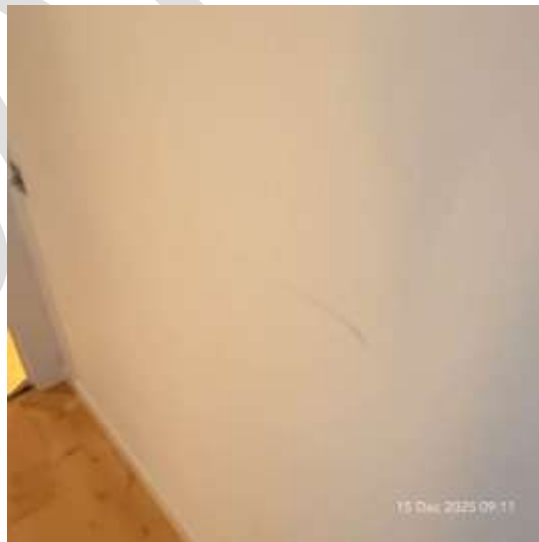
WALLS		
Painted white	mid level scuff marks to right hand side of light switch, low level scuffing around power points opposite bed, area of scuff marking at mid level to right hand side of bed, line scuff mark to left side of headboard	2 additional screw fixings to left hand wall, additional picture hook with scuff marking left hand side of window - tenant , wear and tear shading over bed area, mid and low level scuff marking to left hand wall, further wear and tear usage

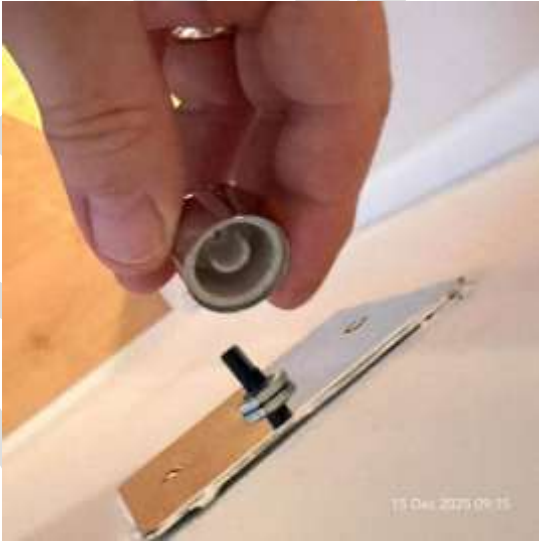
White mattress protector		not seen - tenant
Polished chrome dimmer switch and polished chrome power points		Knob cover off, plastic broken to interior

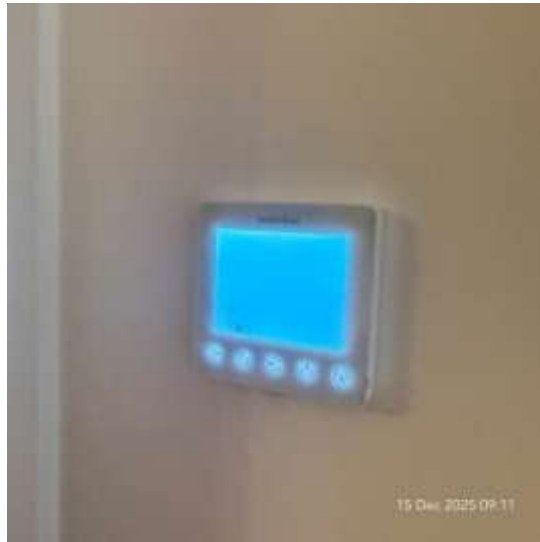
Eswa heating thermostat to wall		replaced with Heatmiser thermostat

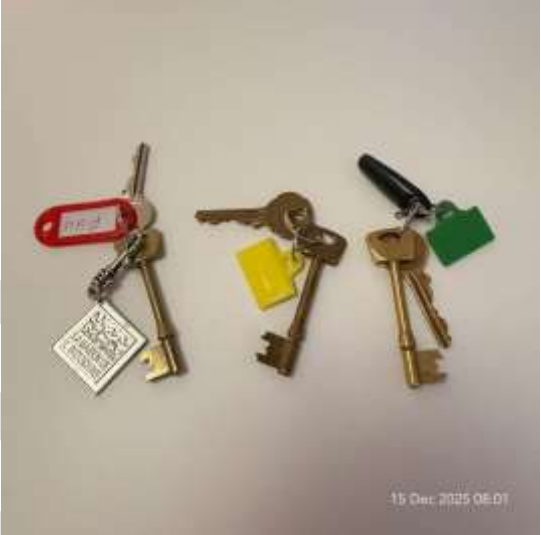
DESCRIPTION AT CHECK IN	DESCRIPTION AT CHECK OUT
<p style="text-align: center;">3 sets of 2 keys to tenant</p>	<p style="text-align: center;">3 sets of 2 keys and 1 garage fob returned to Sample agent office</p>

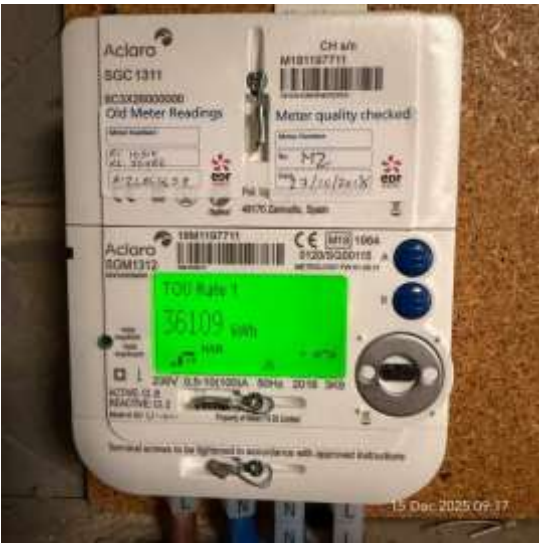
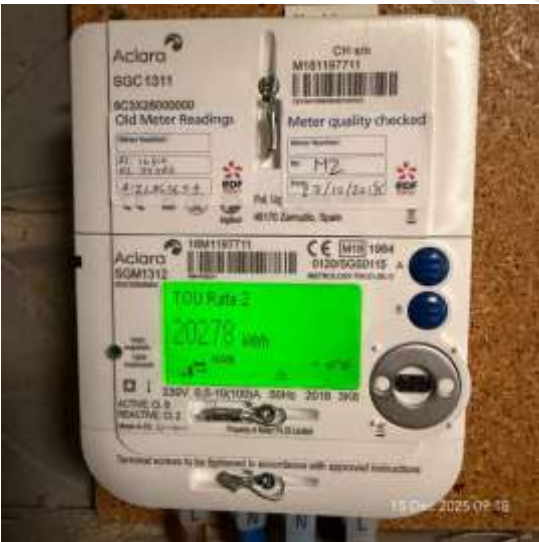
ELECTRIC METER:		GAS METER:	
READING	Rate 1: 36109 kwh Rate 2: 20278 kwh	READING	N/A
SERIAL NUMBER	18M1197711	SERIAL NUMBER	
LOCATION	Hall riser	LOCATION
