CHECK OUT REPORT

SAMPLE ADDRESS

SAMPLE DATE

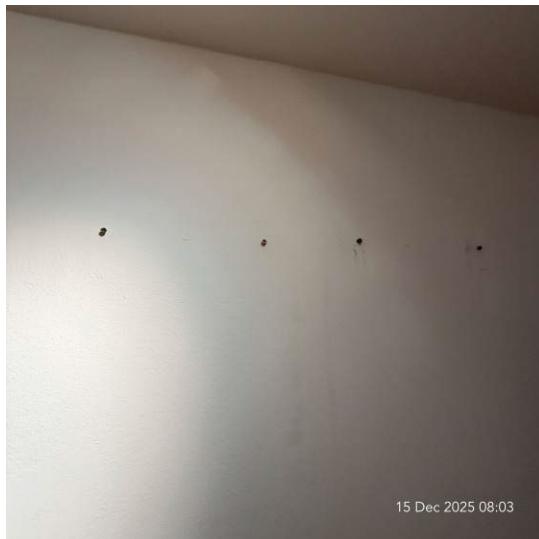
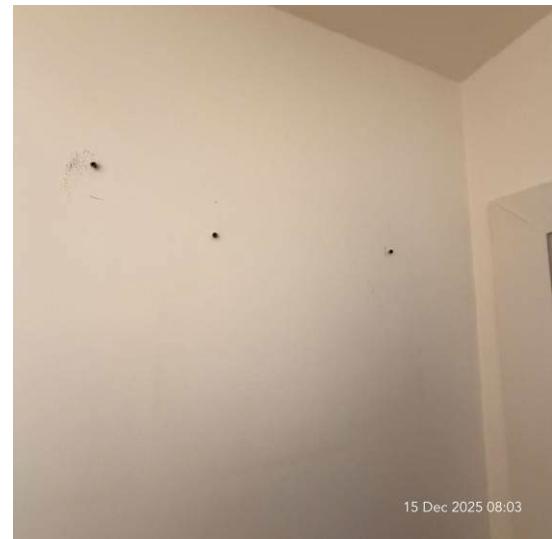
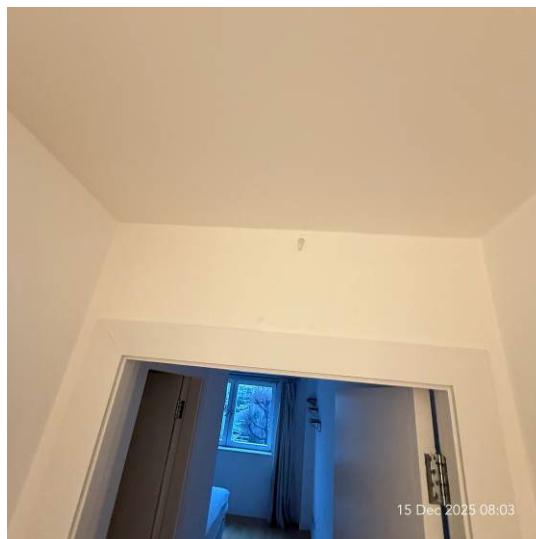
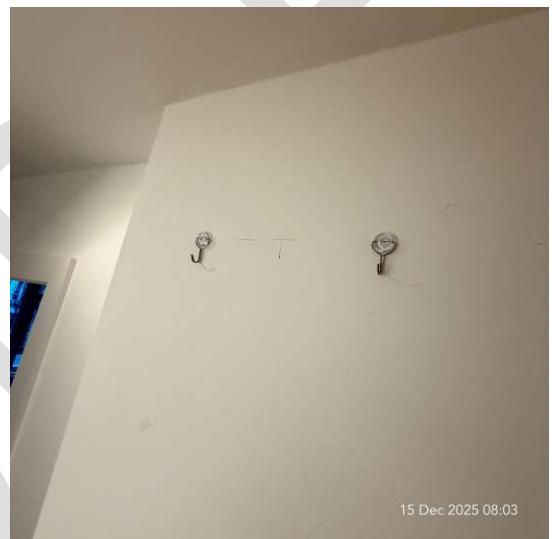
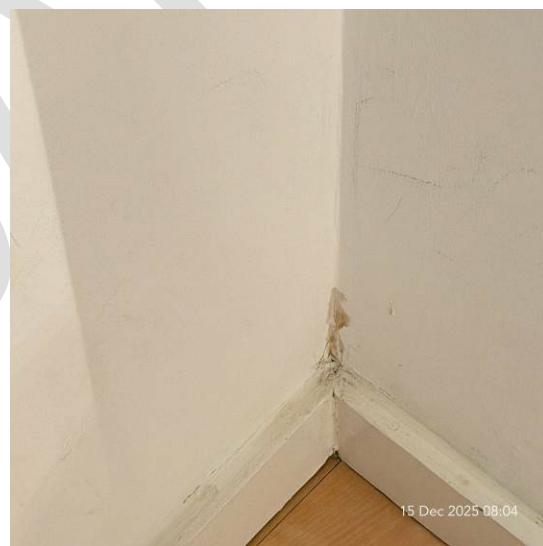
ENTRANCE HALL		
DESCRIPTION	CHECK IN CONDITION	CHECK OUT CONDITION AS CHECK IN UNLESS STATED
DOOR		
Exterior: grey oak style door with 44 in chrome numerals, chrome knocker, chrome letterbox, chrome handle, 2 chrome locks, chrome blanking plate	Slight scratch mark by knocker, shaded with slight paint marks around edges of door, knocker loose	knocker loose as per check in – landlord's maintenance
Interior: painted white with chrome letterbox with cover, chrome spyhole with cover, chrome lever handle, chrome lock, chrome twist lock, chrome arm door closer		handle now loose and screw require tightening – landlord's maintenance
WALLS		
Painted white	Slight scuff marking to angle to left side of shower room, few mid to low level scuff marks to right side of shower room, mid level scuff marked area to left hand side of bedroom 1	6 additional high level screw fixings left side of bedroom 1, picture hook over bedroom 1 and 2 further hook fixings left side of kitchen – tenant , small leak stained area low level left side of entrance appears from attended bathroom leak mid tenancy – landlord's attention , few mid to low level scuff marks either side of bathroom and light further wear and tear usage

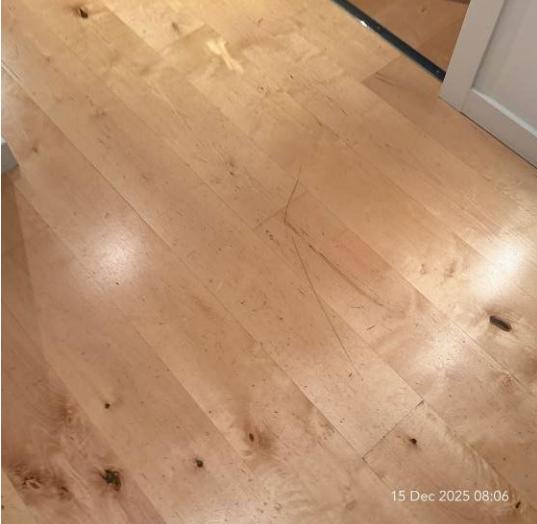
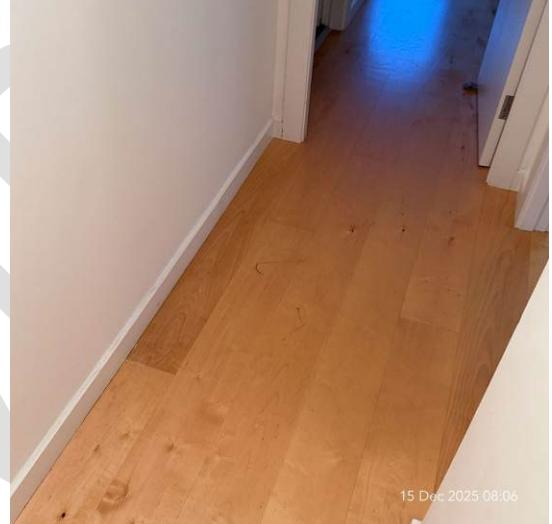
WOODWORK		
Painted white	few minor light angle rubs to architrave onto kitchen, small chip defect to edge of skirting to left side of kitchen	wear and tear light scuffing to architraves, minor light angle rubs
FLOORING		
Light wood strip flooring with chrome and rubber doorstop	Professionally cleaned, scattered indentation marks to walkways, long scratch mark forward of entrance, areas of line indentation marks to left hand side of shower room, few dark scratch marks to centre in front of reception room	Professionally cleaned, defect as per check in

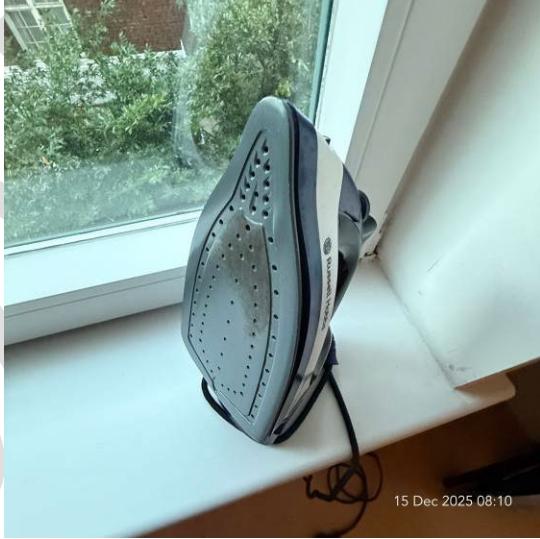
CURTAINS/BLINDS		
n/a		
CONTENTS		
Comelit video entryphone mounted onto white perspex panel with 4 plastic screw caps		As per check in
Rectangular mirror in shades of grey patterned frame		As per check in
Fitted cupboard units with dark wood doors with soft closers and small chrome stud fixing to edge of 3 doors	Soft closers slightly intermittent	As per check in
<ul style="list-style-type: none"> Left double with white laminate interior and 3 shelves with striped light wood trim, further concealed shelf with light wood trim, 5 white laminate drawers with light wood trim and chrome handles 	patchy shading to upper sections to interior	As per check in
<ul style="list-style-type: none"> Russell Hobbs iron 	Not tested	found in bedroom 2, marking to plate which may improve with further cleaning - tenant

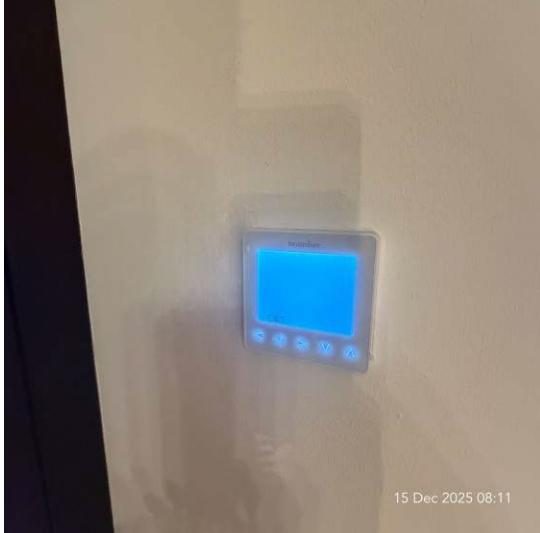
Eswa heating thermostat to wall	Discolouration	replaced with Heatmiser thermostat tested for power only

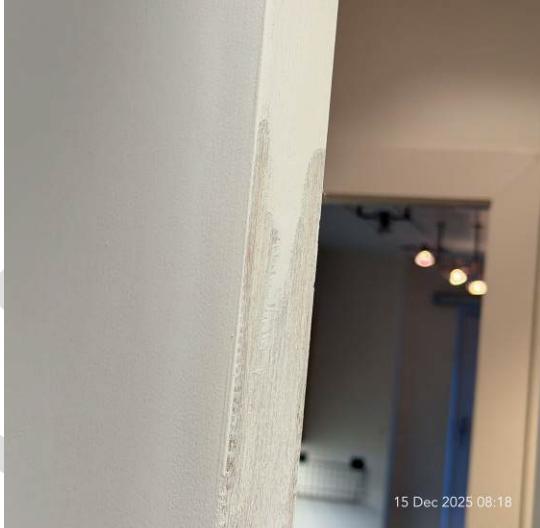
SHOWER ROOM		
DESCRIPTION	CHECK IN CONDITION	CHECK OUT CONDITION AS CHECK IN UNLESS STATED
DOOR		
Painted white with chrome lever handles and chrome twist lock, double chrome hook to interior	Low level edge chip to exterior, line shaded mark to base edge, handle slightly loose to exterior	Few minor light wear and tear edge chips, door edge shaved and touched up – possible due to leak during tenancy

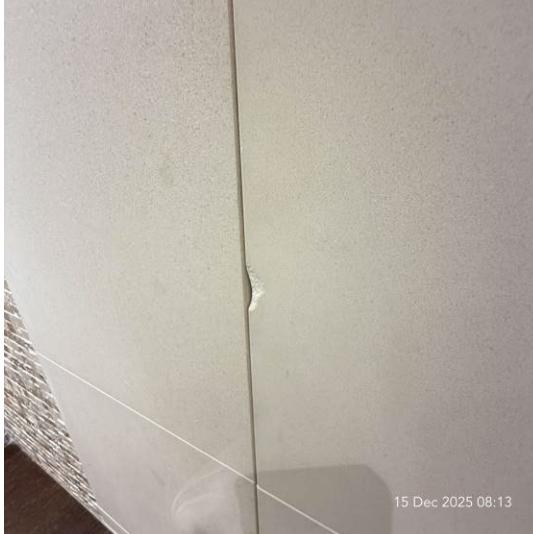
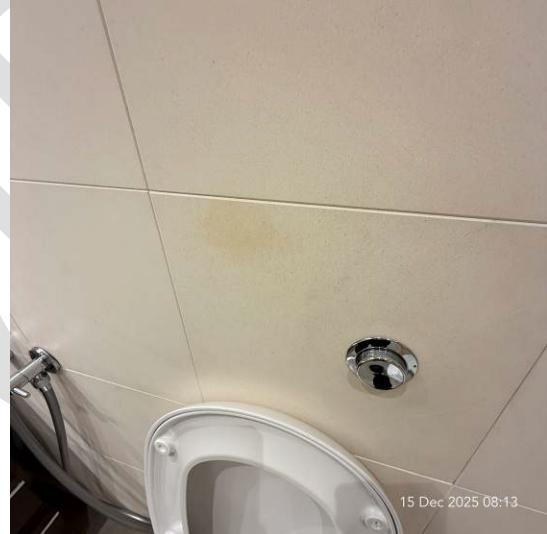
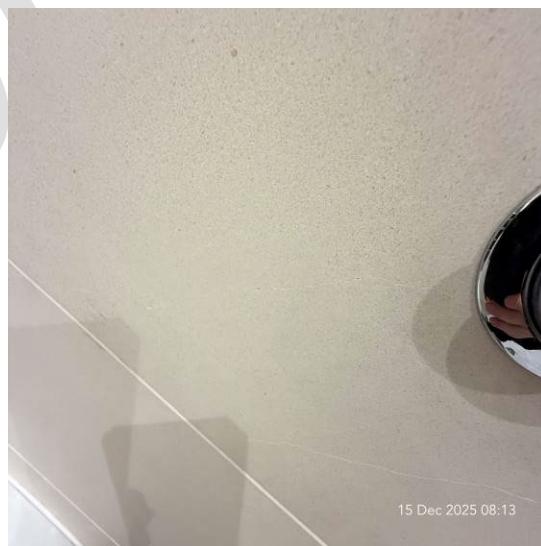
Dark cream limestone style tiles	<p>professionally cleaned, few light scuff marks within shower cubicle Minor discolouration and slight paint marks around top edges of tiles, 4 small chip defects to edge by access panel</p>	<p>Cream limestone tiles professionally cleaned, additional chip defect to access panel left hand side, area of discolouration to tiles by flush which may improve with further clean, hairline crack defect to access panel by flush</p> <p>Limestone effect laminate panelling now fitted to walls in shower cubicle, professionally cleaned – informed by tenant there was a leak during tenancy resulting in these being fitted approx 2 years ago, professionally cleaned</p>
----------------------------------	--	--

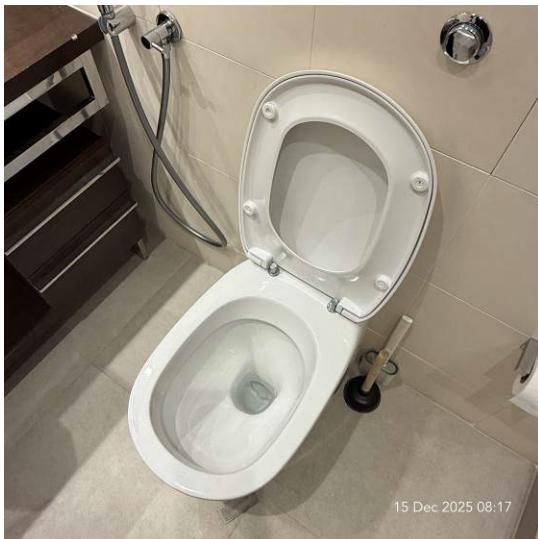
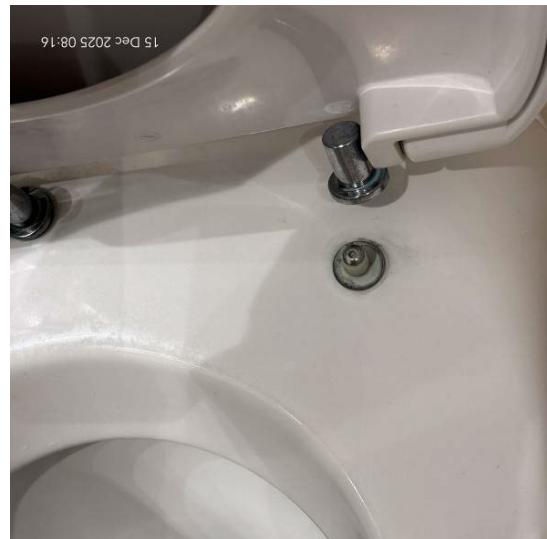
Low level dark wood shelf unit with 2 drawers with chrome handles and chrome legs	Scattered worn marks	<i>As per check in</i>
White WC with white seat and lid, encased cistern with chrome flush	Seat off brackets, 4 buffers off to seat	professionally cleaned, defects as per check in, right hand seat bracket comes off and requires securing, landlord maintenance

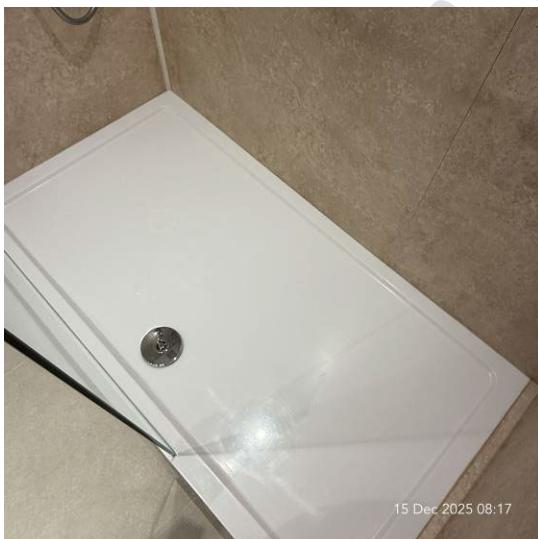
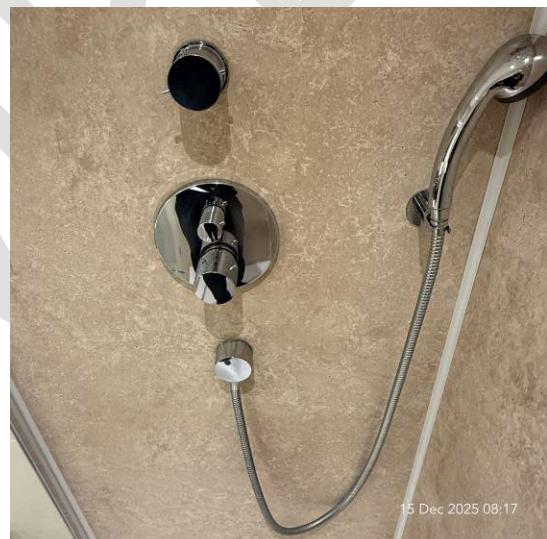
Chrome toilet roll holder		
Walk-in shower cubicle with fitted tempered glass shower screen		shower cubicle replaced since commencement with white shower tray with fixed tempered glass shower screen

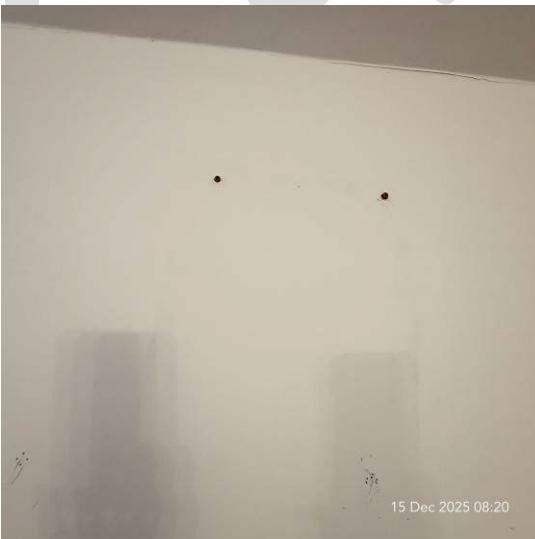
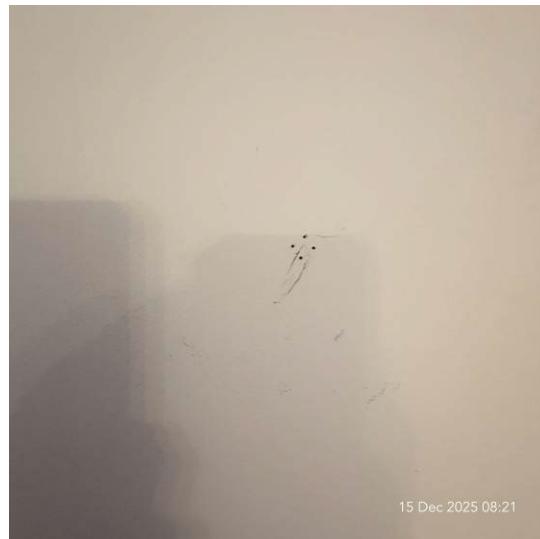
BEDROOM 1 - MASTER		
DESCRIPTION	CHECK IN CONDITION	CHECK OUT CONDITION AS CHECK IN UNLESS STATED
DOOR		
Painted white with chrome lever handles and chain door closer	Minor patchy shading to centre on exterior	<i>As per check in</i>
WALLS		
Painted white	Slight cracking around fuse point to right side of en suite, few small scuff marks under window, minor shrinkage cracking over wardrobes	2 screw fixings with picture shading to high level opposite the entrance, picture hook removal mark to same wall and 2 screw holes – tenant , area of mid to low level scuffing to centre on same wall, 6 rawl plug fixings and shading to corner left side of window – tenant , wear and tear shading with slight cracking around light switch for ensuite, light wear and tear scuff marking under window, low level possible water stain to angle right hand side of ensuite – landlord's information

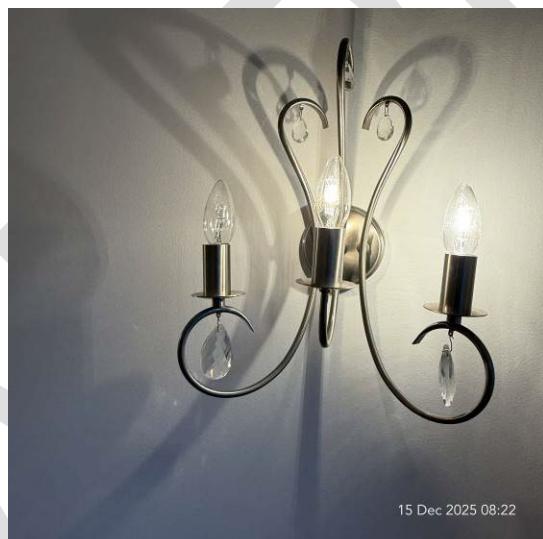
2 chrome triple arm wall lights with candle bulbs and crystal effect droplets	In working order	1 bulb not working to right hand fitting - tenant
---	------------------	--

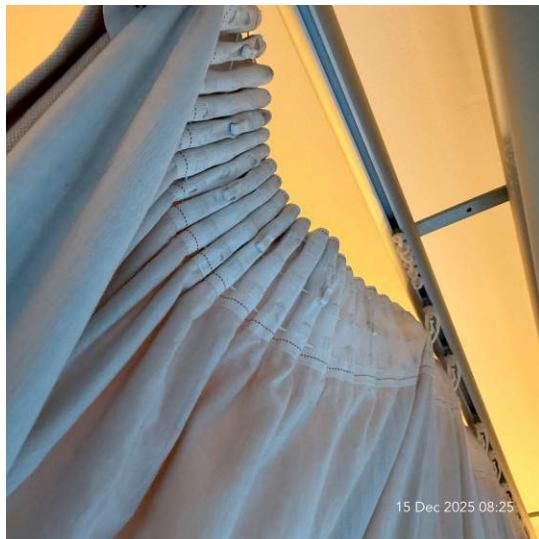
Pair of full length lined cream curtains on double chrome curtain pole with ball finials	Slight creasing, in clean order, minor paint marks to curtain pole	numerous hooks have broken off to left hand curtain and few to right hand curtain, very dusty to hem, not cleaned - tenant
--	--	---

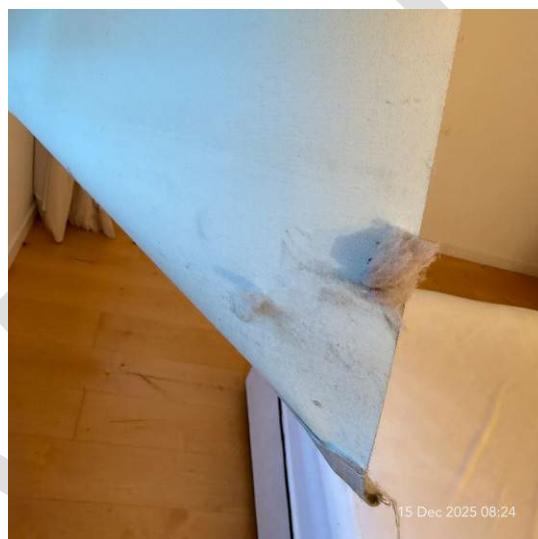
Shades of grey blackout roller blind with plastic pulley

Slight puckering down centre of blind

Tested, very dusty to lining side and requires vacuuming - **tenant**

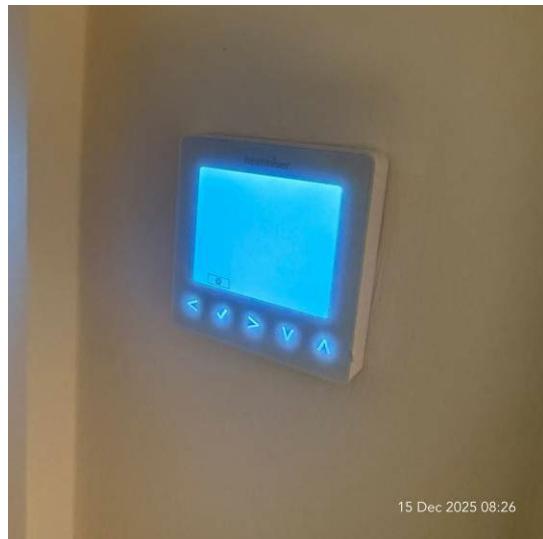
Eswa heating thermostat to wall

replaced during tenancy with Heatmiser thermostat

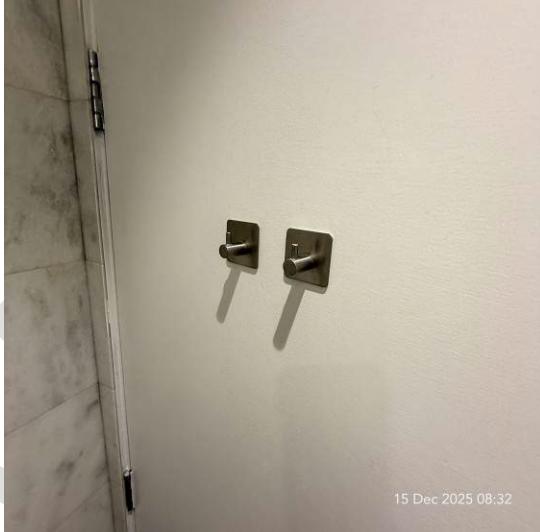
ENSUITE BATHROOM		
DESCRIPTION	CHECK IN CONDITION	CHECK OUT CONDITION AS CHECK IN UNLESS STATED
DOOR		
Painted white with chrome lever handles and chrome twist lock	Small chip defect to left edge on exterior, minor blistering along base edge to exterior	2 additional chrome hooks to interior of door - tenant

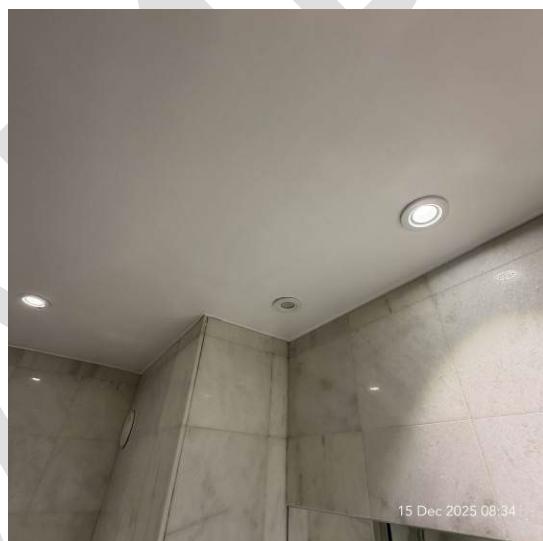
7 inset LED spotlights	All in working order	1 bulb not working - tenant
------------------------	----------------------	------------------------------------

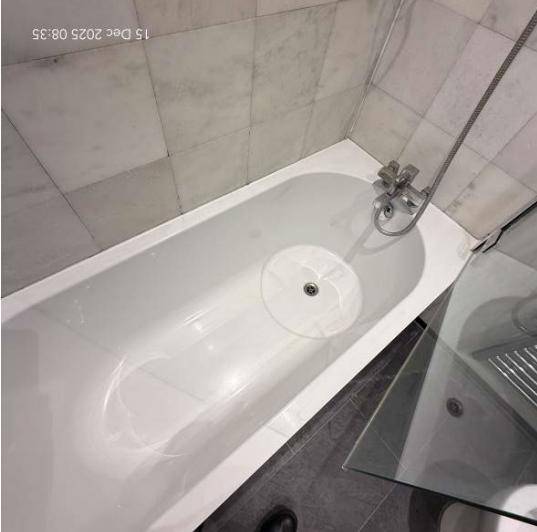
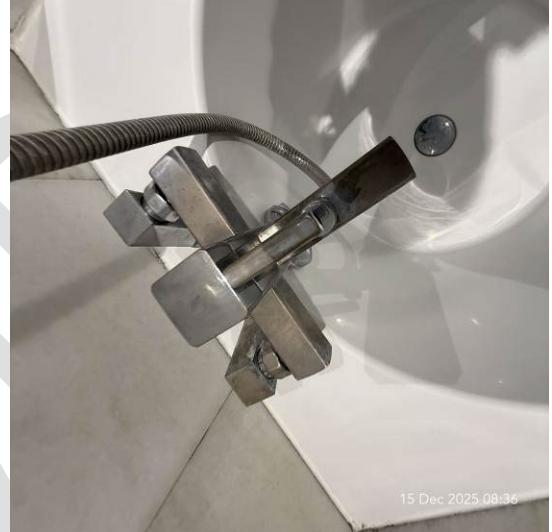
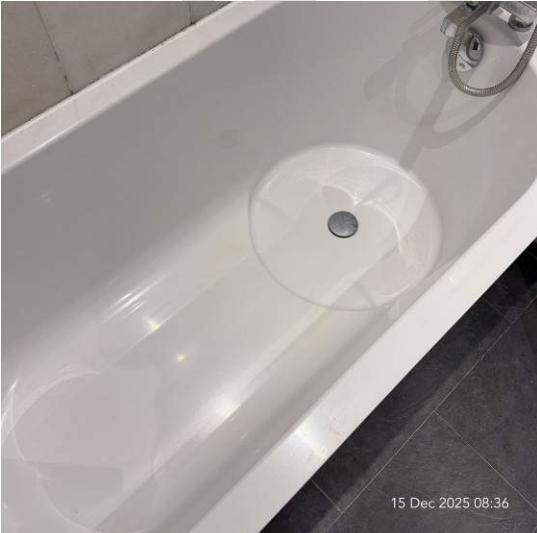
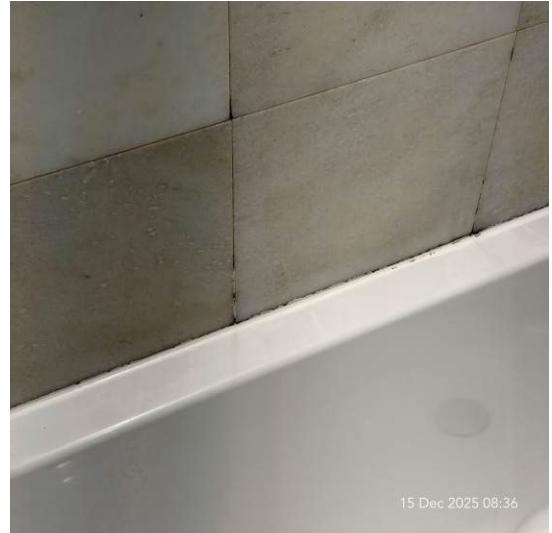
Chrome toilet roll holder		As per check in
Chrome ladder heated towel rail	Cap missing to top right hand bracket	As per check in
Vent to wall	Slight discolouration around edge	As per check in
White bath with chrome mixer taps with shower attachment, chrome shower hose and head on chrome shower holder to wall, pop-up waste	Heavy tarnishing/abrasions to tap, slight wear to coating on shower head, professionally cleaned	Professionally cleaned. pop up plug sticking landlord maintenance , slight yellowing discolouration to interior of bath which may improve with further cleaning - tenant , mastic slightly splitting around edge of bath and requires renewing – landlord maintenance

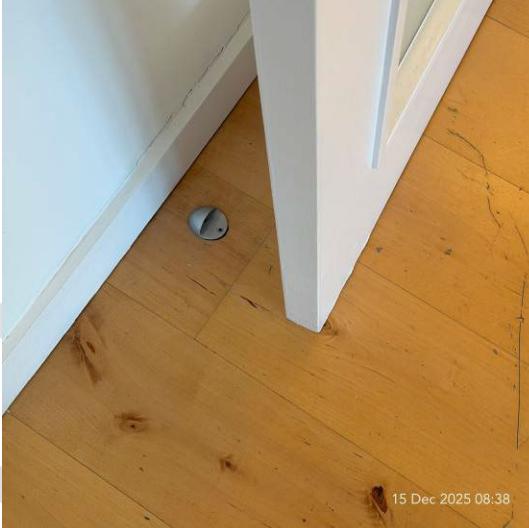
RECEPTION ROOM		
DESCRIPTION	CHECK IN CONDITION	CHECK OUT CONDITION AS CHECK IN UNLESS STATED
DOOR		
Painted white with 2 glazed panels, chrome lever handles and chain door closer	Door closer disconnected and painted over, handles loose	Handles loose, door slightly binds with floor when fully opened – landlord's maintenance

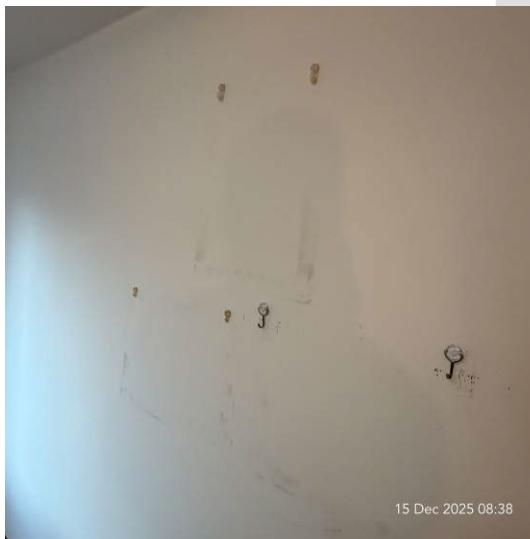
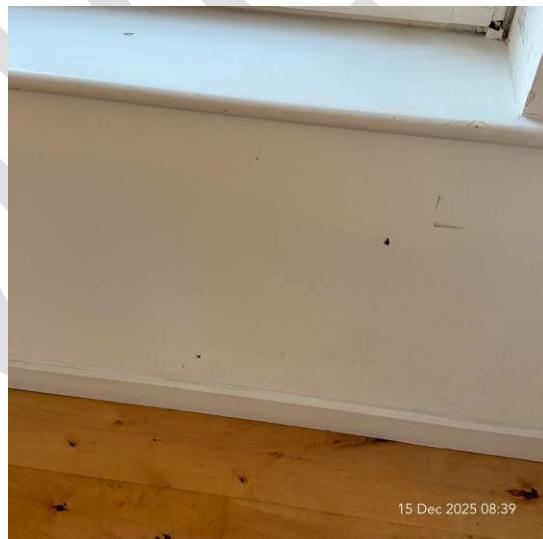
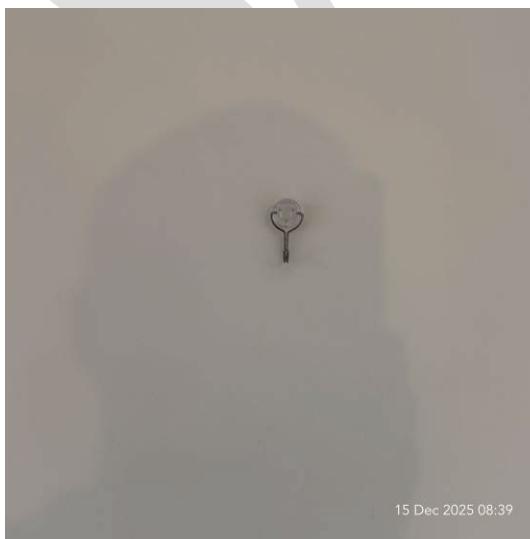
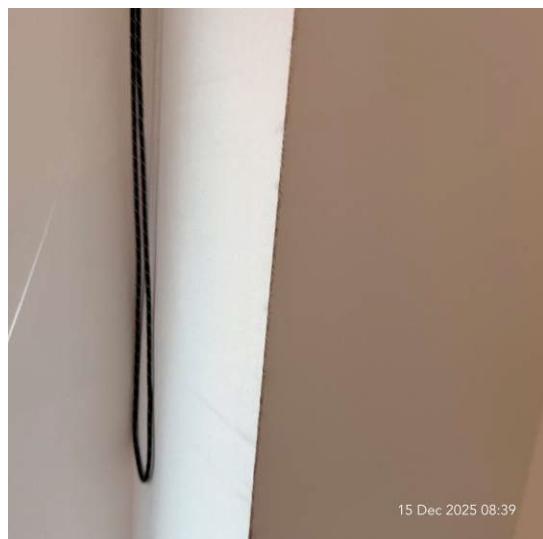
Right hand wall – 4 picture hooks and 2 slightly larger hook fixings, 5 picture hook removal marks and picture shading, further hook fixing left hand side of right hand window, scuff marking under same window, mid to low level angle scuffing right hand side of windows, 4 rawl plug fixings with line shaded areas left hand side of the windows and 1 further screw fixing over the sofa, - tenant

wear and tear shading around light switch area, wear and tear cracking over skirting to right hand wall

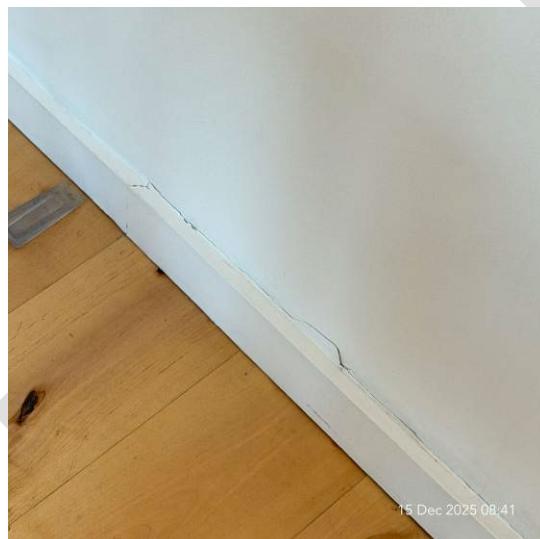
Painted white	small scuff mark on architrave	Professionally cleaned, wear and tear slight ageing discolouration, general shrinkage cracking
---------------	--------------------------------	--

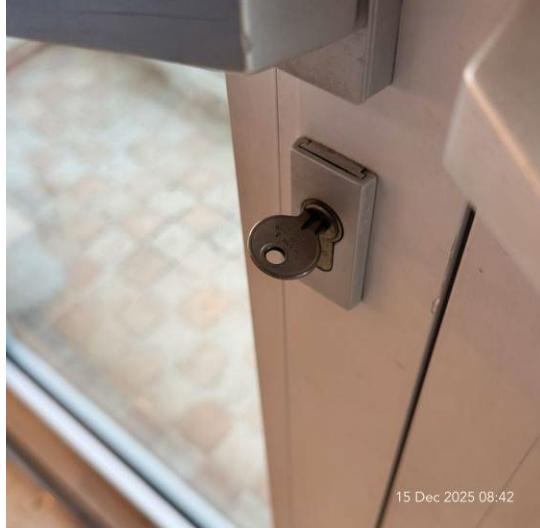
Pair of white framed double glazed doors onto balcony with chrome handles, lock and key	Cleaned to interior and exterior, patchy shading to frame	keys seen in lock, cleaned to interior only, exterior requires cleaning - tenant

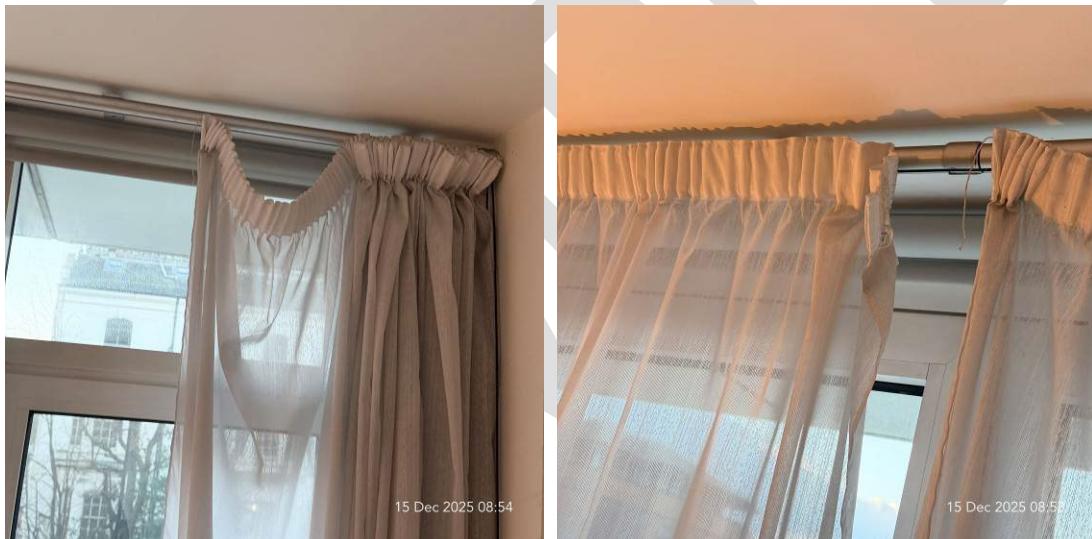
Pair of slightly longer than full length white voile curtains on chrome curtain pole with 2 pulleys	2 faint black line marks at low level on left hand curtain, clean order	Tested, not cleaned, require cleaning, number of hooks off - tenant
---	---	--

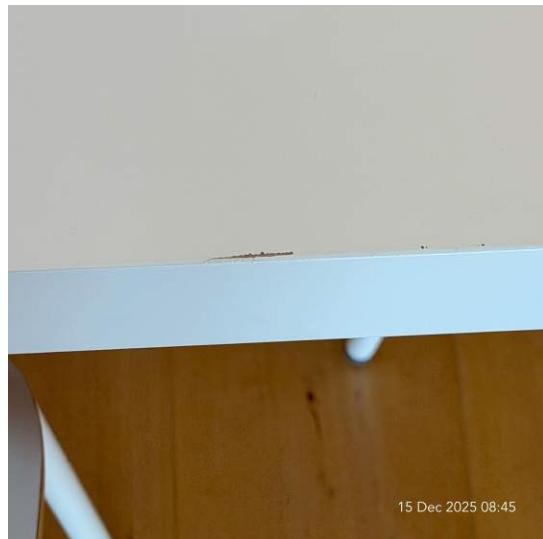
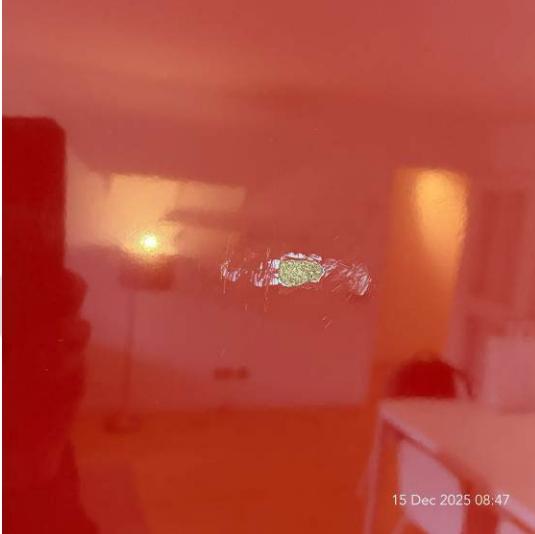
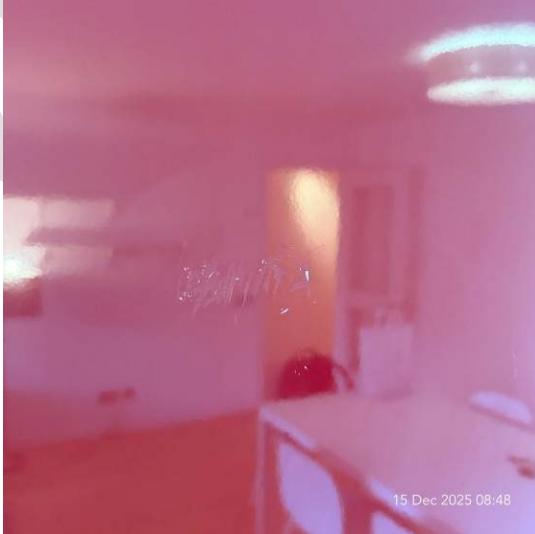
6 white laminate and light wood trim dining chairs with white metal frames with plastic capping to base of frames		<i>As per check in</i>
Large burgundy gloss laminate panel to wall with black wooden 2-section panel attached with 2 tempered glass opaque shelves fitted	Top shelf badly cracked and chipped to centre	1" scrape defect with sticky tape mark right hand side, area of scratch marks to right hand side, 2 areas of rubs/abrasions, fe smal chips low level scuffs behind tv - tenant

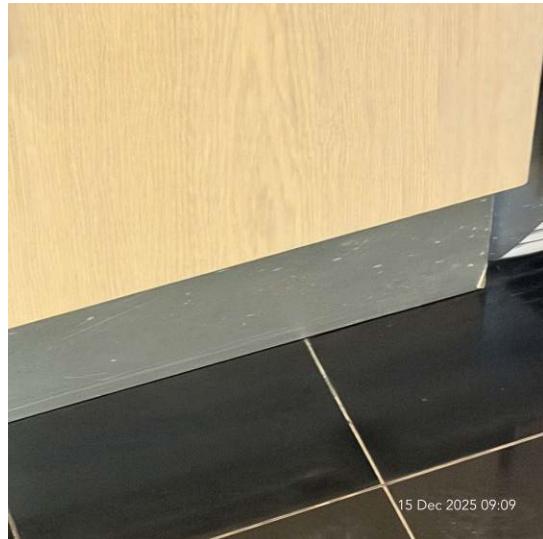
Range of grey oak style wall, base and drawer units with chrome handles	chip to side of cupboard to left of sink, chip defect to top of drawer unit to right side of hob, hinge loose to cupboard under hob and to cupboard over hob, slight wear to plinth over hob, filled screw hole behind handle on each drawer under hob, 1 hinge off to far left hand cupboard, screw fixing to interior of same unit, long line scratch mark to door housing water cylinder, chip to base off refrigerator housing	Professionally cleaned, general further usage to interior, loose hinges as per check in, landlord maintenance
• 4 striplights under wall units	All in working order	<i>As per check in</i>
• Brushed stainless steel effect kickspaces		Require further cleaning - tenant

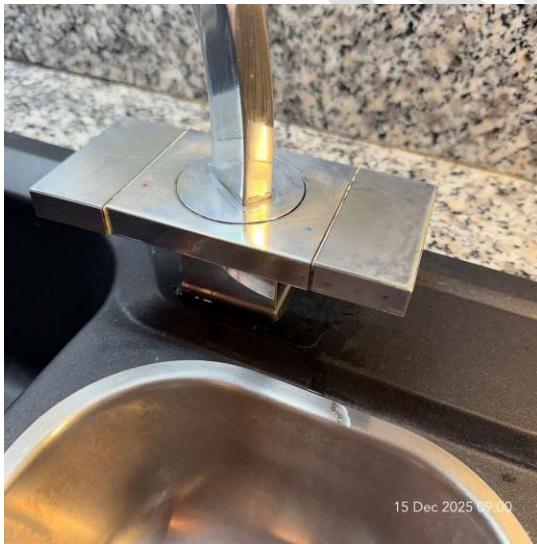
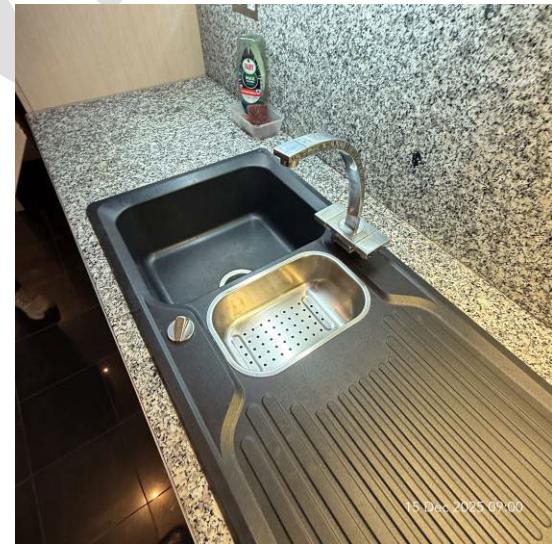
• Matching end wall shelf unit		<i>As per check in</i>
Shades of black and grey granite worksurfaces with chrome trim	1cm chip defect to edge over drawer unit to left of hob	Require further cleaning - tenant
Matching breakfast bar		<i>As per check in</i>
Black speckled Blanco 1 ½ bowl sink unit with stainless steel drainer bowl, Insinkerator waste disposal, chrome mixer taps and plastic strainer plug	Waste disposal tested for power only – not grinding, making buzzing noise only, abrasions to mixer taps, very slight scale residue around edges of half bowl	general wear and tear usage, leak at join to mixer taps – landlord's attention , waste disposal tested for power only and noted as not grinding at commencement now has no power

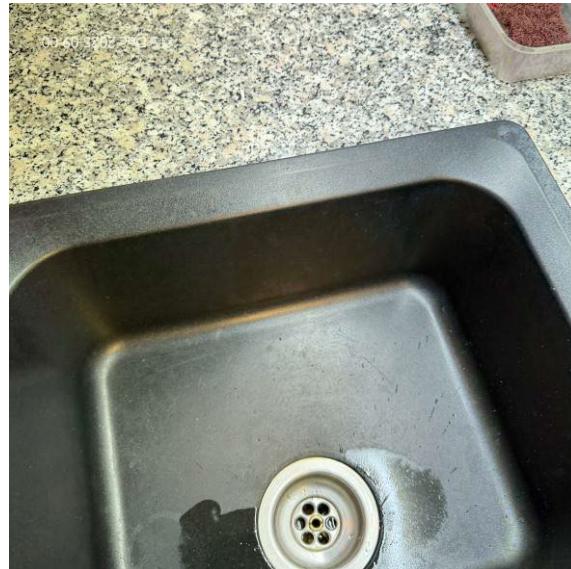
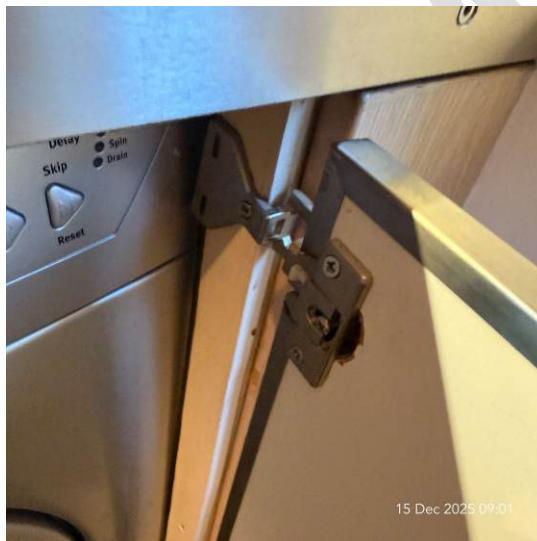
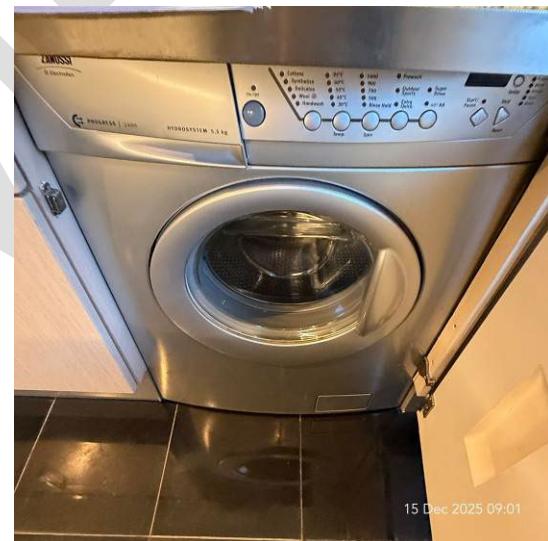
Stainless steel coloured Zanussi washing machine with outer brushed stainless steel décor door with chrome handle

Tested for power only, professionally cleaned, drip marks to base of casing

top hinge to décor door loose and requires repair – **landlord maintenance**, tested for power only, professionally cleaned, mildew staining to seal which may improve with further cleaning, **tenant**

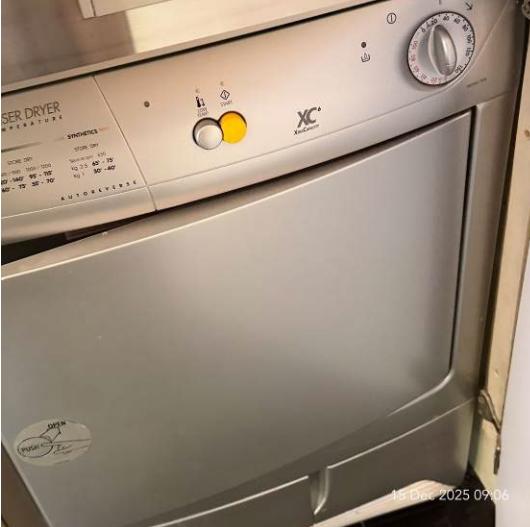
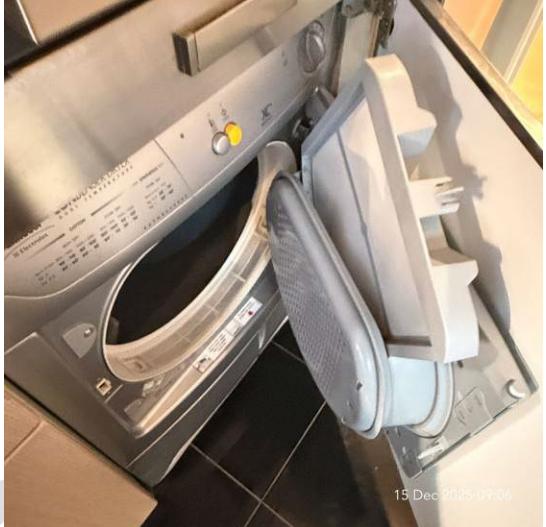
<p>Stainless steel effect Zanussi condensing tumble dryer with brushed stainless steel style décor door with chrome handle</p>	<p>Tested for power only, professionally cleaned, slight discolouration to filter, décor door slightly smearable</p>	<p>tested for power only, door release slightly sticking – landlord maintenance, vent to base of tumble dryer requires cleaning dryer - tenant</p>

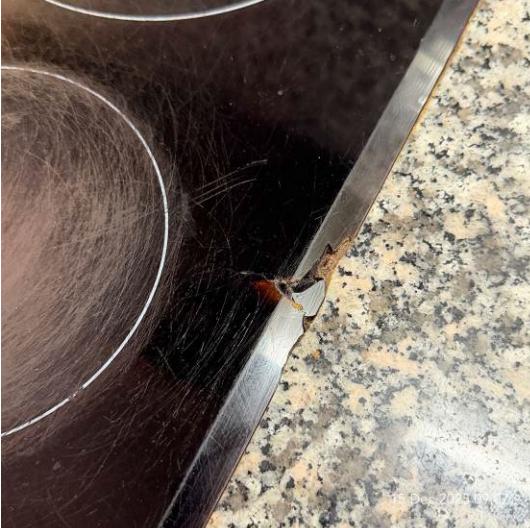
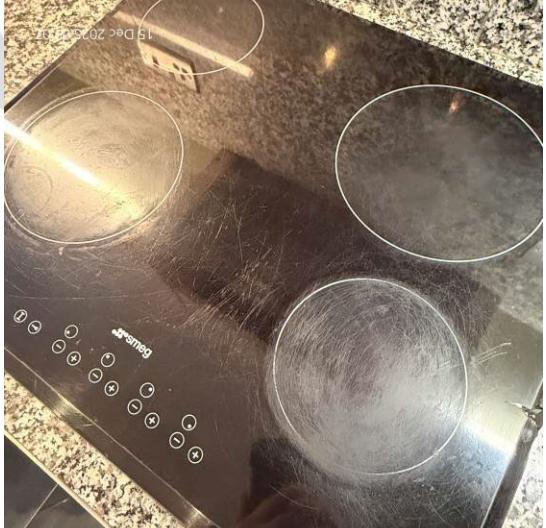
<p>Smeg 4-ring black ceramic hob</p>	<p>Tested for power only, scratches to front rings, 2 chip defects to left edge</p>	<p>Professionally cleaned, chip defects to left edge as per check in, further chip and crack defect to right edge - tenant, heavy marking to rings and scratch marks - tenant, tested for power only</p>

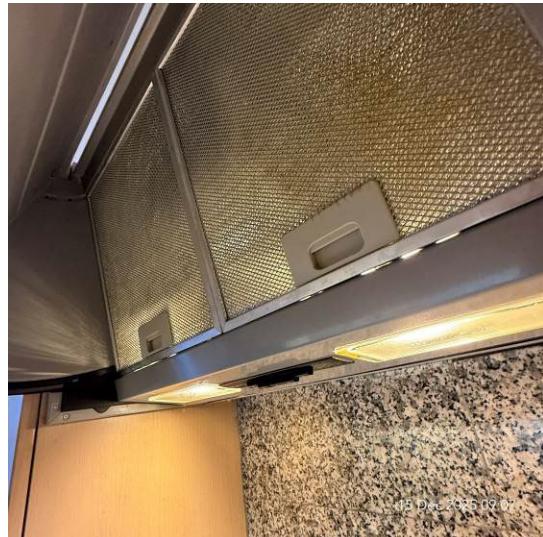
<p>Neff stainless steel extractor hood with 2 filters and 2 lights</p>	<p>Tested for power only, lights in working order</p>	<p>tested for power only, light in working order, tacky around control panel and requires further clean - tenant</p>

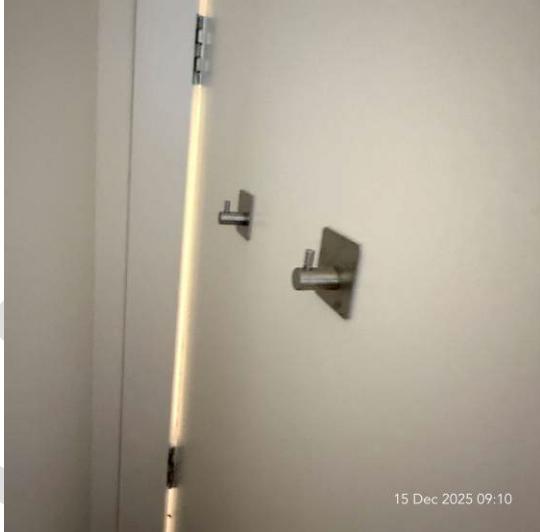
BEDROOM 2		
DESCRIPTION	CHECK IN CONDITION	CHECK OUT CONDITION AS CHECK IN UNLESS STATED
DOOR		
Painted white with chrome lever handles and chain door closer	Handles slightly loose Minor chip defect to edge	2 additional chrome hooks to interior - tenant , further minor wear and tear chips to door

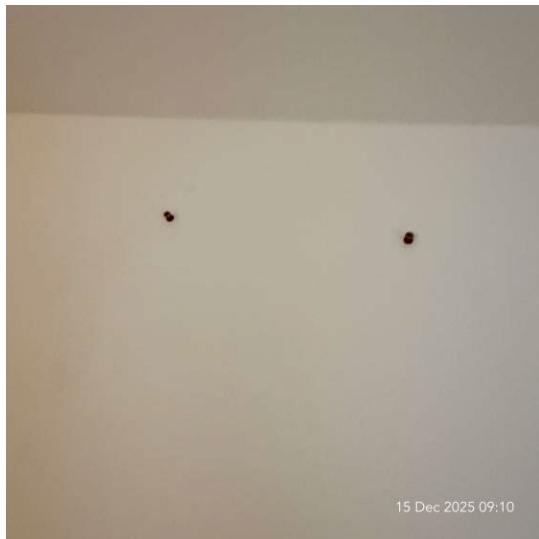
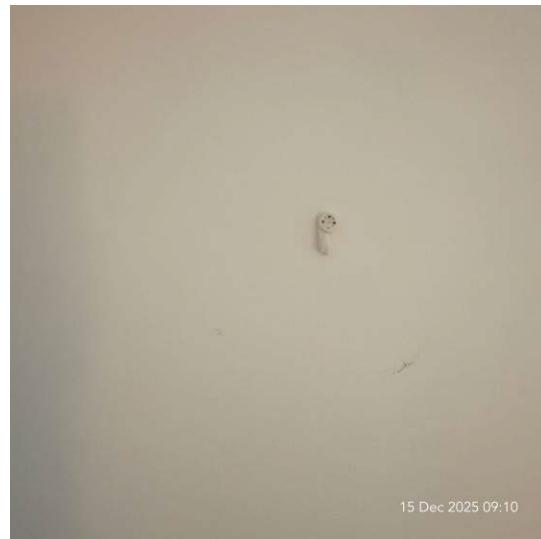
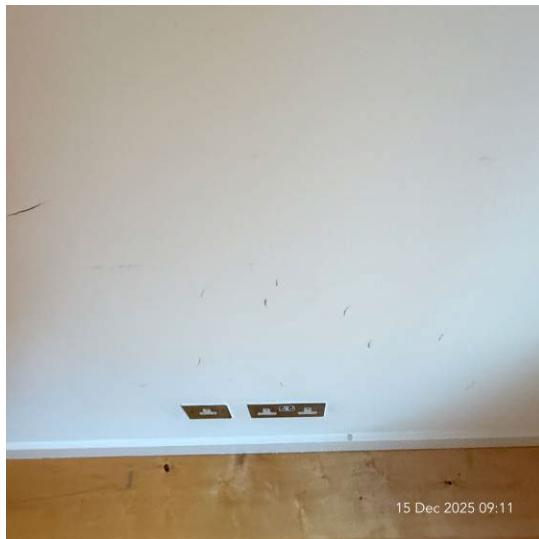
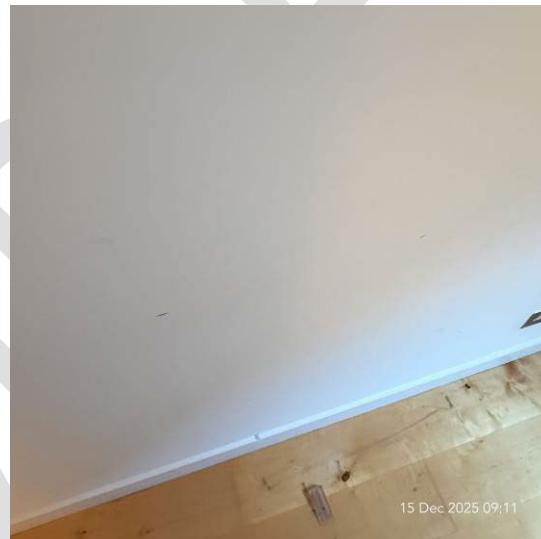
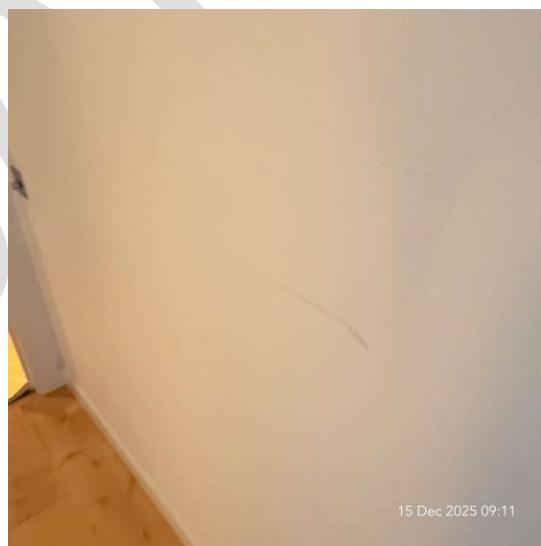
15 Dec 2025 09:10		
WALLS		
Painted white	mid level scuff marks to right hand side of light switch, low level scuffing around power points opposite bed, area of scuff marking at mid level to right hand side of bed, line scuff mark to left side of headboard	2 additional screw fixings to left hand wall, additional picture hook with scuff marking left hand side of window - tenant , wear and tear shading over bed area, mid and low level scuff marking to left hand wall, further wear and tear usage

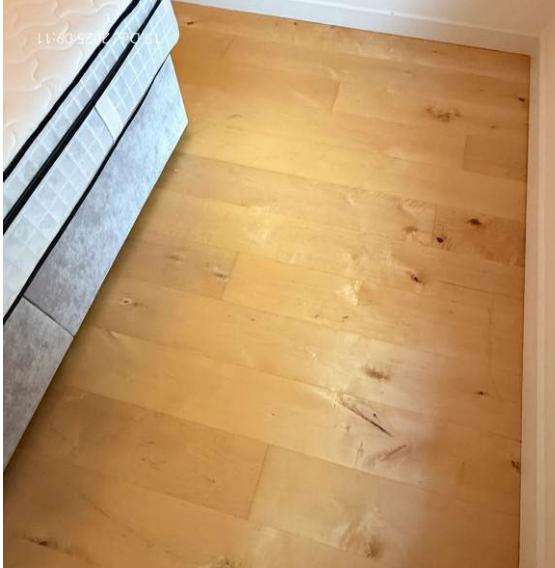
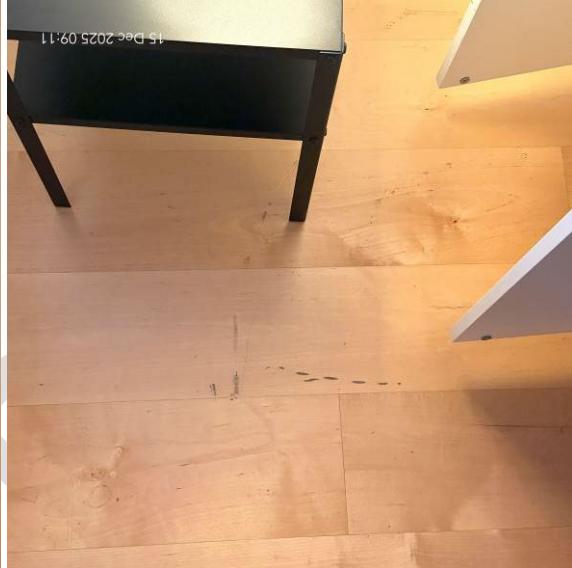
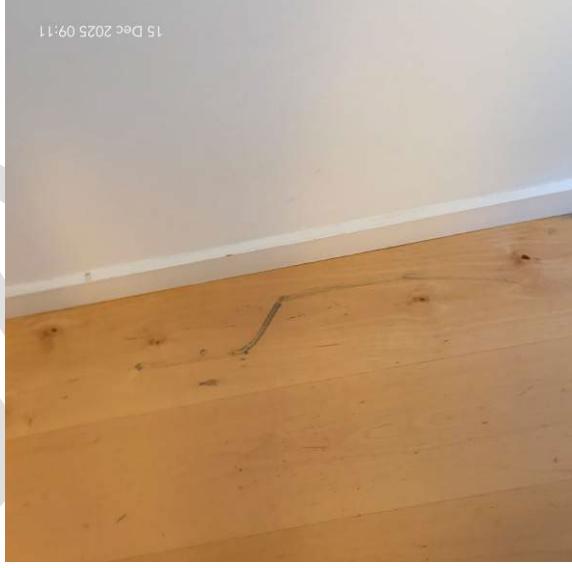
FLOORING		
Continuation of wood strip flooring from entrance hall with chrome door strip, chrome and rubber doorstop	Scattered indentation marks to walkways, scattered scratch marks to right hand side of bed area and in front of wardrobes, dark scratch marked areas forward of entrance with further dark scratch mark at foot of bed	Professionally cleaned, defects generally as per check in with further usage

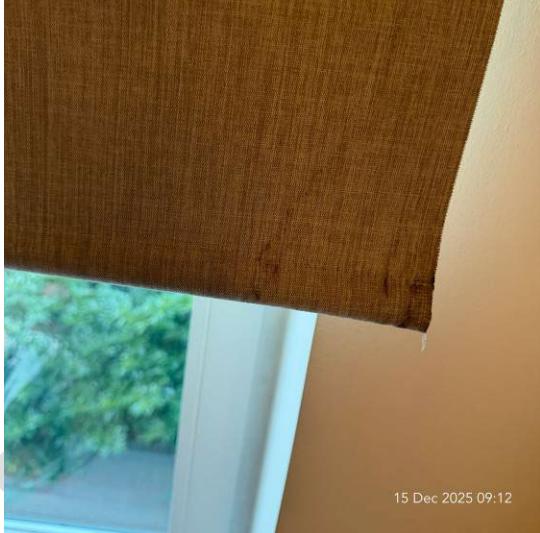
WINDOWS		
White framed double glazed casement window with chrome handle with lock, sill painted white	Cleaned to interior and exterior, few light scuff marks to sill, shaded marks to top of window reveal	Cleaned to interior only, exterior requires cleaning - tenant , wear and tear cracking to base of frame
CURTAINS/BLINDS		
Grey roller blind with plastic pulley		grubby marks to base, age discolouration and shading to lining, requires cleaning - tenant

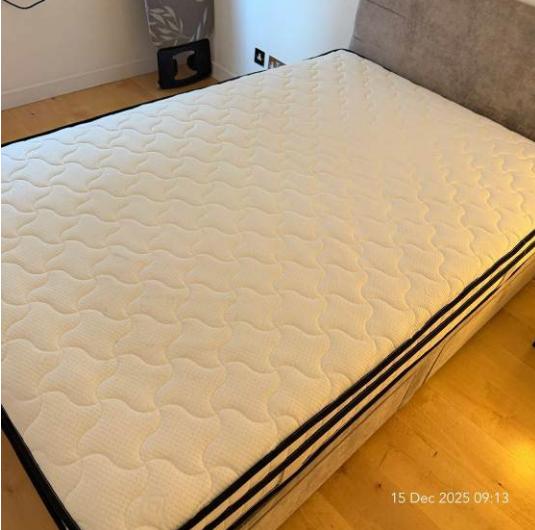
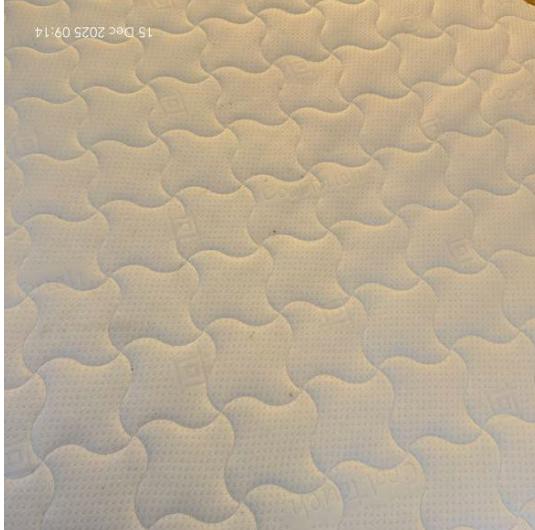
White and black trim small double (4ft) mattress	very minor scattered small spot marks to centre on upper side	few minor marks to top as per check in, inspected both sides

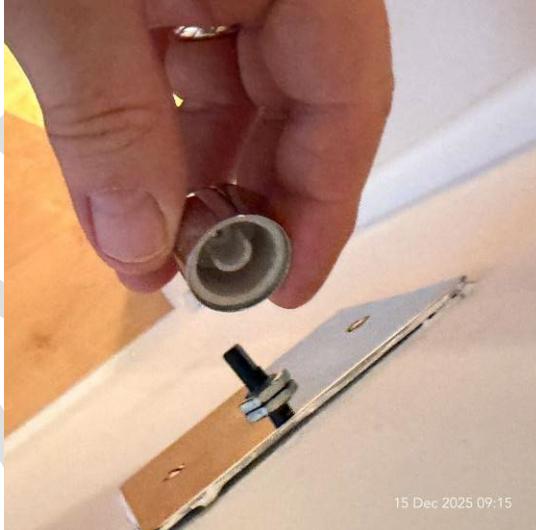
White mattress protector		not seen - tenant
Polished chrome dimmer switch and polished chrome power points		Knob cover off, plastic broken to interior
