CHECK OUT REPORT

SAMPLE ADDRESS

SAMPLE DATE

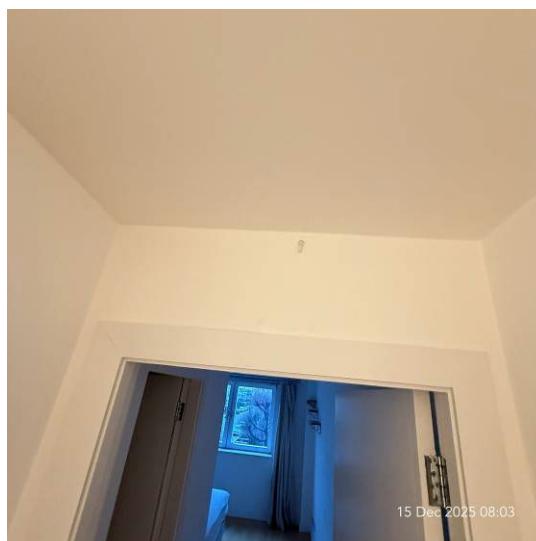
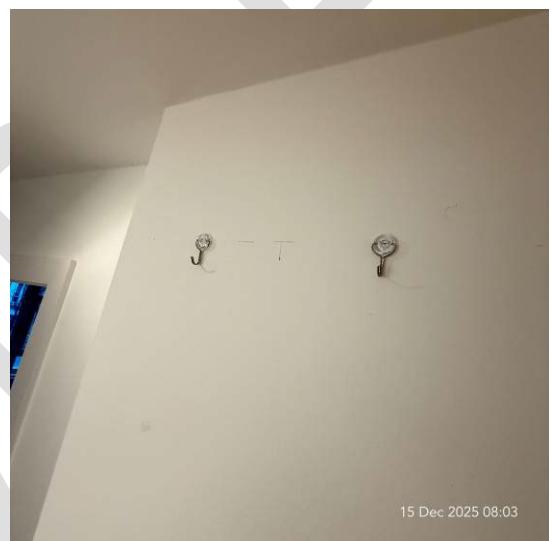
ENTRANCE HALL		
DESCRIPTION	CHECK IN CONDITION	CHECK OUT CONDITION AS CHECK IN UNLESS STATED
DOOR		
Exterior: grey oak style door with 44 in chrome numerals, chrome knocker, chrome letterbox, chrome handle, 2 chrome locks, chrome blanking plate	Slight scratch mark by knocker, shaded with slight paint marks around edges of door, knocker loose	knocker loose as per check in – landlord's maintenance
Interior: painted white with chrome letterbox with cover, chrome spyhole with cover, chrome lever handle, chrome lock, chrome twist lock, chrome arm door closer		handle now loose and screw require tightening – landlord's maintenance
WALLS		
Painted white	Slight scuff marking to angle to left side of shower room, few mid to low level scuff marks to right side of shower room, mid level scuff marked area to left hand side of bedroom 1	6 additional high level screw fixings left side of bedroom 1, picture hook over bedroom 1 and 2 further hook fixings left side of kitchen – tenant , small leak stained area low level left side of entrance appears from attended bathroom leak mid tenancy – landlord's attention , few mid to low level scuff marks either side of bathroom and light further wear and tear usage

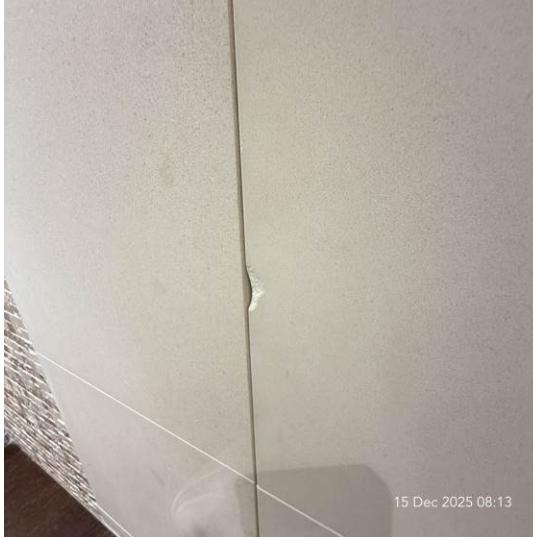
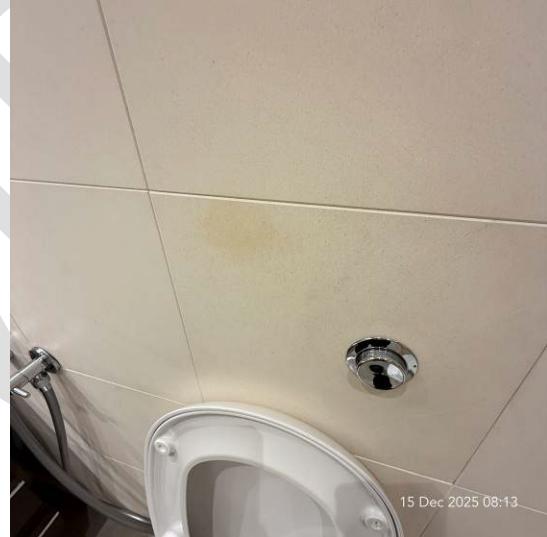
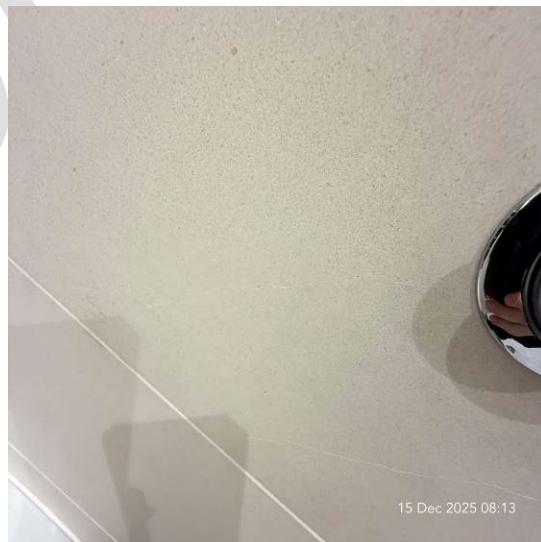
Dark cream limestone style tiles	<p>professionally cleaned, few light scuff marks within shower cubicle Minor discolouration and slight paint marks around top edges of tiles, 4 small chip defects to edge by access panel</p>	<p>Cream limestone tiles professionally cleaned, additional chip defect to access panel left hand side, area of discolouration to tiles by flush which may improve with further clean, hairline crack defect to access panel by flush</p> <p>Limestone effect laminate panelling now fitted to walls in shower cubicle, professionally cleaned – informed by tenant there was a leak during tenancy resulting in these being fitted approx 2 years ago, professionally cleaned</p>
----------------------------------	--	--

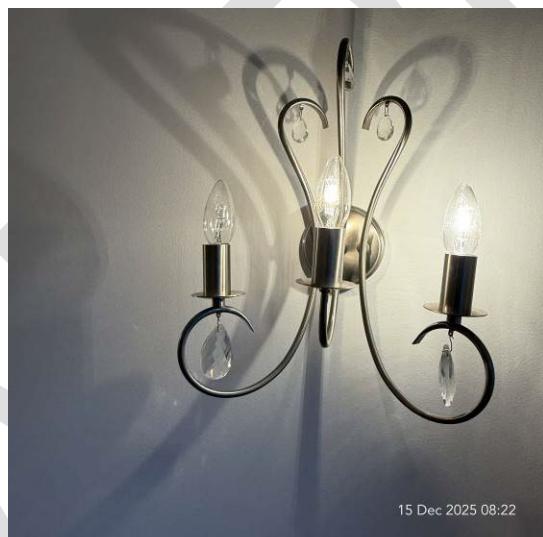
1 bulb not working to right hand fitting - **tenant**

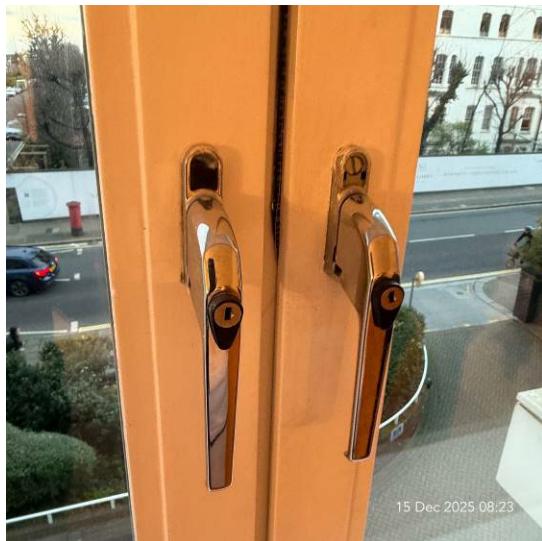
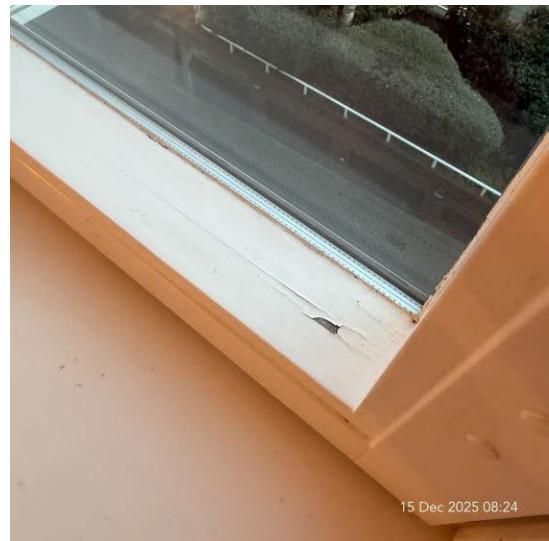
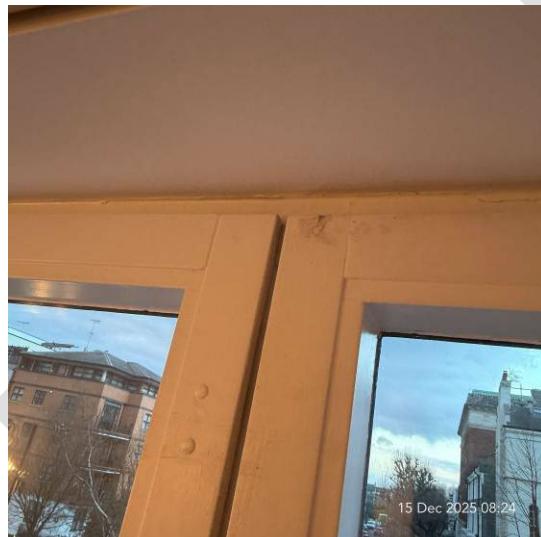
WINDOWS

Cleaned to interior and exterior, 2 keys not seen - **tenant**, further scuff marking to sill area and flaking areas to paintwork to base of frame in parts, scuffing around top of reveal, small filled area to top of right hand window, minor shading to frame

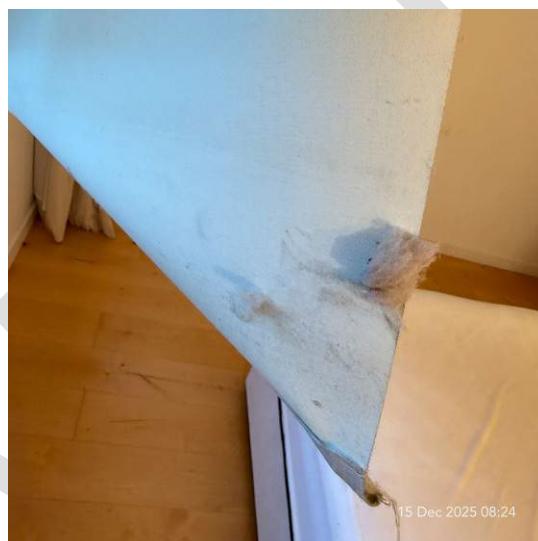
Shades of grey blackout roller blind with plastic pulley

Slight puckering down centre of blind

Tested, very dusty to lining side and requires vacuuming - **tenant**

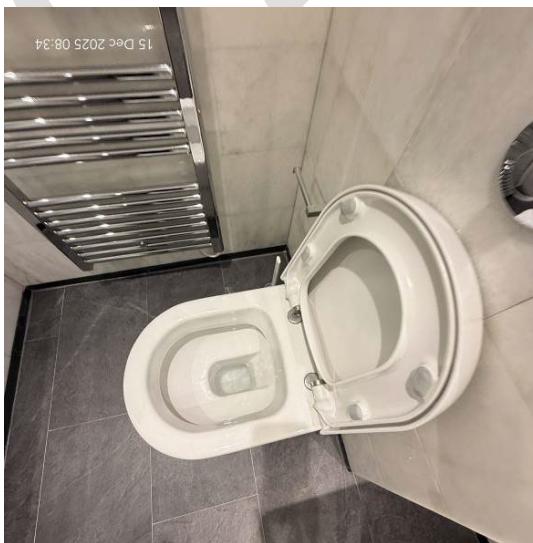
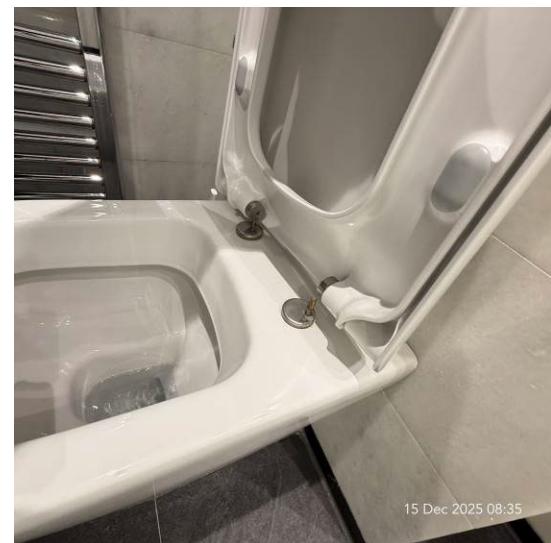
White gloss laminate vanity unit with deep single drawer with opaque glass drawer front and polished chrome frame		professionally cleaned
White WC with white seat and lid, encased cistern with chrome flush	Minor discolouration around base edges of pedestal, professionally cleaned	professionally cleaned, seat bracket comes off landlords maintenance

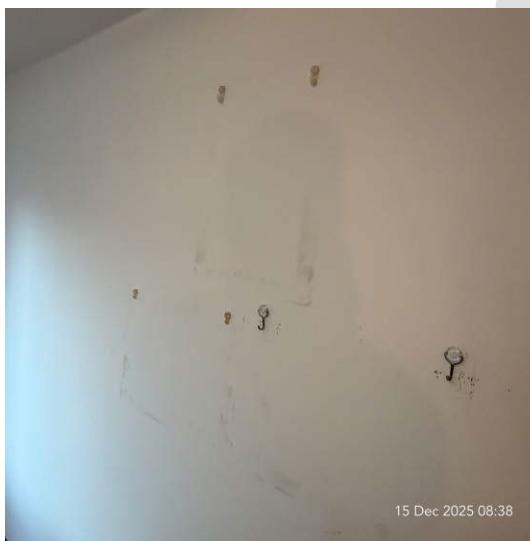
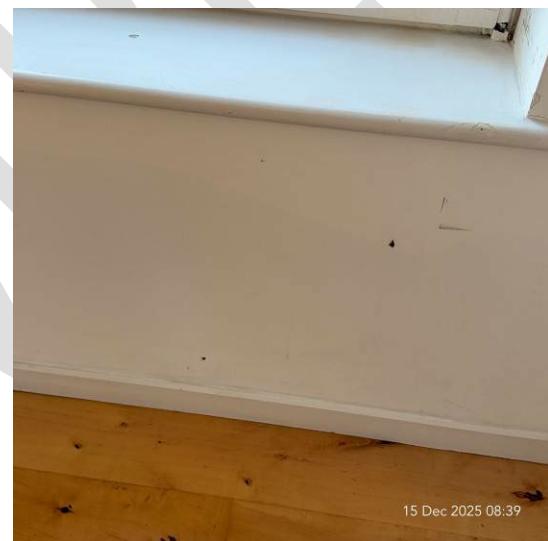
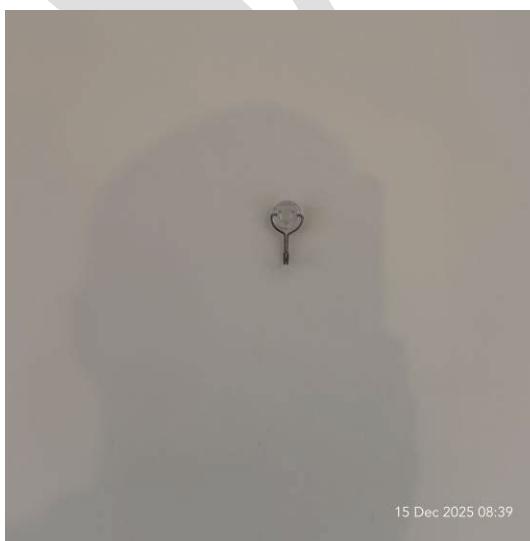
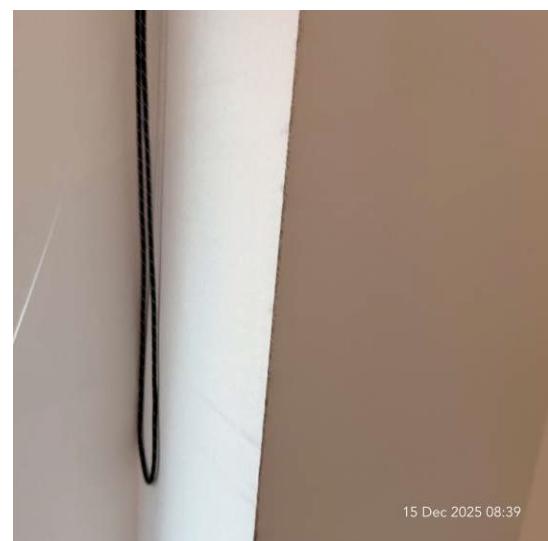
Right hand wall – 4 picture hooks and 2 slightly larger hook fixings, 5 picture hook removal marks and picture shading, further hook fixing left hand side of right hand window, scuff marking under same window, mid to low level angle scuffing right hand side of windows, 4 rawl plug fixings with line shaded areas left hand side of the windows and 1 further screw fixing over the sofa, - tenant

wear and tear shading around light switch area, wear and tear cracking over skirting to right hand wall

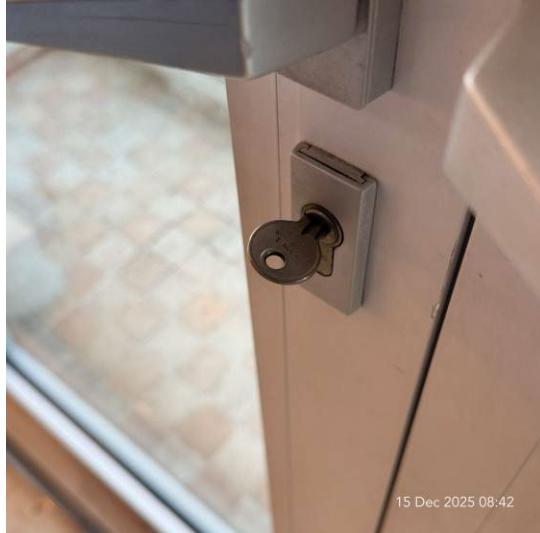
Pair of white framed double glazed doors onto balcony with chrome handles, lock and key	Cleaned to interior and exterior, patchy shading to frame	keys seen in lock, cleaned to interior only, exterior requires cleaning - tenant

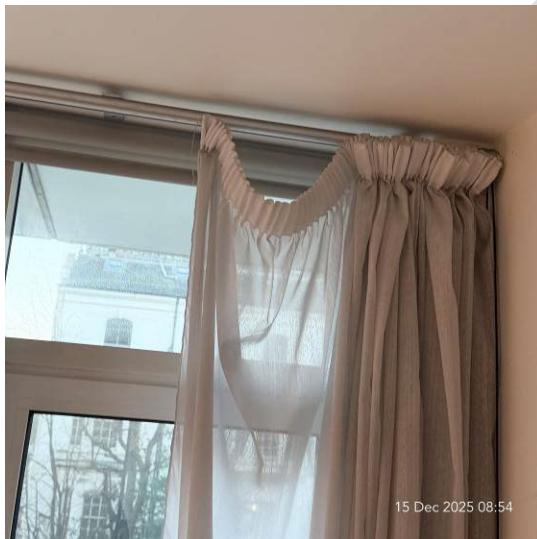
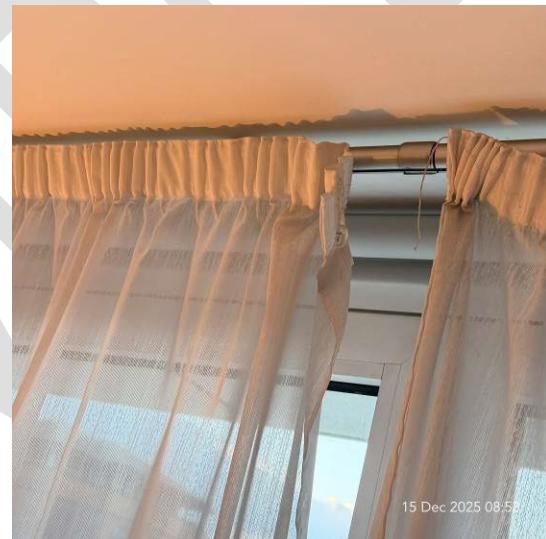
Pair of slightly longer than full length white voile curtains on chrome curtain pole with 2 pulleys

2 faint black line marks at low level on left hand curtain, clean order

Tested, not cleaned, require cleaning, number of hooks off - **tenant**

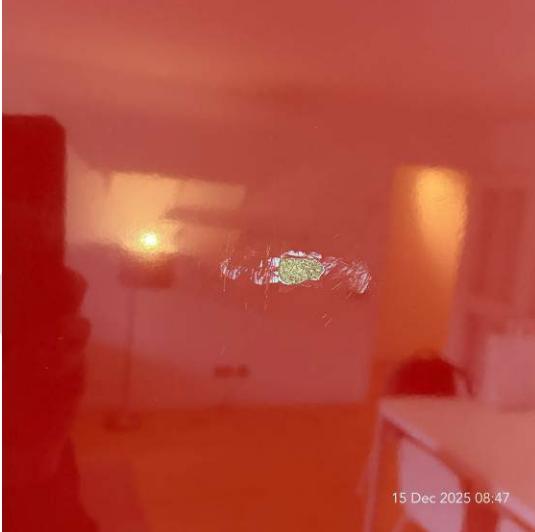
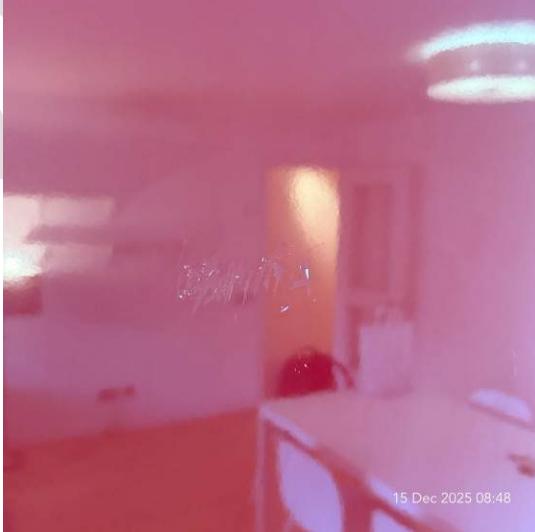
6 white laminate and light wood trim dining chairs with white metal frames with plastic capping to base of frames		<i>As per check in</i>
Large burgundy gloss laminate panel to wall with black wooden 2-section panel attached with 2 tempered glass opaque shelves fitted	Top shelf badly cracked and chipped to centre	1" scrape defect with sticky tape mark right hand side, area of scratch marks to right hand side, 2 areas of rubs/abrasions, fe smal chips low level scuffs behind tv - tenant

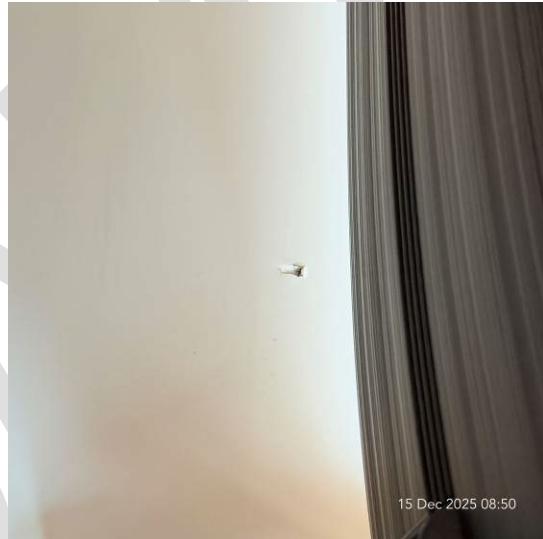
2 folders containing assorted instruction manuals		<i>As per check in</i>
Samsung 50" LCD TV on black table top stand with remote control and instruction manual		<i>As per check in</i>
Long rectangular white laminate TV cabinet with 3 cupboards with grey laminate doors each with shelf to interior, cable cover		Small indent to top - tenant

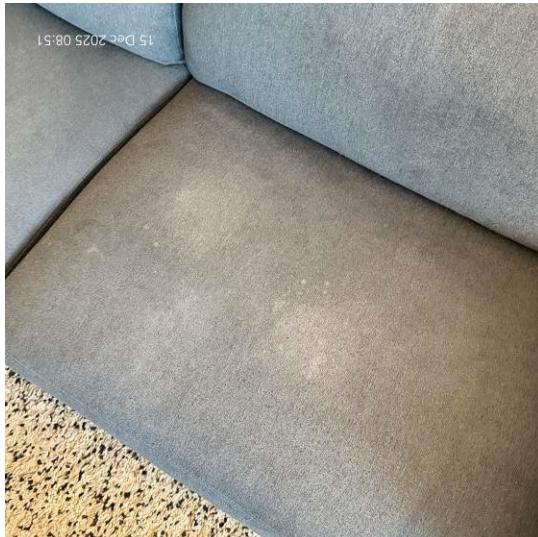
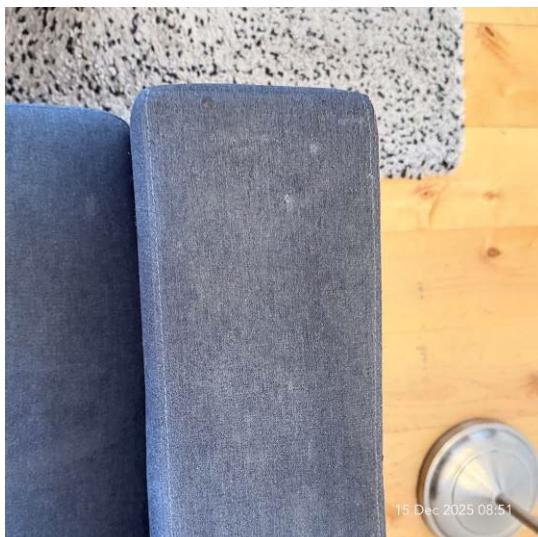
Grey fleece style 2-seater sofa with 2 fixed seat cushions and 2 Velcro backrest cushions on polished chrome legs		not cleaned, heavy patchy faded staining to seat cushions and to left arm, requires cleaning, stains may remain - tenant
---	--	---

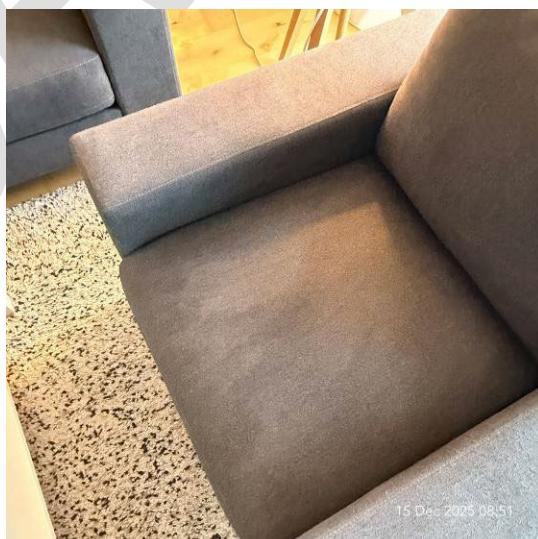
Matching armchair on chrome legs

slightly patchy faded appearance
to seats - **tenant**

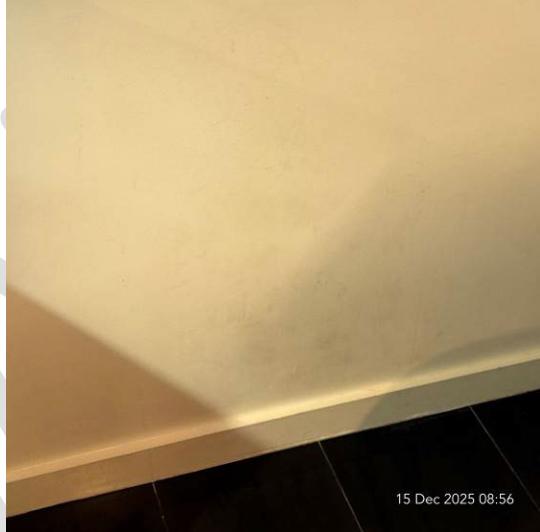
KITCHEN		
DESCRIPTION	CHECK IN CONDITION	CHECK OUT CONDITION AS CHECK IN UNLESS STATED
DOOR		
Painted white with glazed panel, chrome lever handles and chain door closer	Door closer disconnected, nail fixing to interior	<i>As per check in</i>
WALLS		
Painted white	1 removable plastic hook, 2 filled and unpainted nail holes to right side of window, few minor drip marks under window	<i>wear and tear</i> patchy shading under window area

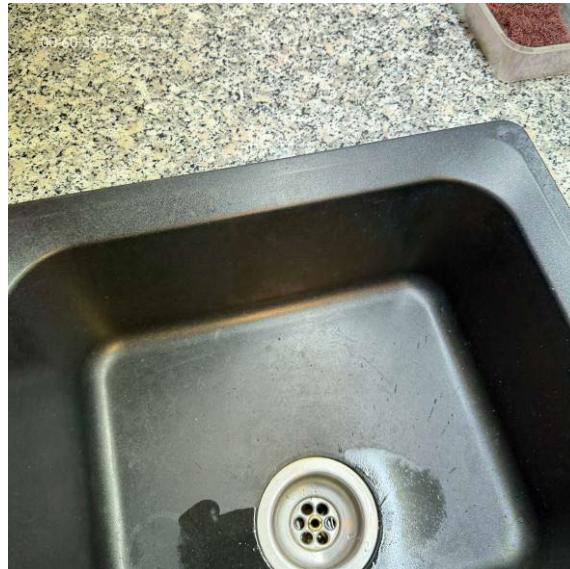
Stainless steel coloured Zanussi washing machine with outer brushed stainless steel décor door with chrome handle

Tested for power only, professionally cleaned, drip marks to base of casing

top hinge to décor door loose and requires repair – **landlord maintenance**, tested for power only, professionally cleaned, mildew staining to seal which may improve with further cleaning, **tenant**

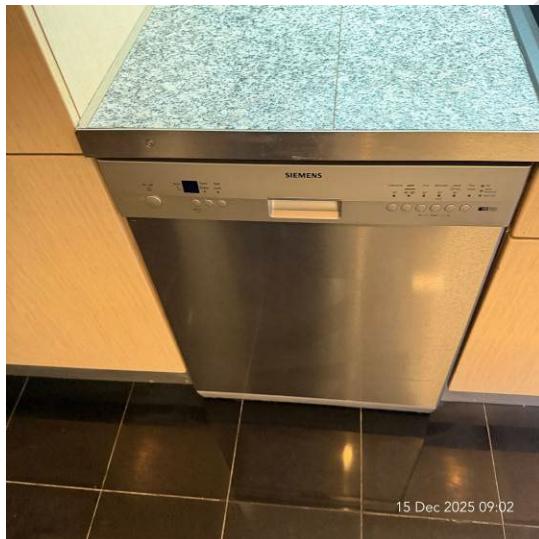
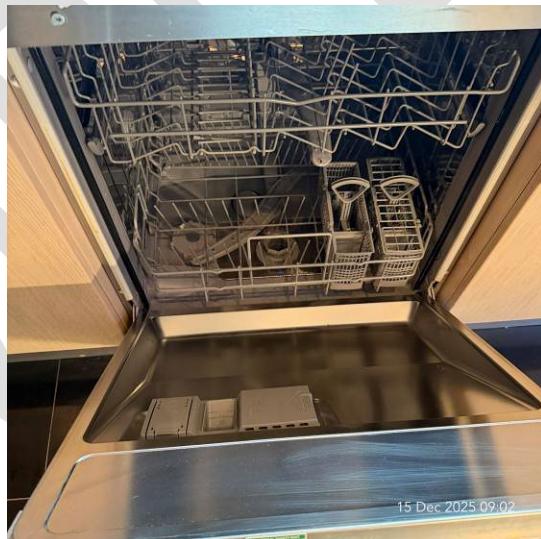
Brushed stainless steel style Siemens dishwasher with 2 baskets and cutlery basket

Tested for power only, minor indents to interior of door, professionally cleaned

tested for power only, professionally cleaned

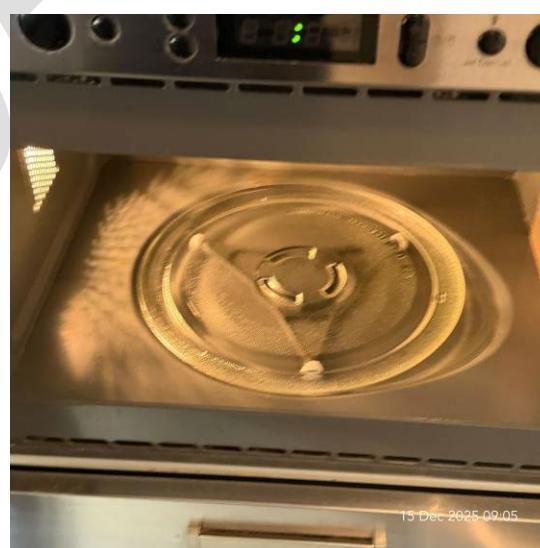
Fitted stainless steel trim Ikea microwave with black glass door front with brushed stainless steel handle and glass turntable

Tested for power only

Professionally cleaned, tested for power only, addition oven tin to remove

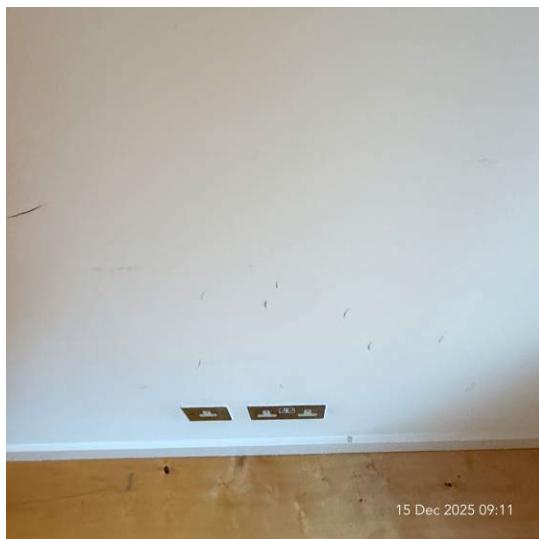
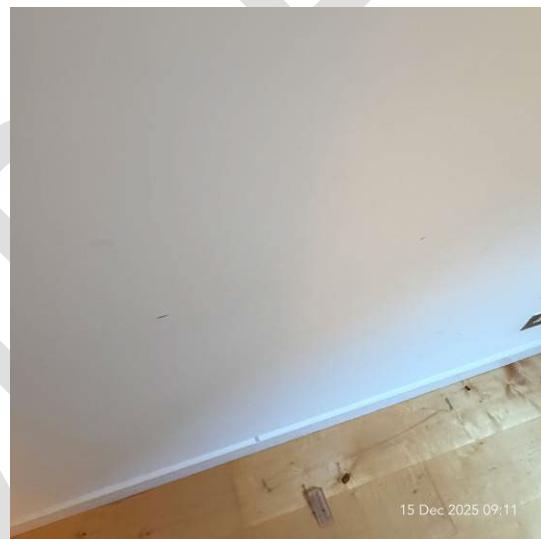
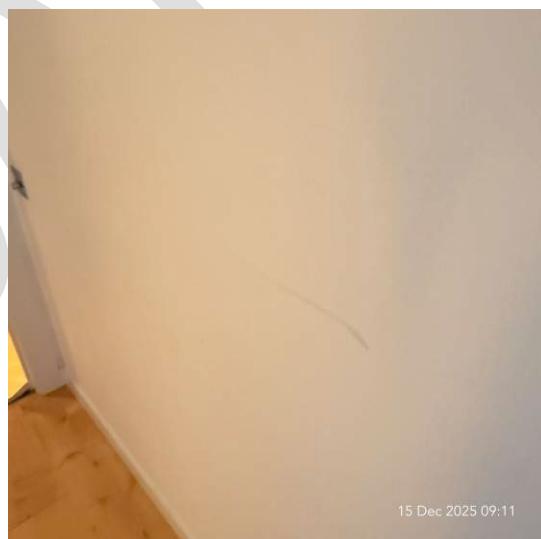
15 Dec 2025 09:10		
WALLS		
Painted white	mid level scuff marks to right hand side of light switch, low level scuffing around power points opposite bed, area of scuff marking at mid level to right hand side of bed, line scuff mark to left side of headboard	2 additional screw fixings to left hand wall, additional picture hook with scuff marking left hand side of window - tenant , wear and tear shading over bed area, mid and low level scuff marking to left hand wall, further wear and tear usage

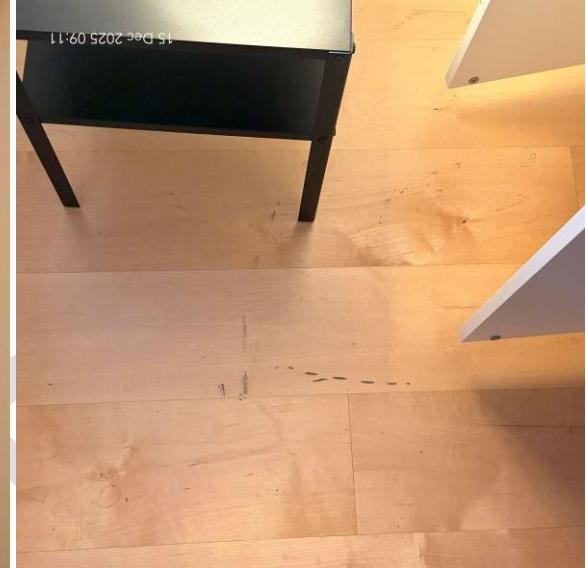
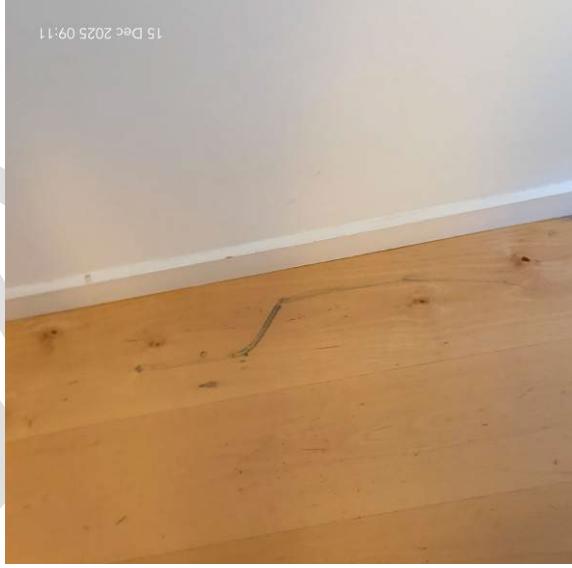
FLOORING		
Continuation of wood strip flooring from entrance hall with chrome door strip, chrome and rubber doorstop	Scattered indentation marks to walkways, scattered scratch marks to right hand side of bed area and in front of wardrobes, dark scratch marked areas forward of entrance with further dark scratch mark at foot of bed	Professionally cleaned, defects generally as per check in with further usage

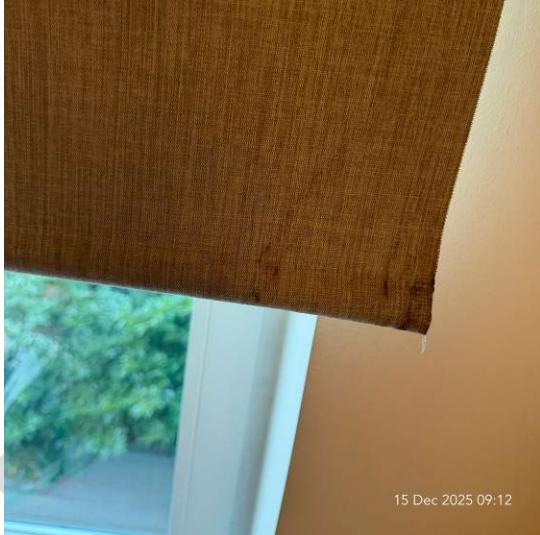
WINDOWS		
White framed double glazed casement window with chrome handle with lock, sill painted white	Cleaned to interior and exterior, few light scuff marks to sill, shaded marks to top of window reveal	Cleaned to interior only, exterior requires cleaning - tenant , wear and tear cracking to base of frame
CURTAINS/BLINDS		
Grey roller blind with plastic pulley		grubby marks to base, age discolouration and shading to lining, requires cleaning - tenant
