INTERIM INSPECTION REPORT

SAMPLE ADDRESS

SAMPLE DATE

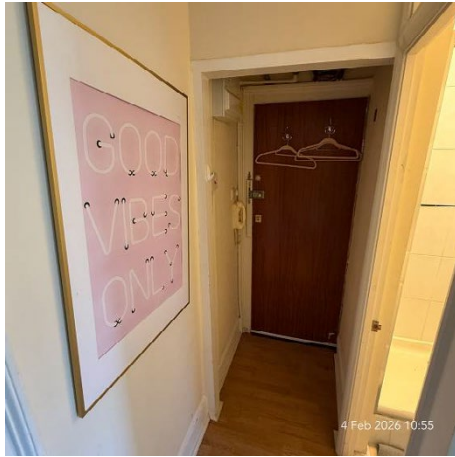
Staining noted adjacent to the shower room door, consistent with previous water ingress. Area appeared dry at the time of inspection, with damp meter readings within a normal range (indicative only). Leak staining to ceiling as per check in

Heat detector hanging loose from ceiling and requires repair

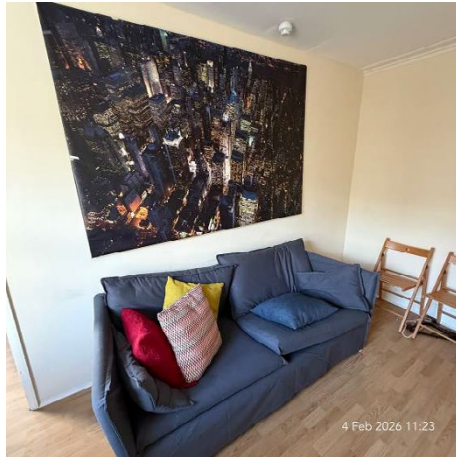
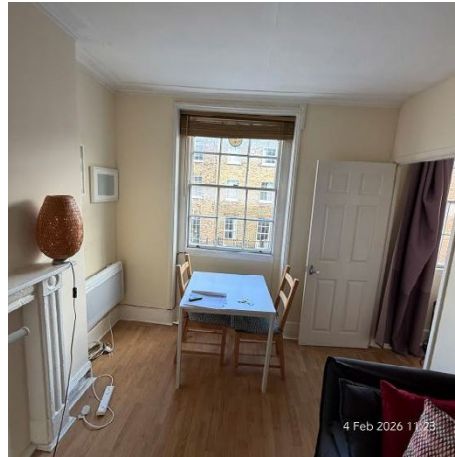
RECEPTION ROOM

leak staining under window, area appeared dry at the time of inspection, with damp meter readings within a normal range (indicative only)

Paint flaking to base of frame possibly due to leak damage as noted under decor

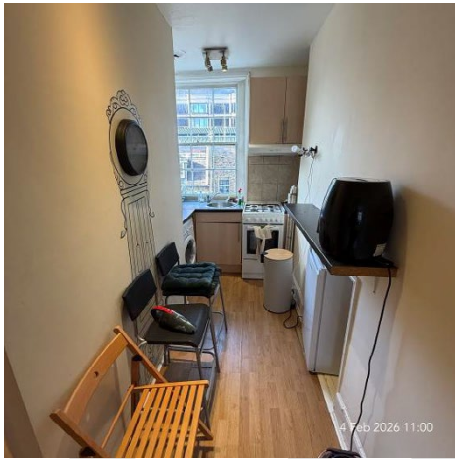
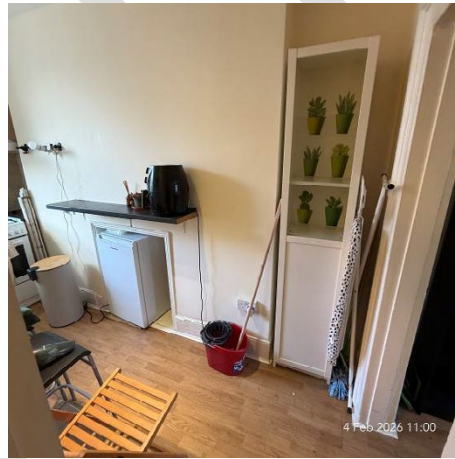
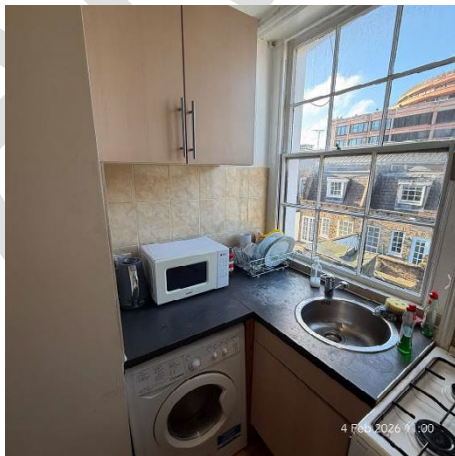
KITCHEN

Decor	further low level scuffs and splash marks to walls, now very grubby to wall left hand side of entrance
Flooring	Observed to be in reasonable condition, consistent with normal occupation and the condition recorded at check-in.
Windows	Crack to 1 pane – appears due to stress.
Units & worktops	1: Kitchen unit door below sink noted as being taped at commencement now no longer taped but hinge loose. 2: Worktops as per check in
Sink & taps	Loose taps repaired since check in
Appliances	Appliances observed externally only. No testing carried out. Cleanliness below the standard recorded at check-in.
Cleanliness	below the standard recorded at check-in
Content defects	Venetian blind off and broken

Blind as above

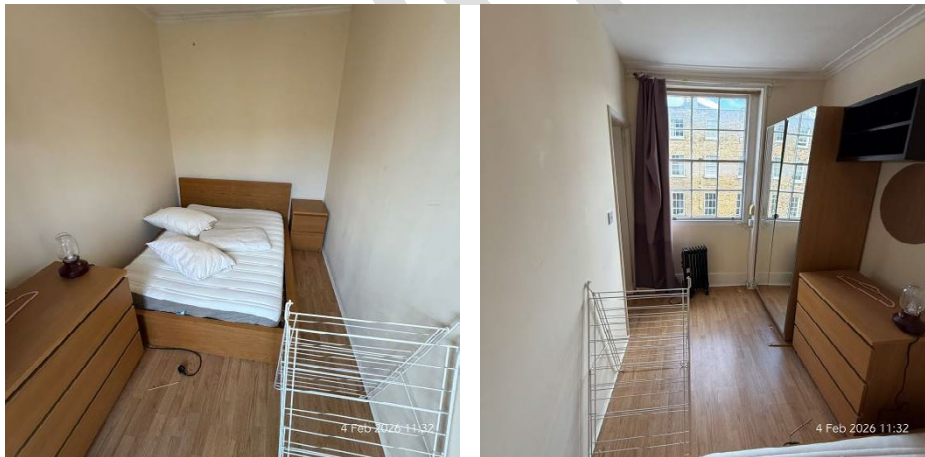
BEDROOM

Decor	Appears in reasonable condition at the time of inspection, with minor marks consistent with normal occupation.
Flooring	Observed to be in reasonable condition, consistent with normal occupation and the condition recorded at check-in.
Windows	mildew and slight flaking around frames, may indicate a condensation related issue although none evident at time of inspection
Cleanliness	below the standard recorded at check-in
Content defects	No observable additions to condition recorded at check-in.
Maintenance issues	None.

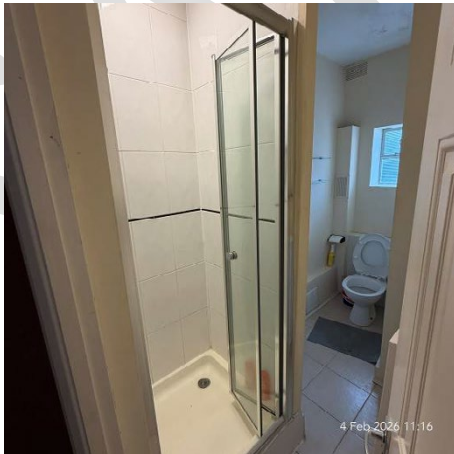
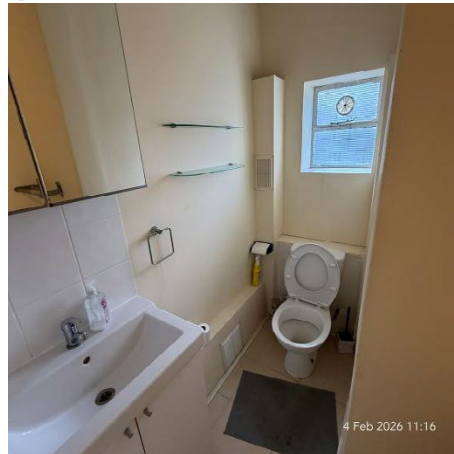
SHOWER ROOM

Large leak damaged area over WC which continues to wall to same area

Defects as per check in, cleaning below the standard recorded at check-in

Toilet seat replaced since check in, cleaning below the standard recorded at check-in

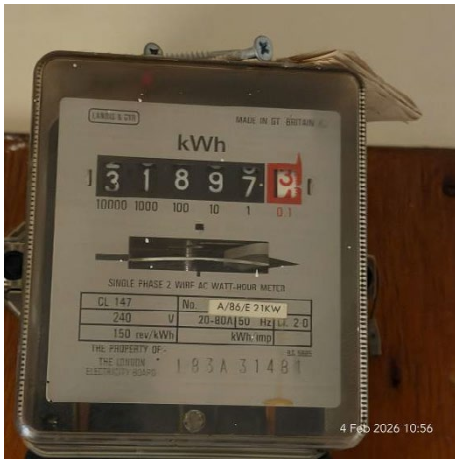
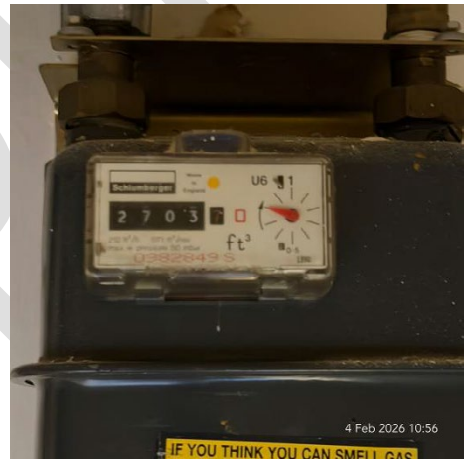
ELECTRIC METER:		GAS METER:	
READING	31897	READING	2703
SERIAL NUMBER	183A31481	SERIAL NUMBER	0982849S
LOCATION	Entrance Hall	LOCATION	Entrance Hall
