**INTERIM INSPECTION REPORT**

**SAMPLE ADDRESS**

<b>Inspection date:</b>	4 <sup>th</sup> February 2026
<b>Tenancy Check in date:</b>	3 <sup>rd</sup> August 2025
<b>Property type:</b>	1 bedroom, furnished apartment
<b>Tenant Present:</b>	No
<b>Access Gained To:</b>	All main rooms
<b>Access Restrictions (if any):</b>	none

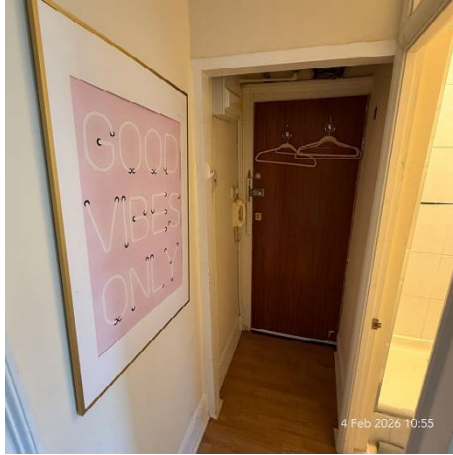
Staining noted adjacent to the shower room door, consistent with previous water ingress. Area appeared dry at the time of inspection, with damp meter readings within a normal range (indicative only). Leak staining to ceiling as per check in

Heat detector hanging loose from ceiling and requires repair

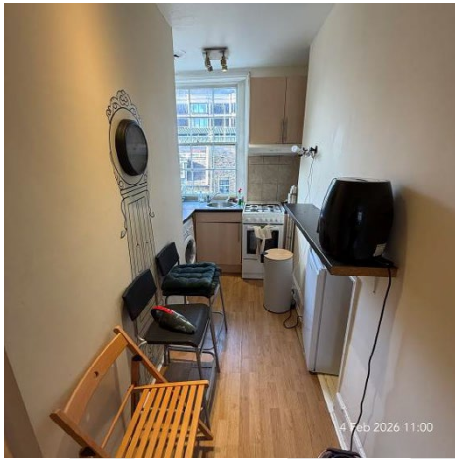
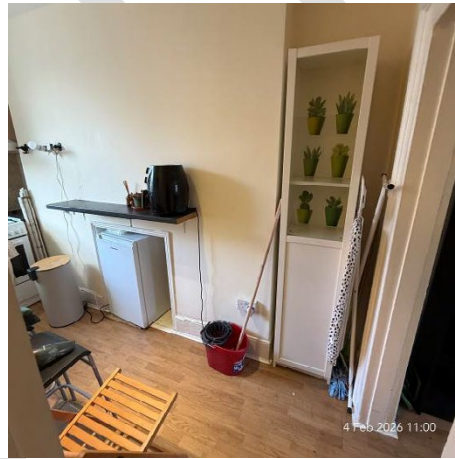
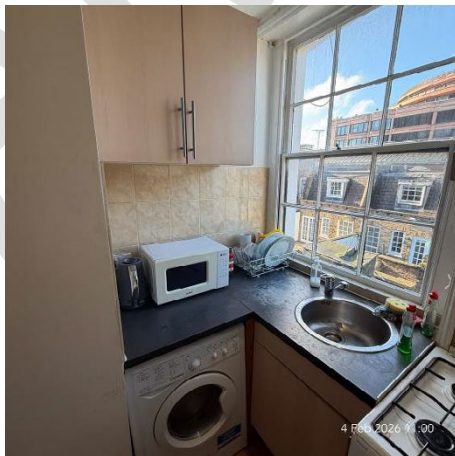
**KITCHEN**

<b>Decor</b>	further low level scuffs and splash marks to walls, now very grubby to wall left hand side of entrance
<b>Flooring</b>	as per check in
<b>Windows</b>	Crack to 1 pane – appears due to stress.
<b>Units &amp; worktops</b>	1: Kitchen unit door below sink noted as being taped at commencement now no longer taped but hinge loose. 2: Worktops as per check in
<b>Sink &amp; taps</b>	Loose taps repaired since check in
<b>Appliances (visual only)</b>	Appliances observed externally only. No testing carried out. Cleanliness below the standard recorded at check-in.
<b>Cleanliness</b>	below the standard recorded at check-in
<b>Content defects</b>	Venetian blind off and broken

Blind as above

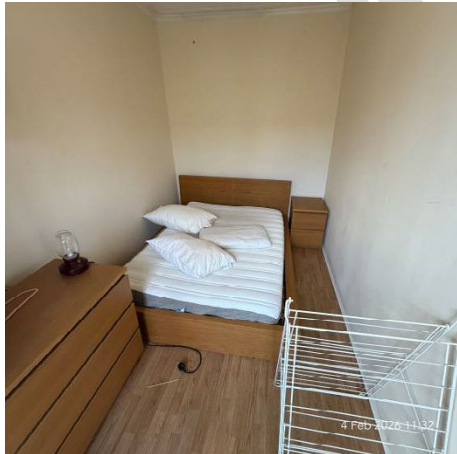
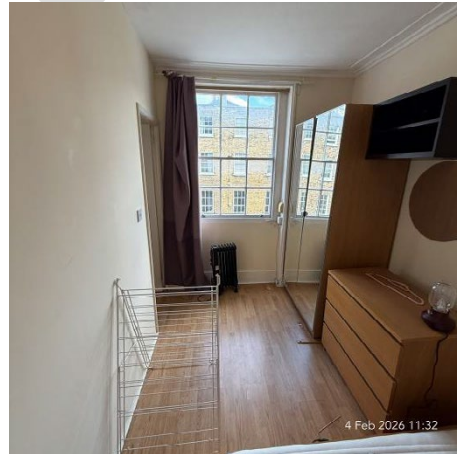
## BEDROOM

<b>Decor</b>	Defect as per check in with further patchy shading around bed area
<b>Flooring</b>	as per check in
<b>Windows</b>	mildew and slight flaking around frames, may indicate a condensation related issue although none evident at time of inspection
<b>Cleanliness</b>	below the standard recorded at check-in
<b>Content defects</b>	As per check in
<b>Maintenance issues</b>	none

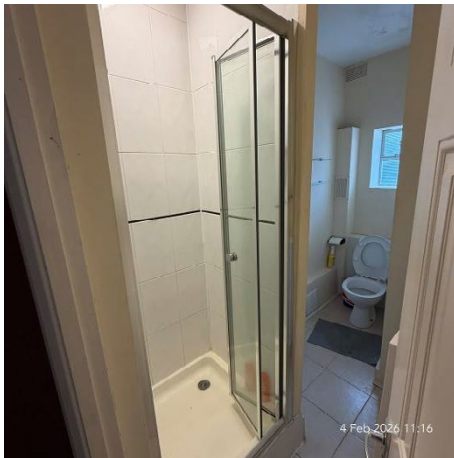
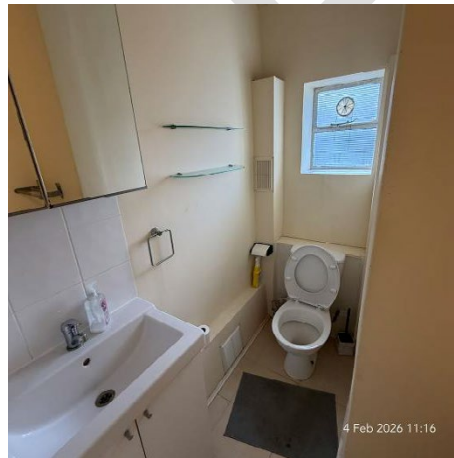
## SHOWER ROOM

<b>Decor</b>	Large leak damaged area over WC which continues to wall to same area
